Profile/Photo Observation Report

Street:	N Michigan Ave.	Flow Control:	Not Controlled
City:	Hobart, IN	Year Renewed:	
Location:	Other	Tape/Media #:	
Purpose:	Not Known	Dia/Height:	8"
Use:	Sanitary	Material:	VCP
Drain Area:	NA	Lining:	
Category:	NA		
Comment:

Location Details:		Direction of Survey:	Downstream
US MH:	M-704-017	DS MH:	M-704-016
		Total Length Surveyed (ft):	16.8

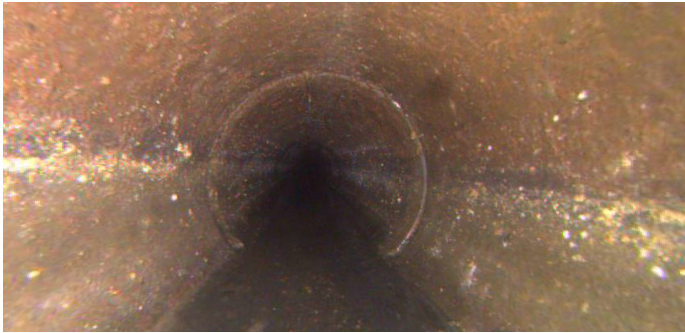
Code:	MWL
Description:	Water Level

Distance (ft):	.0
Structural Grade:	0
O&M Grade:	0
Clock Start/From:	
Clock To:	
1st Value:	
2nd Value:	
Value Percent:	5.000
Continuous Index:	
Within 8" of Joint:	NO
Remarks:

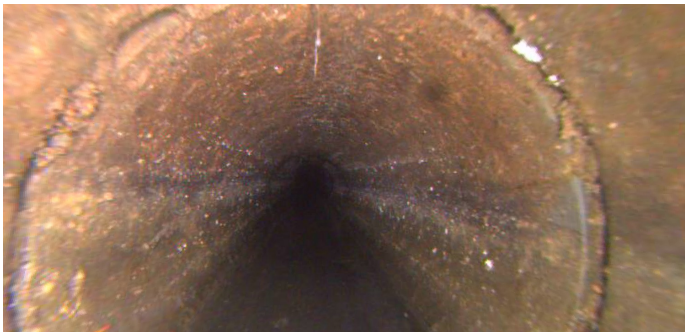
Code:	RFJ
Description:	Roots Fine Joint

Distance (ft):	1.1
Structural Grade:	0
O&M Grade:	1
Clock Start/From:	12
Clock To:	
1st Value:	
2nd Value:	
Value Percent:	
Continuous Index:	
Within 8" of Joint:	YES
Remarks:

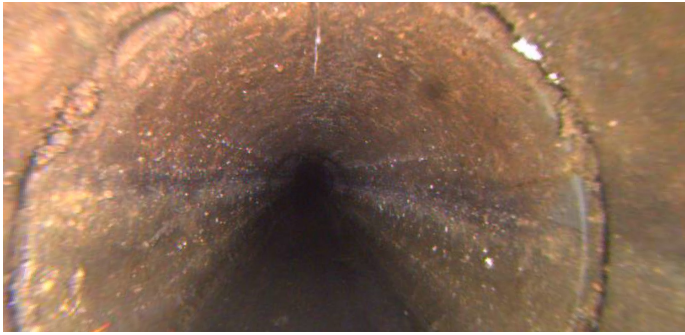
Code: **DAGS**
Description: **Deposits Attached Grease**

Distance (ft): **1.1**
Structural Grade: **0**
O&M Grade: **2**
Clock Start/From: **8**
Clock To: **4**
1st Value:
2nd Value:
Value Percent: **5.000**
Continuous Index: **S01**
Within 8" of Joint: **NO**
Remarks:

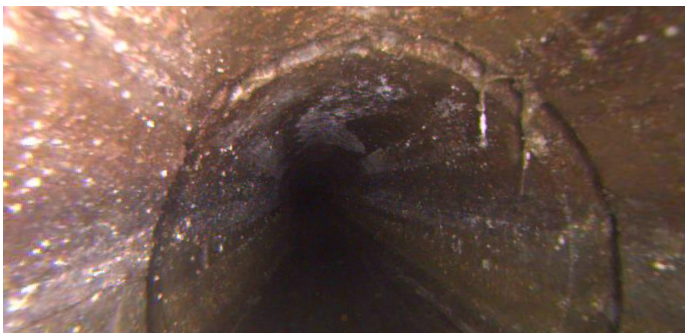
Code: **RFJ**
Description: **Roots Fine Joint**

Distance (ft): **5.6**
Structural Grade: **0**
O&M Grade: **1**
Clock Start/From: **11**
Clock To: **1**
1st Value:
2nd Value:
Value Percent:
Continuous Index:
Within 8" of Joint: **YES**
Remarks:

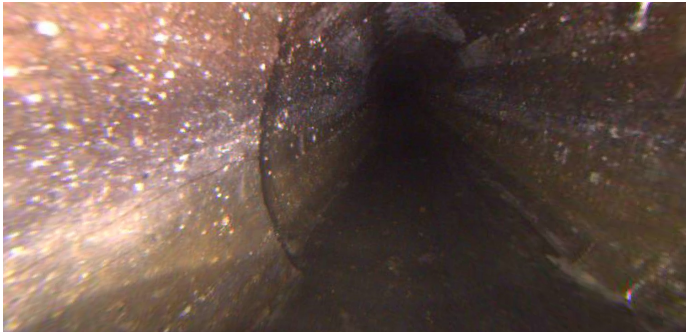
Code: **CL**
Description: **Crack Longitudinal**

Distance (ft): **5.6**
Structural Grade: **2**
O&M Grade: **0**
Clock Start/From: **9**
Clock To:
1st Value:
2nd Value:
Value Percent:
Continuous Index:
Within 8" of Joint: **YES**
Remarks:

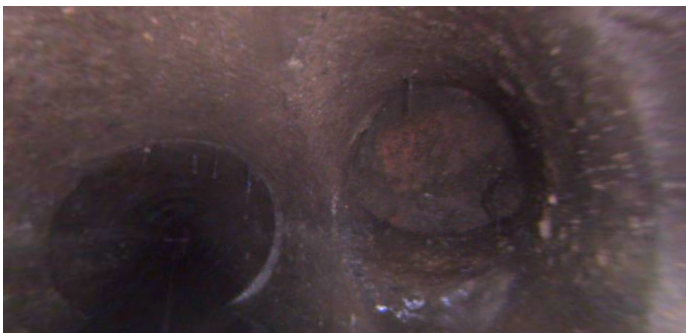
Code: **TFC**
Description: **Tap Factory Capped**

Distance (ft): **11.3**
Structural Grade: **0**
O&M Grade: **0**
Clock Start/From: **9**
Clock To:
1st Value: **4.000**
2nd Value:
Value Percent:
Continuous Index:
Within 8" of Joint:
Remarks:

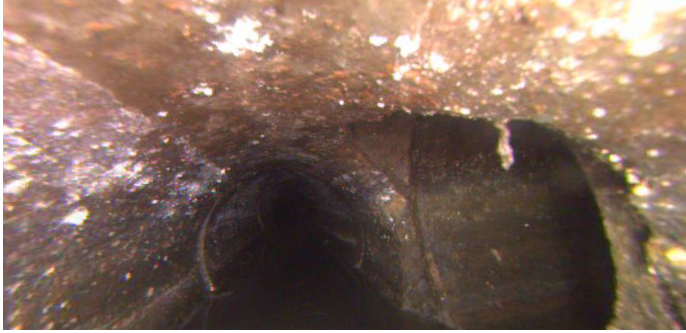
Code: **TB**
Description: **Tap Break-in**

Distance (ft): **14.8**
Structural Grade: **0**
O&M Grade: **0**
Clock Start/From: **3**
Clock To:
1st Value: **4.000**
2nd Value:
Value Percent:
Continuous Index:
Within 8" of Joint:
Remarks:

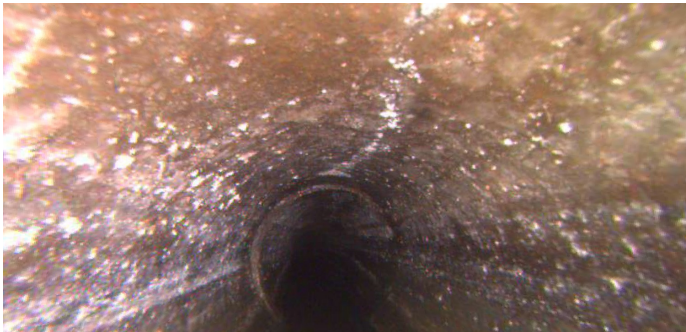
Code: **MSA**
Description: **Abandoned Survey**

Distance (ft): **16.8**
Structural Grade: **0**
O&M Grade: **0**
Clock Start/From:
Clock To:
1st Value:
2nd Value:
Value Percent:
Continuous Index:
Within 8" of Joint: **NO**
Remarks: **debris**

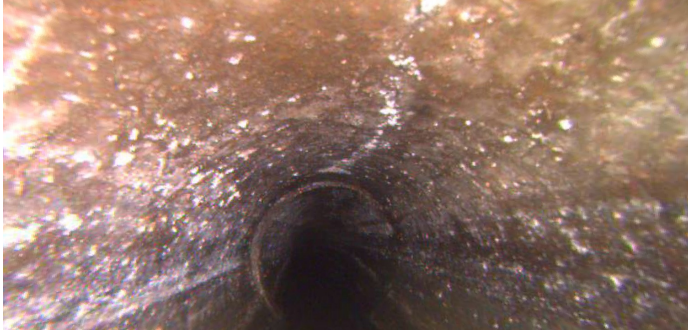
Code:	DAGS
Description:	Deposits Attached Grease
Distance (ft):	16.8
Structural Grade:	0
O&M Grade:	2
Clock Start/From:	8
Clock To:	4
1st Value:	
2nd Value:	
Value Percent:	5.000
Continuous Index:	F01
Within 8" of Joint:	NO
Remarks:
