# Profile/Photo Observation Report

| Pipe Length (ft): | 330.5 | Owner: | City of Hobart | Pre Clean: | Heavy Cleaning |

| Street: | North Michigan Avenue | Flow Control: | Not Controlled |
| US MH: | M-704-018 | DS MH: | M-704-017 |

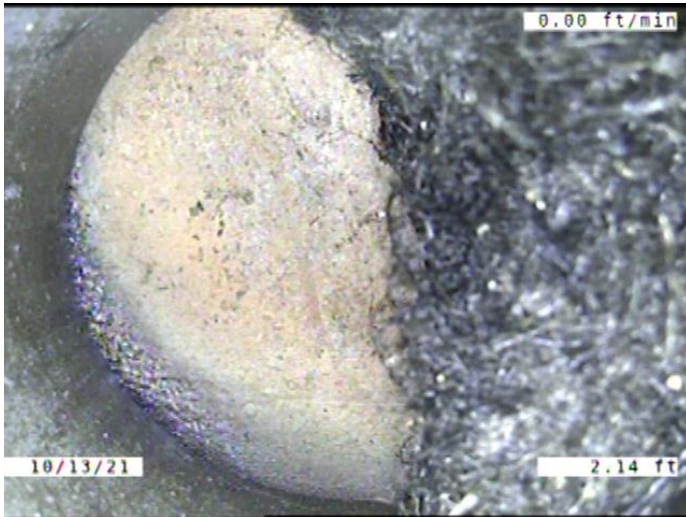
| Code: | <b>TFD</b> |
| Description: | <b>Tap Factory Defective</b> |
| Remarks: | <b>CAPPED. ROOTS GROWING AROUND THE CAP</b> |

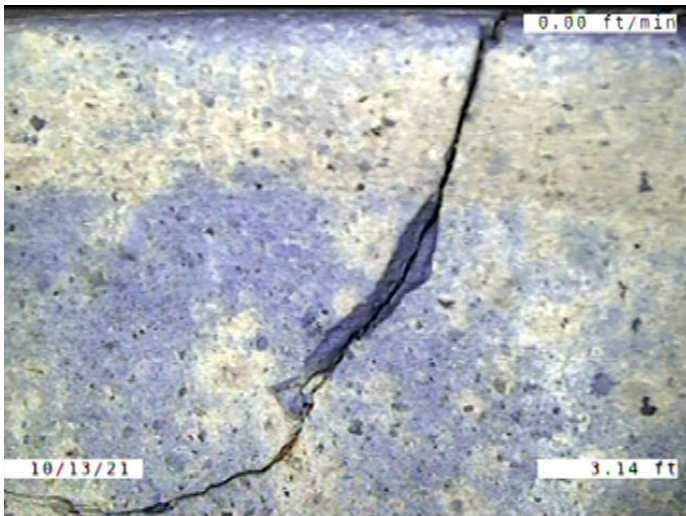
| Code: | <b>FS</b> |
| Description: | <b>Fracture Spiral</b> |
| Structural Grade: | <b>3</b> |

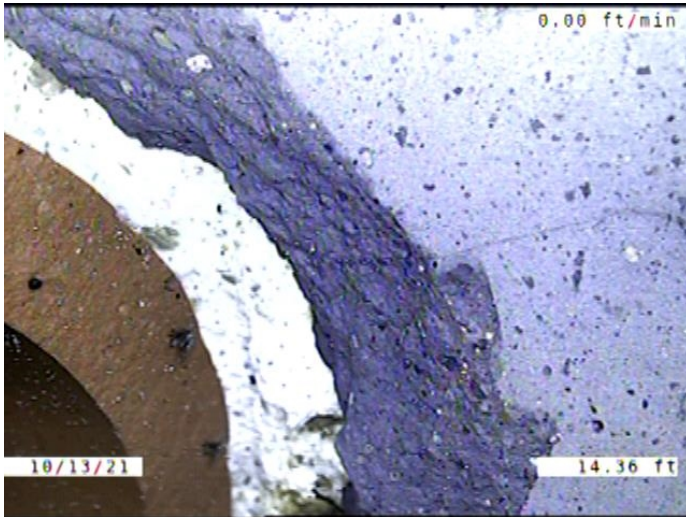
Code: **SSS**  
 Description: **Surface Damage Surface Spalling**

Distance (ft): **14.4**  
 Structural Grade: **2**  
 O&M Grade: **0**  
 Clock Start/From: **9**  
 Clock To: **1**  
 1st Value:  
 2nd Value:  
 Value Percent:  
 Continuous Index:  
 Within 8" of Joint: **YES**  
 Remarks:

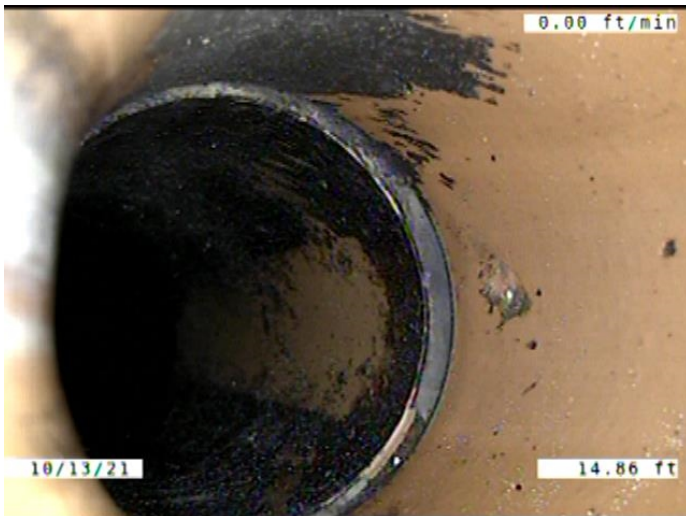
Code: **TBI**  
 Description: **Tap Break-in Intruding**

Distance (ft): **14.9**  
 Structural Grade: **0**  
 O&M Grade: **2**  
 Clock Start/From: **10**  
 Clock To:  
 1st Value: **4.000**  
 2nd Value: **1.000**  
 Value Percent:  
 Continuous Index:  
 Within 8" of Joint: **YES**  
 Remarks:

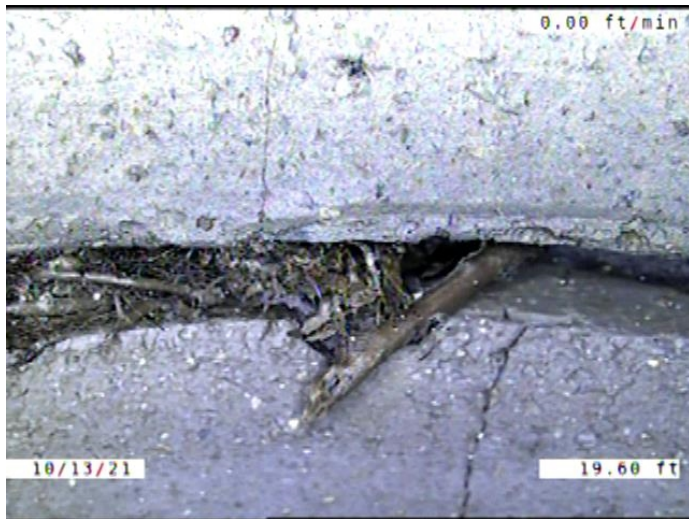
Code: **CM**  
Description: **Crack Multiple**

Distance (ft): **19.6**  
Structural Grade: **3**  
O&M Grade: **0**  
Clock Start/From: **10**  
Clock To: **11**  
1st Value:  
2nd Value:  
Value Percent:  
Continuous Index:  
Within 8" of Joint: **YES**  
Remarks:

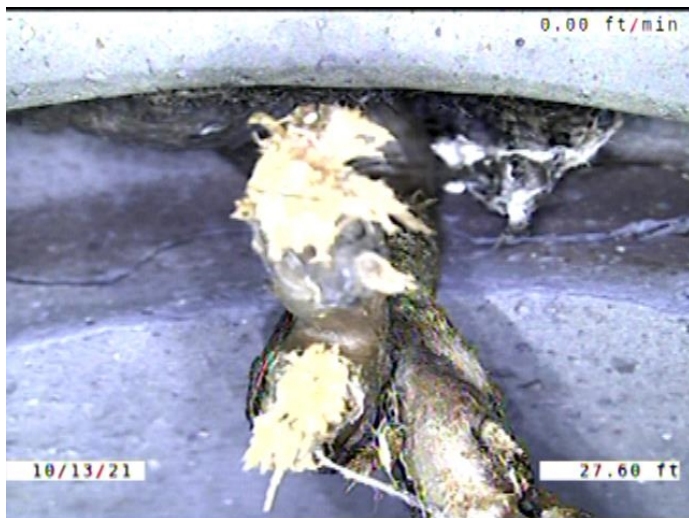
Code: **RTJ**  
Description: **Roots Tap Joint**

Distance (ft): **27.6**  
Structural Grade: **0**  
O&M Grade: **2**  
Clock Start/From: **2**  
Clock To: **3**  
1st Value:  
2nd Value:  
Value Percent: **5.000**  
Continuous Index:  
Within 8" of Joint: **YES**  
Remarks:

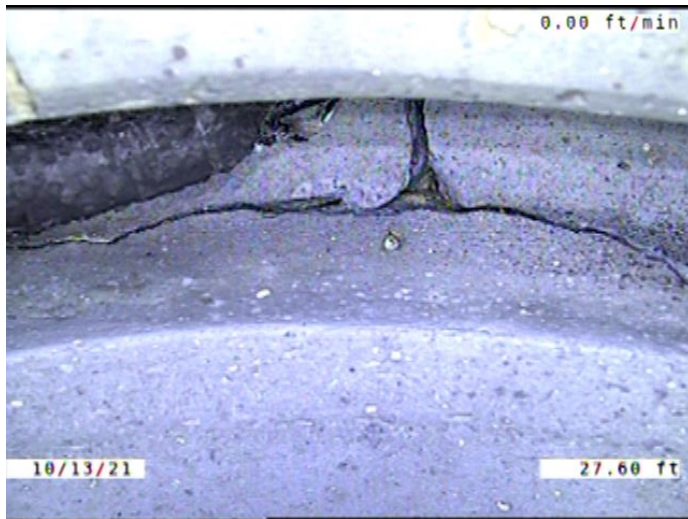
Code: **FM**  
Description: **Fracture Multiple**

Distance (ft): **27.6**  
Structural Grade: **4**  
O&M Grade: **0**  
Clock Start/From: **1**  
Clock To: **3**  
1st Value:  
2nd Value:  
Value Percent:  
Continuous Index:  
Within 8" of Joint: **YES**  
Remarks:

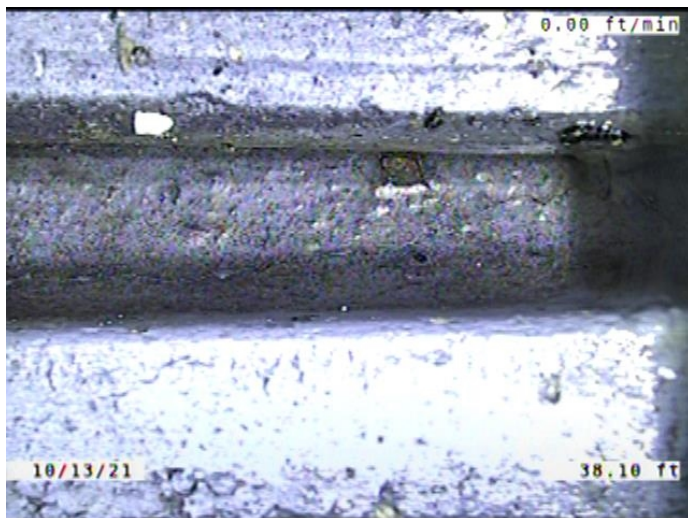
Code: **JAL**  
Description: **Joint Angular Large**

Distance (ft): **38.1**  
Structural Grade: **4**  
O&M Grade: **0**  
Clock Start/From:  
Clock To:  
1st Value:  
2nd Value:  
Value Percent:  
Continuous Index:  
Within 8" of Joint: **NO**  
Remarks:

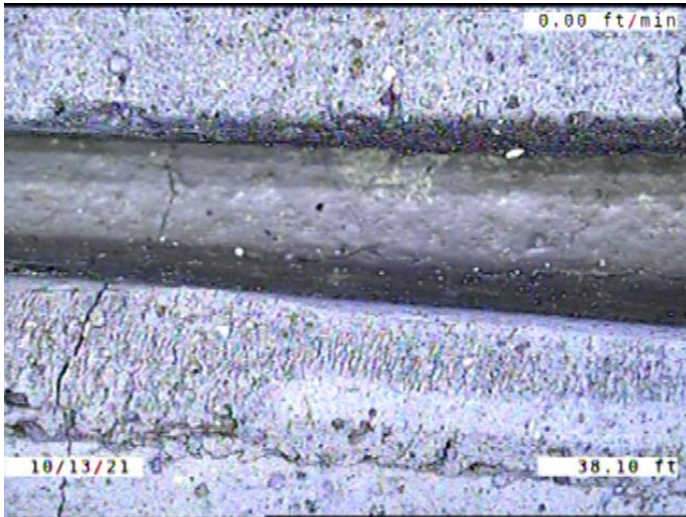
Code: **CM**  
Description: **Crack Multiple**

Distance (ft): **38.1**  
Structural Grade: **3**  
O&M Grade: **0**  
Clock Start/From: **9**  
Clock To: **3**  
1st Value:  
2nd Value:  
Value Percent:  
Continuous Index:  
Within 8" of Joint: **YES**  
Remarks:

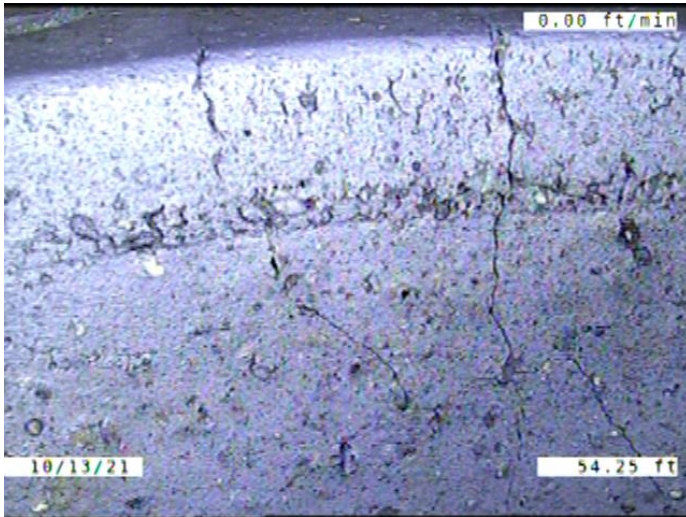
Code: **CM**  
 Description: **Crack Multiple**

Distance (ft): **54.2**  
 Structural Grade: **3**  
 O&M Grade: **0**  
 Clock Start/From: **9**  
 Clock To: **3**  
 1st Value:  
 2nd Value:  
 Value Percent:  
 Continuous Index:  
 Within 8" of Joint: **YES**  
 Remarks:

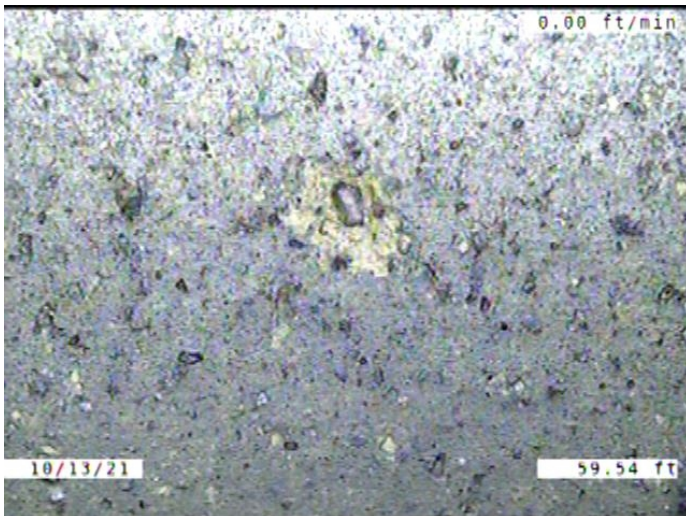
Code: **SSS**  
 Description: **Surface Damage Surface Spalling**

Distance (ft): **59.5**  
 Structural Grade: **2**  
 O&M Grade: **0**  
 Clock Start/From: **1**  
 Clock To:  
 1st Value:  
 2nd Value:  
 Value Percent:  
 Continuous Index:  
 Within 8" of Joint: **YES**  
 Remarks:

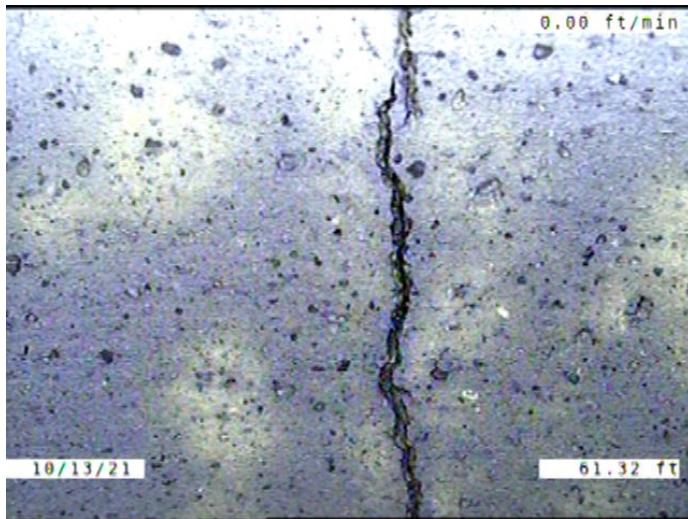
Code: **FL**  
Description: **Fracture Longitudinal**

Distance (ft): **61.3**  
Structural Grade: **3**  
O&M Grade: **0**  
Clock Start/From: **2**  
Clock To:  
1st Value:  
2nd Value:  
Value Percent:  
Continuous Index:  
Within 8" of Joint: **NO**  
Remarks:

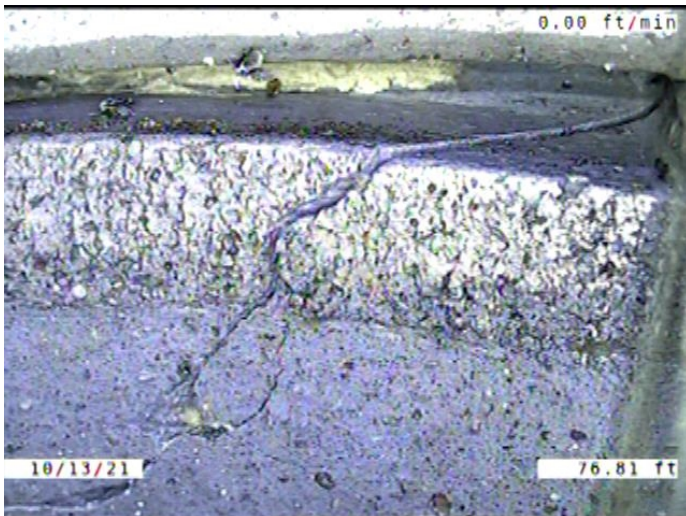
Code: **FM**  
 Description: **Fracture Multiple**

Distance (ft): **76.8**  
 Structural Grade: **4**  
 O&M Grade: **0**  
 Clock Start/From: **12**  
 Clock To: **3**  
 1st Value:  
 2nd Value:  
 Value Percent:  
 Continuous Index:  
 Within 8" of Joint: **YES**  
 Remarks:

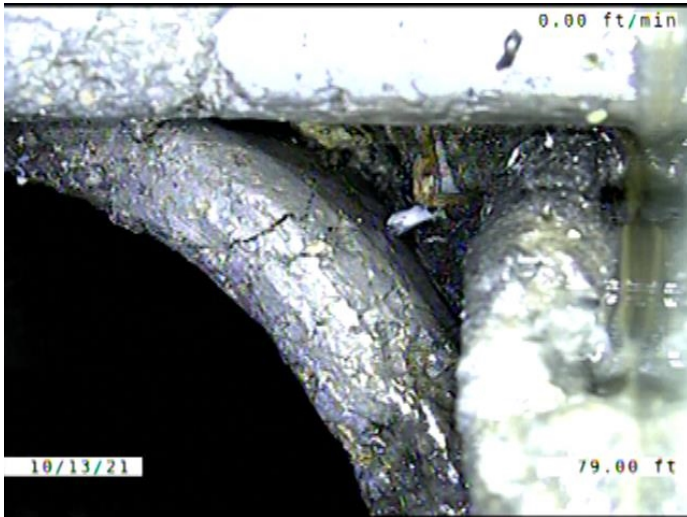
Code: **BSV**  
Description: **Broken Soil Visible**

Distance (ft): **79.0**  
Structural Grade: **5**  
O&M Grade: **0**  
Clock Start/From: **10**  
Clock To: **3**  
1st Value:  
2nd Value:  
Value Percent:  
Continuous Index:  
Within 8" of Joint: **YES**  
Remarks:

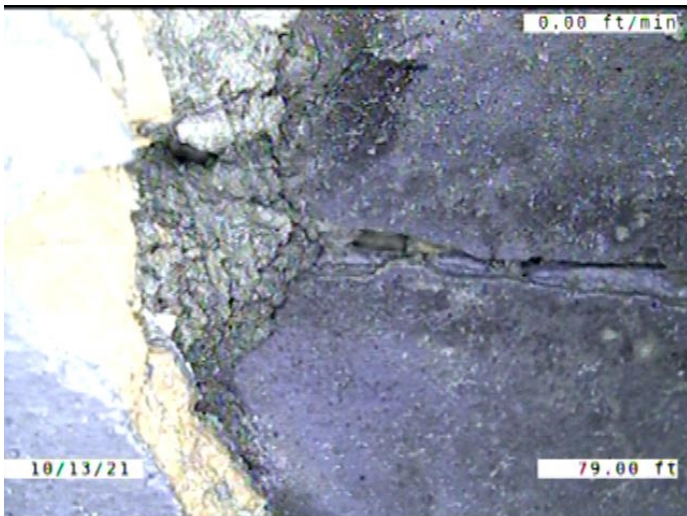
Code: **SMW**  
Description: **Surface Damage Missing Wall**

Distance (ft): **79.0**  
Structural Grade: **5**  
O&M Grade: **0**  
Clock Start/From: **12**  
Clock To: **3**  
1st Value:  
2nd Value:  
Value Percent:  
Continuous Index:  
Within 8" of Joint: **YES**  
Remarks: **LOOKS LIKE SOMEONE TRIED TO REPAIR IT**

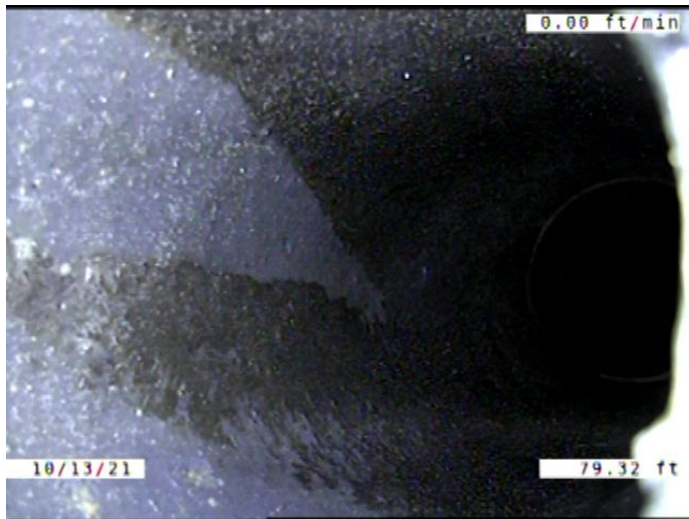
| Code: | <b>TBD</b> |
| Description: | <b>Tap Break-in/Hammer Defective</b> |
| Remarks: | <b>Defective</b> |

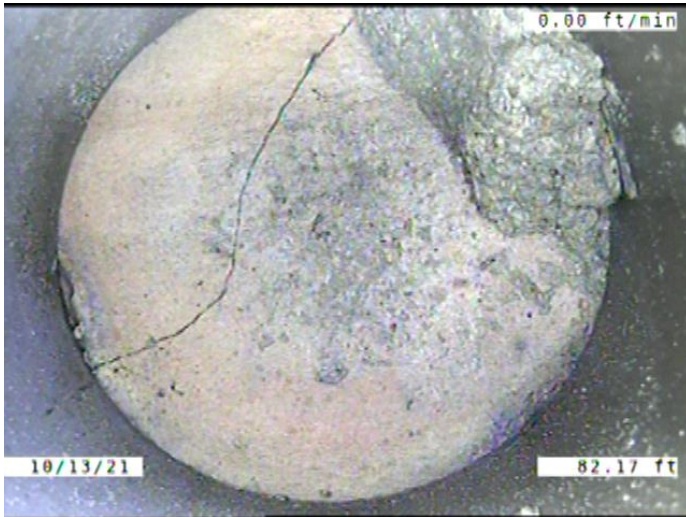
Code: **TFC**  
Description: **Tap Factory Capped**

Distance (ft): **82.2**  
Structural Grade: **0**  
O&M Grade: **0**  
Clock Start/From: **2**  
Clock To:  
1st Value: **4.000**  
2nd Value:  
Value Percent:  
Continuous Index:  
Within 8" of Joint: **YES**  
Remarks: **CAP BROKEN**

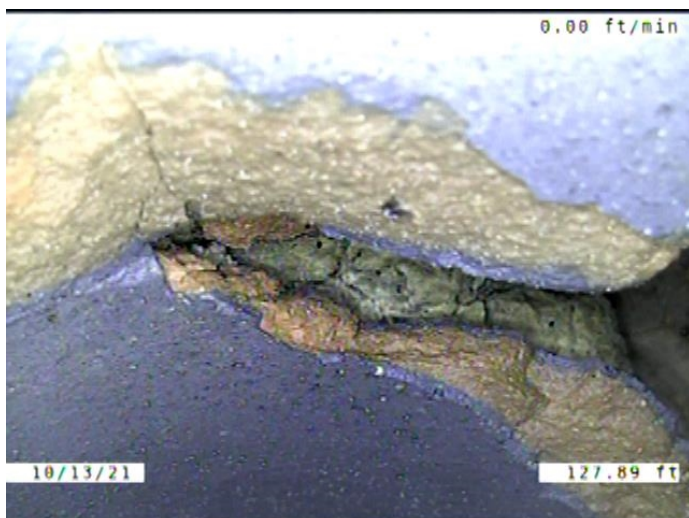
Code: **BSV**  
 Description: **Broken Soil Visible**

Distance (ft): **127.9**  
 Structural Grade: **5**  
 O&M Grade: **0**  
 Clock Start/From: **10**  
 Clock To: **3**  
 1st Value:  
 2nd Value:  
 Value Percent:  
 Continuous Index:  
 Within 8" of Joint: **YES**  
 Remarks:

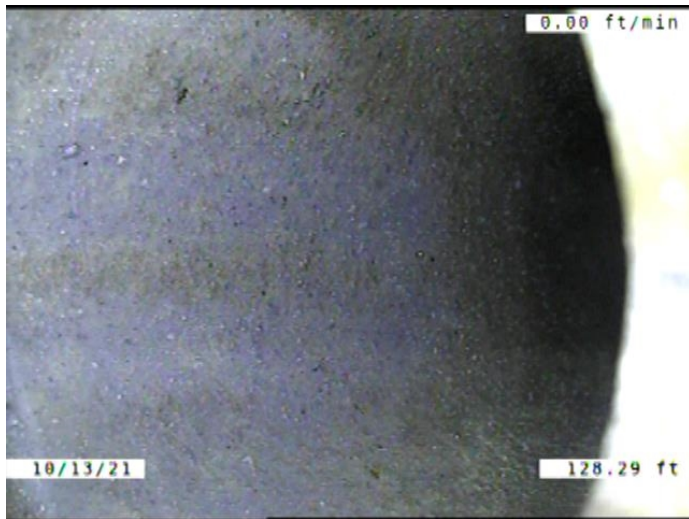
| Code: | <b>TBD</b> |
| Description: | <b>Tap Break-in/Hammer Defective</b> |
| Remarks: | <b>Defective</b> |

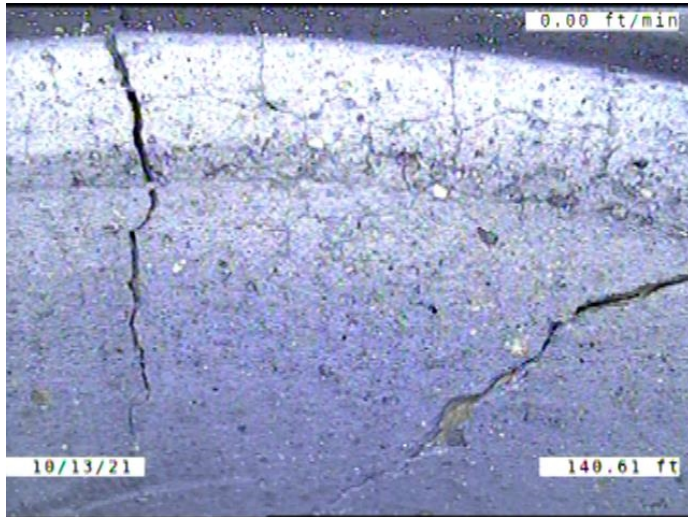
Code: **FM**  
 Description: **Fracture Multiple**

Distance (ft): **140.6**  
 Structural Grade: **4**  
 O&M Grade: **0**  
 Clock Start/From: **10**  
 Clock To: **2**  
 1st Value:  
 2nd Value:  
 Value Percent:  
 Continuous Index:  
 Within 8" of Joint: **YES**  
 Remarks:

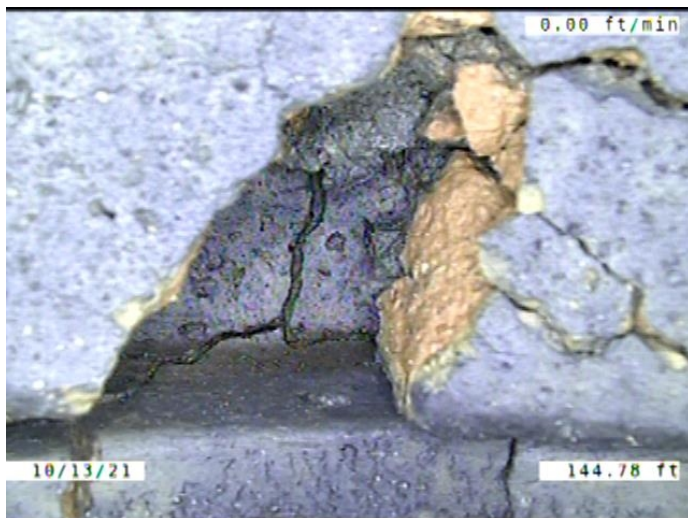
Code: **FM**  
 Description: **Fracture Multiple**

Distance (ft): **144.8**  
 Structural Grade: **4**  
 O&M Grade: **0**  
 Clock Start/From: **9**  
 Clock To: **3**  
 1st Value:  
 2nd Value:  
 Value Percent:  
 Continuous Index:  
 Within 8" of Joint: **YES**  
 Remarks:

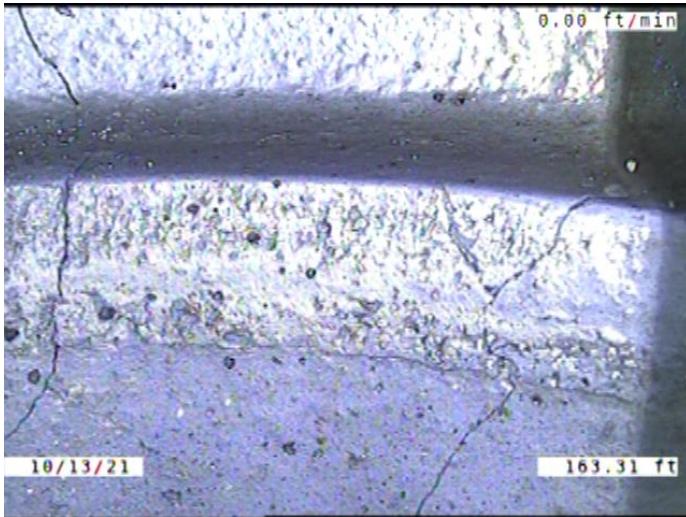
Code: **FM**  
 Description: **Fracture Multiple**

Distance (ft): **163.3**  
 Structural Grade: **4**  
 O&M Grade: **0**  
 Clock Start/From: **9**  
 Clock To: **3**  
 1st Value:  
 2nd Value:  
 Value Percent:  
 Continuous Index:  
 Within 8" of Joint: **YES**  
 Remarks:

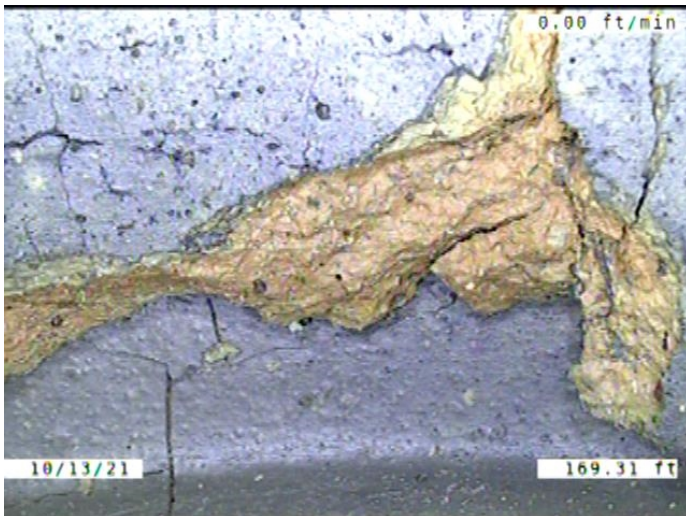
Code: **SMW**  
 Description: **Surface Damage Missing Wall**

Distance (ft): **169.3**  
 Structural Grade: **5**  
 O&M Grade: **0**  
 Clock Start/From: **11**  
 Clock To: **1**  
 1st Value:  
 2nd Value:  
 Value Percent:  
 Continuous Index:  
 Within 8" of Joint: **YES**  
 Remarks: **INSIDE OF THE JOINT**

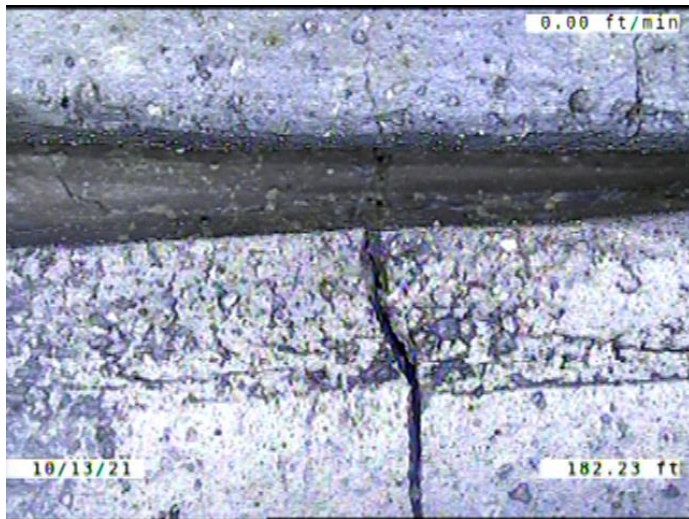
Code: **FM**  
 Description: **Fracture Multiple**

Distance (ft): **182.2**  
 Structural Grade: **4**  
 O&M Grade: **0**  
 Clock Start/From: **9**  
 Clock To: **3**  
 1st Value:  
 2nd Value:  
 Value Percent:  
 Continuous Index:  
 Within 8" of Joint: **YES**  
 Remarks:

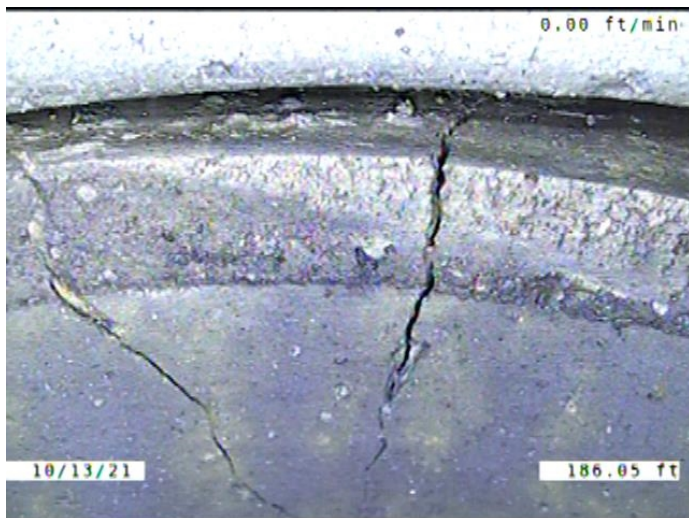
Code: **FM**  
 Description: **Fracture Multiple**

Distance (ft): **186.0**  
 Structural Grade: **4**  
 O&M Grade: **0**  
 Clock Start/From: **10**  
 Clock To: **4**  
 1st Value:  
 2nd Value:  
 Value Percent:  
 Continuous Index:  
 Within 8" of Joint: **YES**  
 Remarks:

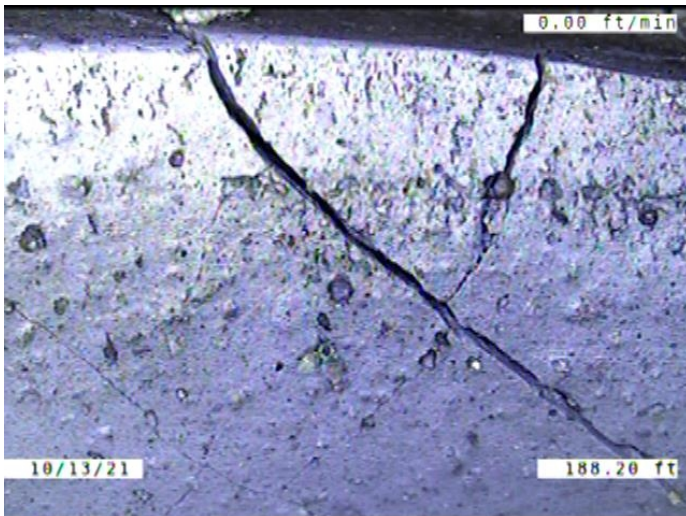
Code: **B**  
 Description: **Broken**

Distance (ft): **188.2**  
 Structural Grade: **4**  
 O&M Grade: **0**  
 Clock Start/From: **8**  
 Clock To: **4**  
 1st Value:  
 2nd Value:  
 Value Percent:  
 Continuous Index:  
 Within 8" of Joint: **YES**  
 Remarks:

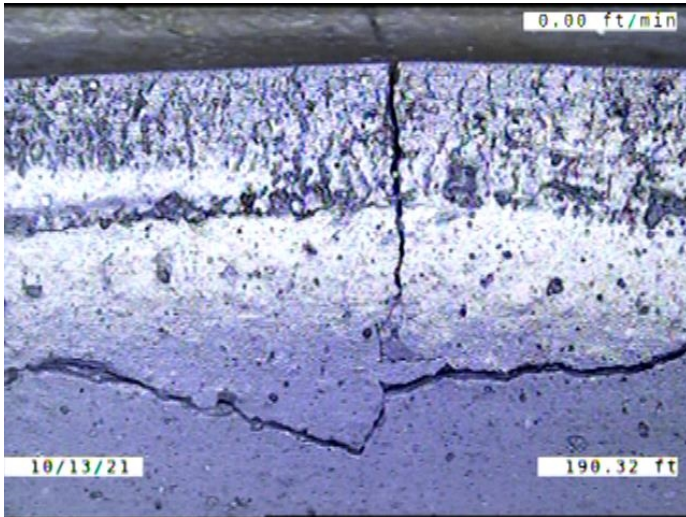
Code: **FM**  
 Description: **Fracture Multiple**

Distance (ft): **190.3**  
 Structural Grade: **4**  
 O&M Grade: **0**  
 Clock Start/From: **10**  
 Clock To: **3**  
 1st Value:  
 2nd Value:  
 Value Percent:  
 Continuous Index:  
 Within 8" of Joint: **YES**  
 Remarks:

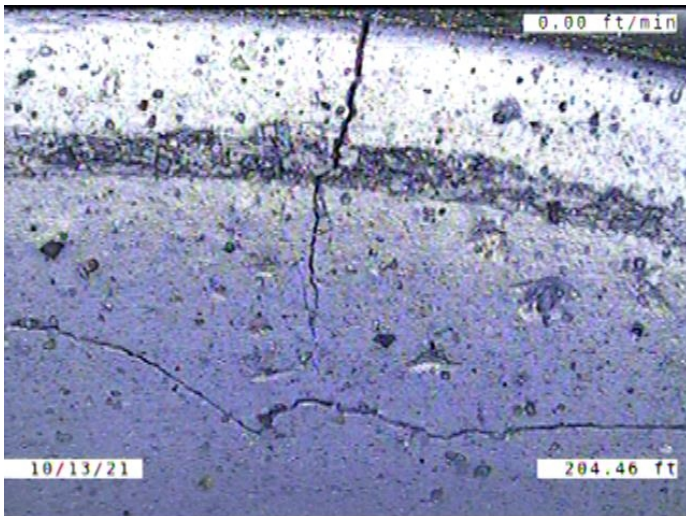
Code: **FM**  
 Description: **Fracture Multiple**

Distance (ft): **204.5**  
 Structural Grade: **4**  
 O&M Grade: **0**  
 Clock Start/From: **9**  
 Clock To: **2**  
 1st Value:  
 2nd Value:  
 Value Percent:  
 Continuous Index:  
 Within 8" of Joint: **YES**  
 Remarks:

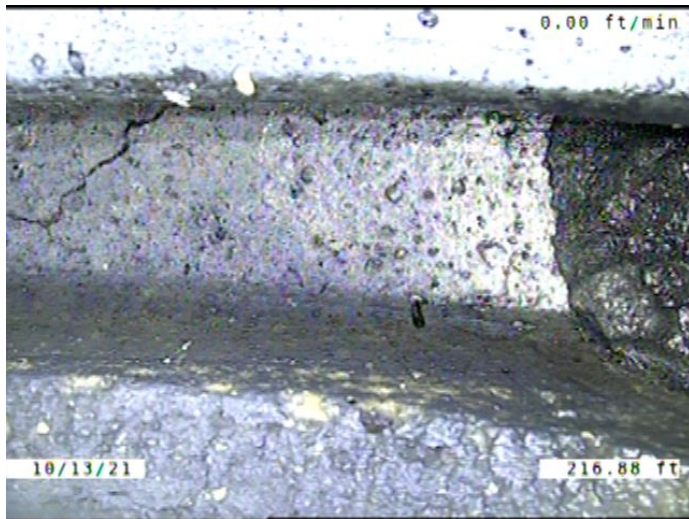
Code: **JAM**  
Description: **Joint Angular Medium**

Distance (ft): **216.9**  
Structural Grade: **3**  
O&M Grade: **0**  
Clock Start/From:  
Clock To:  
1st Value:  
2nd Value:  
Value Percent:  
Continuous Index:  
Within 8" of Joint: **NO**  
Remarks:

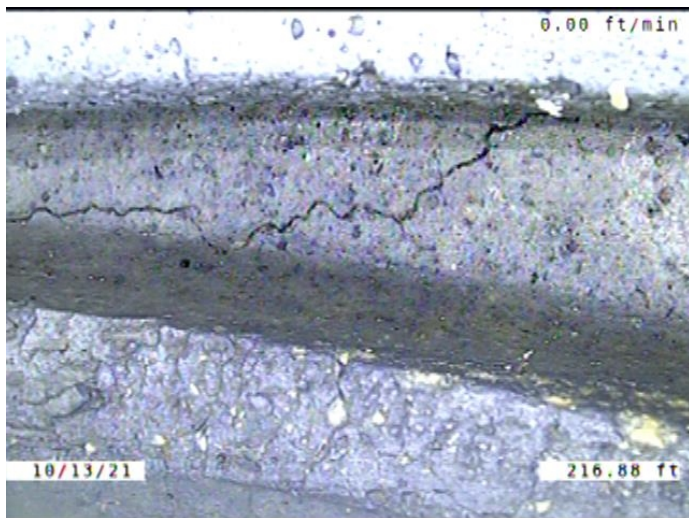
Code: **FM**  
Description: **Fracture Multiple**

Distance (ft): **216.9**  
Structural Grade: **4**  
O&M Grade: **0**  
Clock Start/From: **12**  
Clock To: **3**  
1st Value:  
2nd Value:  
Value Percent:  
Continuous Index:  
Within 8" of Joint: **YES**  
Remarks:

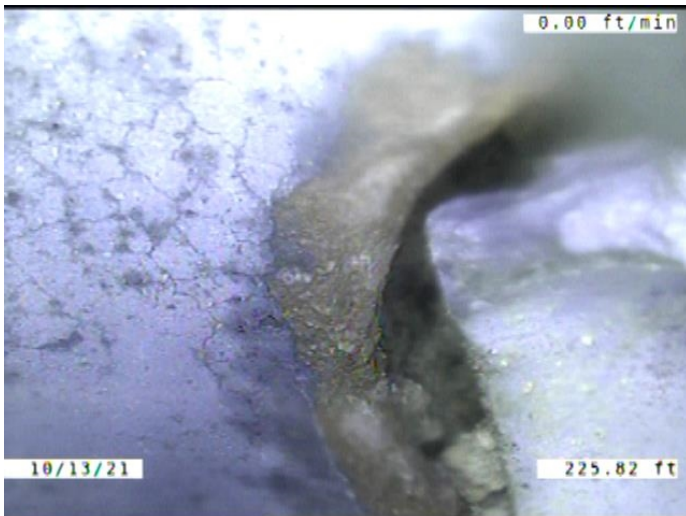
Code: **SSS**  
 Description: **Surface Damage Surface Spalling**

Distance (ft): **225.8**  
 Structural Grade: **2**  
 O&M Grade: **0**  
 Clock Start/From: **12**  
 Clock To: **3**  
 1st Value:  
 2nd Value:  
 Value Percent:  
 Continuous Index:  
 Within 8" of Joint: **YES**  
 Remarks:

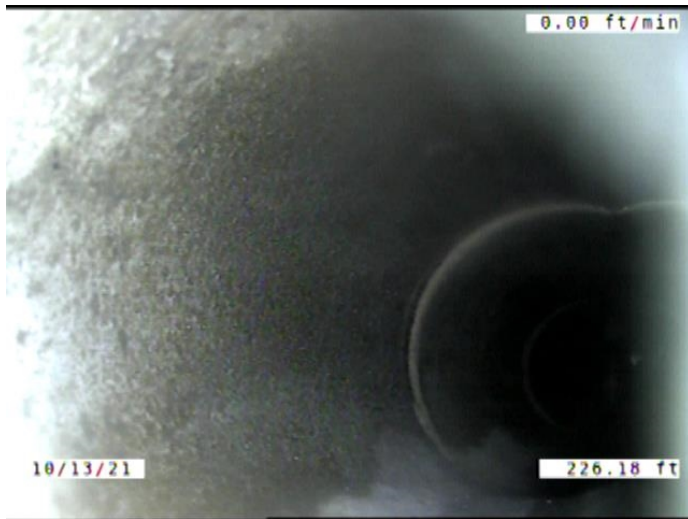
Code: **TBI**  
Description: **Tap Break-in Intruding**

Distance (ft): **226.2**  
Structural Grade: **0**  
O&M Grade: **2**  
Clock Start/From: **3**  
Clock To:  
1st Value: **4.000**  
2nd Value: **1.000**  
Value Percent:  
Continuous Index:  
Within 8" of Joint: **YES**  
Remarks:

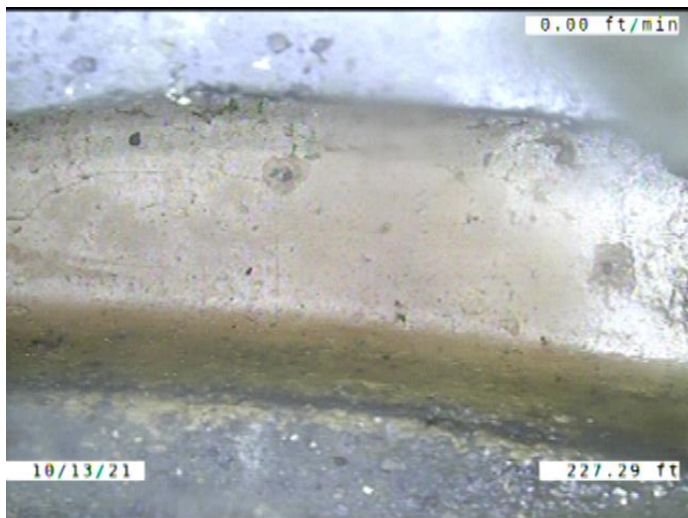
Code: **JAM**  
Description: **Joint Angular Medium**

Distance (ft): **227.3**  
Structural Grade: **3**  
O&M Grade: **0**  
Clock Start/From:  
Clock To:  
1st Value:  
2nd Value:  
Value Percent:  
Continuous Index:  
Within 8" of Joint: **NO**  
Remarks:

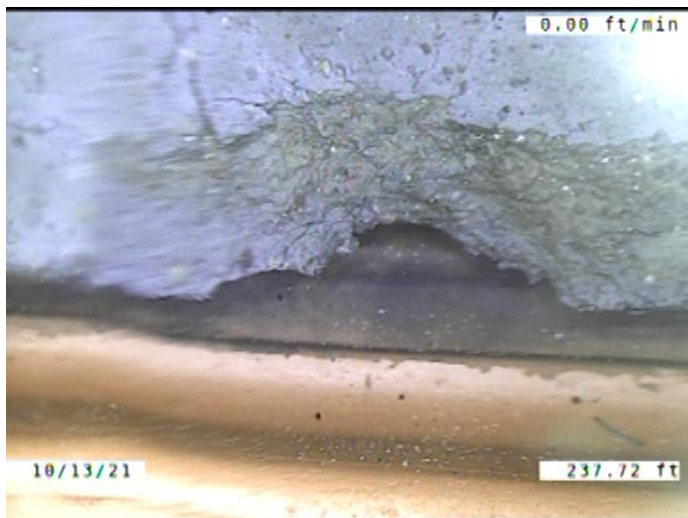
| Code: | <b>SZ</b> |
| Description: | <b>Surface Damage Other</b> |
| Remarks: | <b>A PIECE CHIPPED AWAY FROM THE JOINT</b> |

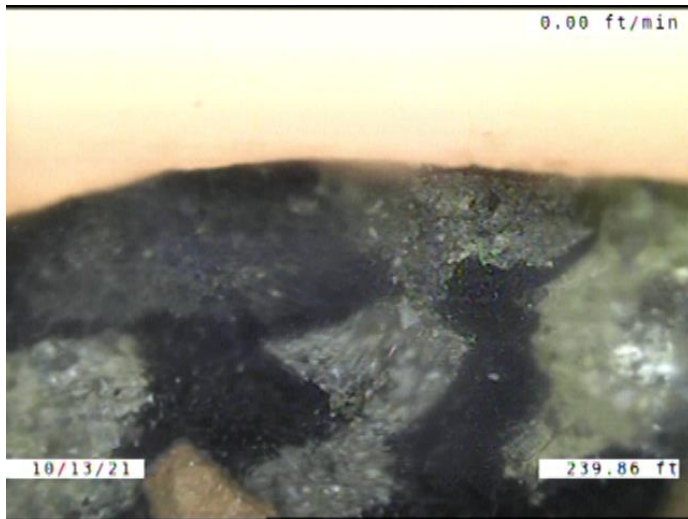
Code: **RPPD**  
Description: **Point Repair Patch Patch Defective**

Distance (ft): **239.9**  
Structural Grade: **4**  
O&M Grade: **0**  
Clock Start/From: **9**  
Clock To: **3**  
1st Value:  
2nd Value:  
Value Percent:  
Continuous Index:  
Within 8" of Joint: **YES**  
Remarks: **Concrete, soil visible**

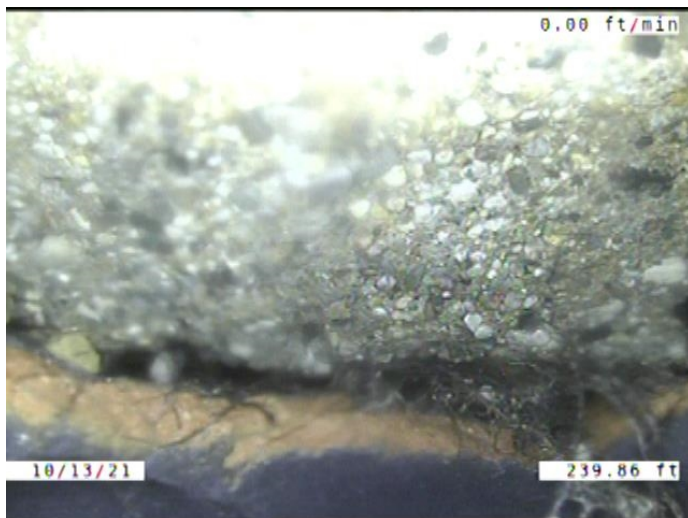
Code: **RFB**  
Description: **Roots Fine Barrel**

Distance (ft): **239.9**  
Structural Grade: **0**  
O&M Grade: **2**  
Clock Start/From: **11**  
Clock To: **12**  
1st Value:  
2nd Value:  
Value Percent:  
Continuous Index:  
Within 8" of Joint: **NO**  
Remarks:

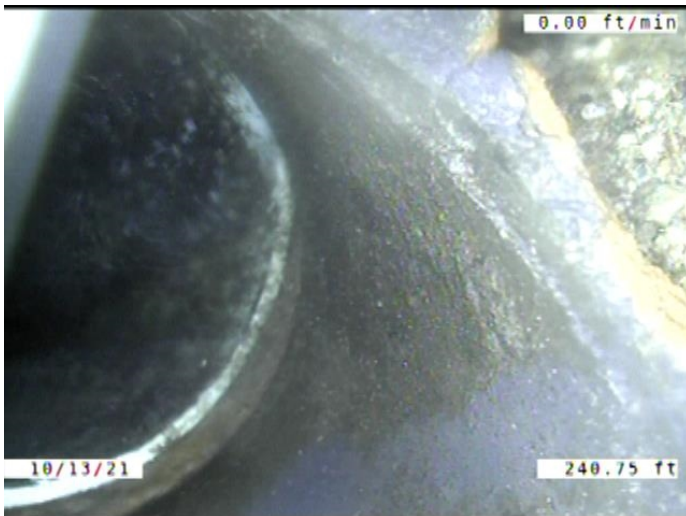
Code: **TBD**  
Description: **Tap Break-in/Hammer Defective**

Distance (ft): **240.8**  
Structural Grade: **0**  
O&M Grade: **3**  
Clock Start/From: **9**  
Clock To:  
1st Value: **4.000**  
2nd Value:  
Value Percent:  
Continuous Index:  
Within 8" of Joint: **YES**  
Remarks: **Defective**
