## **Profile/Photo Observation Report**

Date: Weather: **PACP 7.0** 10/13/2021 Coding: Pipe Length (ft): 330.5 Owner: **City of Hobart** Pre Clean: **Heavy Cleaning** P.O.#: S. Bucklin PSR: P-704-018-017 YES502259 Surveyor:

Street: North Michigan Avenue Flow Control: Not Controlled

US MH: M-704-018 DS MH: M-704-017 Total Length Surveyed (ft): 330.5

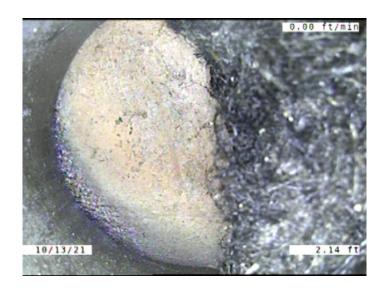
Code: **TFD**

Description: Tap Factory Defective

Distance (ft): 2.1
Structural Grade: 0
O&M Grade: 3
Clock Start/From: 2

Remarks: CAPPED. ROOTS GROWING AROUND

THE CAP

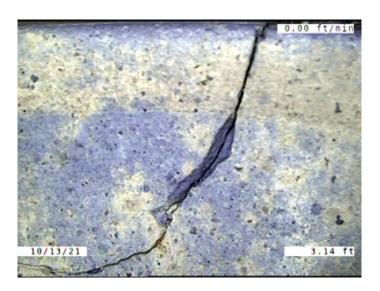
Code: FS

Description: Fracture Spiral

Distance (ft): 3.1
Structural Grade: 3
O&M Grade: 0
Clock Start/From: 1
Clock To: 3
1st Value:
2nd Value:
Value Percent:
Continuous Index:

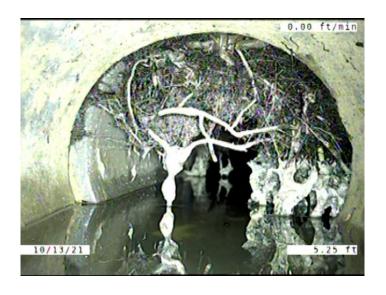
Code: RMJ

Description: Roots Medium Joint

Distance (ft): 5.2
Structural Grade: 0
O&M Grade: 3
Clock Start/From: 9
Clock To: 4

Value Percent: 50.000
Continuous Index: S01
Within 8" of Joint: YES

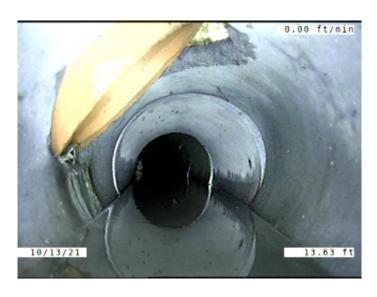
Code: RMJ

Description: Roots Medium Joint

Distance (ft): 13.6
Structural Grade: 0

O&M Grade: 3

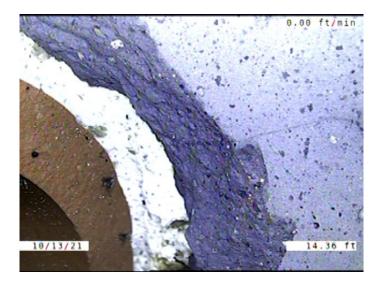
Code: SSS

Description: Surface Damage Surface Spalling

Distance (ft): 14.4
Structural Grade: 2
O&M Grade: 0
Clock Start/From: 9
Clock To: 1

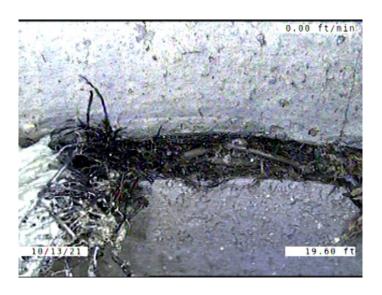
Code: RMJ

Description: **Roots Medium Joint**

Distance (ft): 19.6 Structural Grade: 0 O&M Grade: 3 Clock Start/From: 9 3 Clock To: 1st Value: 2nd Value:

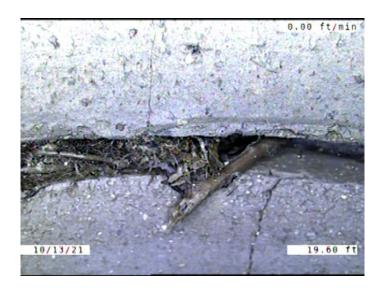
Code: CM
Description: Crack Multiple

Distance (ft): 19.6 Structural Grade: 3 O&M Grade: 0 Clock Start/From: 10 Clock To: 11 1st Value: 2nd Value: Value Percent: Continuous Index: Within 8" of Joint: YES

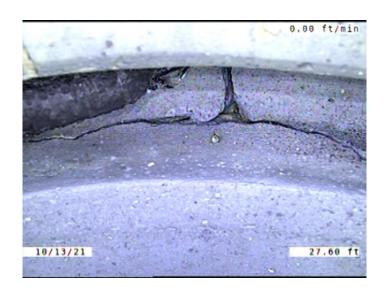
Code: **FM**

Description: Fracture Multiple

Distance (ft): 27.6
Structural Grade: 4
O&M Grade: 0
Clock Start/From: 1
Clock To: 3

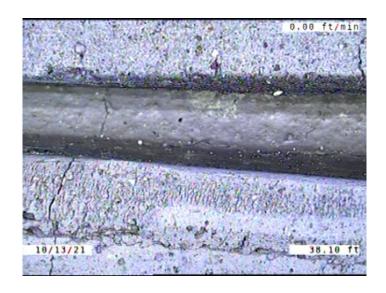
Code: CM

Description: Crack Multiple

Distance (ft): 38.1
Structural Grade: 3
O&M Grade: 0
Clock Start/From: 9
Clock To: 3

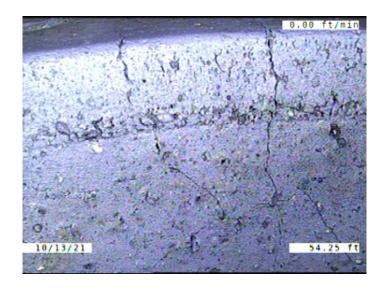
Code: CM

Description: Crack Multiple

Distance (ft): 54.2
Structural Grade: 3
O&M Grade: 0
Clock Start/From: 9
Clock To: 3

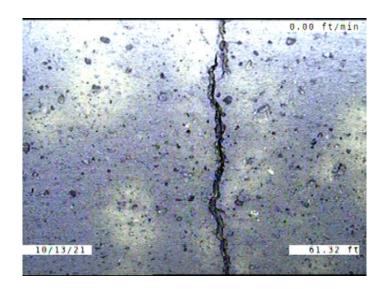
Code: FL

Description: Fracture Longitudinal

Distance (ft): 61.3
Structural Grade: 3
O&M Grade: 0
Clock Start/From: 2

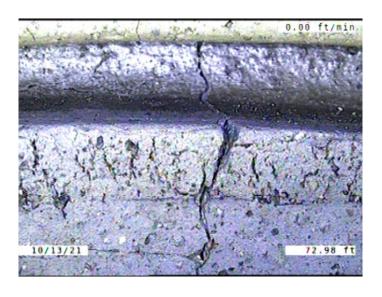
Code: **FM**

Description: Fracture Multiple

Distance (ft): 73.0
Structural Grade: 4

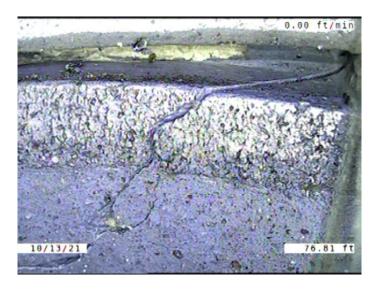
Code: FM

Description: Fracture Multiple

Distance (ft): 76.8
Structural Grade: 4

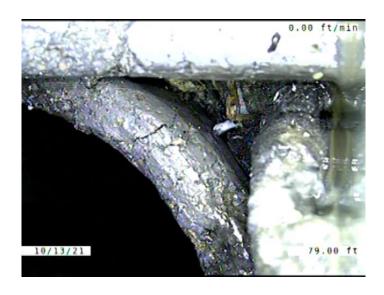
Code: BSV

Description: Broken Soil Visible

Distance (ft): 79.0
Structural Grade: 5
O&M Grade: 0
Clock Start/From: 10
Clock To: 3

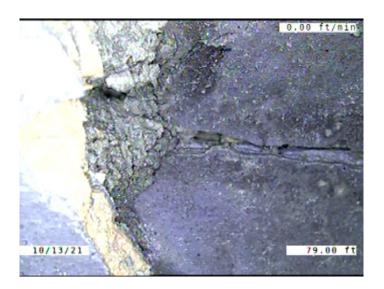
Code: SMW

Description: Surface Damage Missing Wall

Distance (ft): 79.0
Structural Grade: 5
O&M Grade: 0
Clock Start/From: 12
Clock To: 3
1st Value:
2nd Value:
Value Percent:

Remarks: LOOKS LIKE SOMEONE TRIED TO

**REPAIR IT**

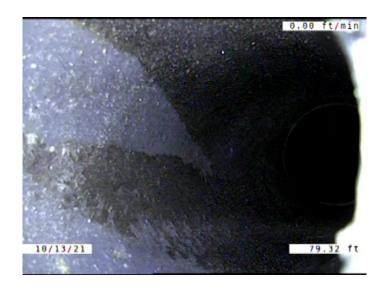
Code: TBD

Description: Tap Break-in/Hammer Defective

Distance (ft): 79.3
Structural Grade: 0
O&M Grade: 3
Clock Start/From: 2

Remarks: **Defective**

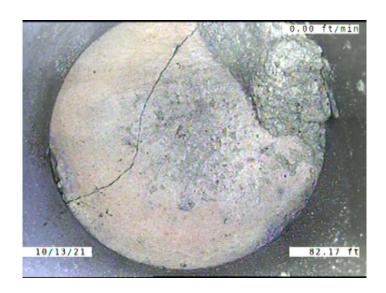
Code: TFC

Description: Tap Factory Capped

Distance (ft): 82.2
Structural Grade: 0
O&M Grade: 0
Clock Start/From: 2

Remarks: CAP BROKEN

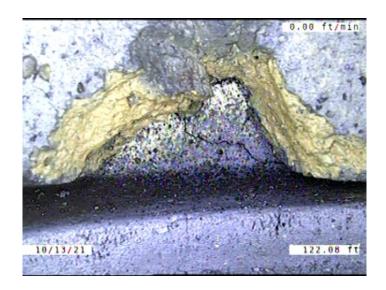
Code: SMW

Description: Surface Damage Missing Wall

Distance (ft): 122.1
Structural Grade: 5
O&M Grade: 0
Clock Start/From: 10
Clock To: 11

Remarks: INSIDE OF THE JOINT

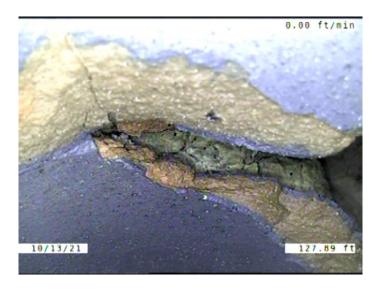
BSV Code:

Description: **Broken Soil Visible**

Distance (ft): 127.9 Structural Grade: 5 O&M Grade: 0 Clock Start/From: 10 3 Clock To: 1st Value: 2nd Value: Value Percent: Continuous Index: Within 8" of Joint:

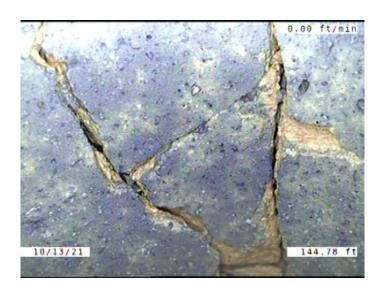
Code: B
Description: Broken

Distance (ft): 144.8 Structural Grade: 4 O&M Grade: 0 Clock Start/From: 11 Clock To: 1 1st Value: 2nd Value: Value Percent: Continuous Index: Within 8" of Joint: YES

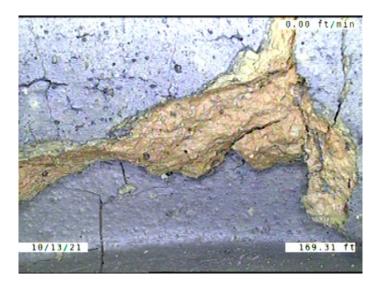
Code: SMW

Description: Surface Damage Missing Wall

Distance (ft): 169.3
Structural Grade: 5
O&M Grade: 0
Clock Start/From: 11
Clock To: 1
1st Value:
2nd Value:

Remarks: INSIDE OF THE JOINT

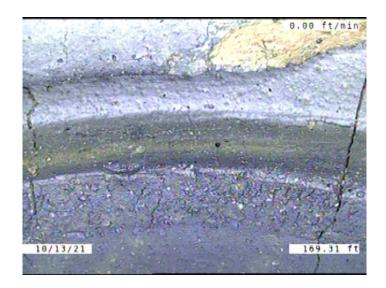
Code: B
Description: Broken

Distance (ft): 169.3 Structural Grade: 4 O&M Grade: 0 Clock Start/From: 9 Clock To: 3 1st Value: 2nd Value: Value Percent: Continuous Index: Within 8" of Joint: YES

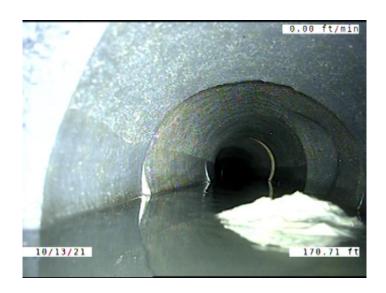
Code: OBZ

Description: Obstruction Other

Distance (ft): 170.7
Structural Grade: 0
O&M Grade: 3
Clock Start/From: 5
Clock To: 7

Remarks: RAGS AND TP

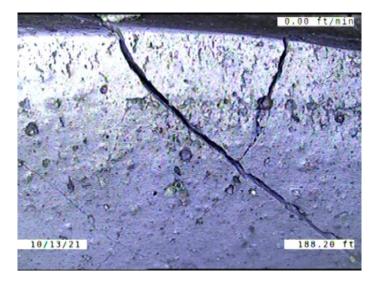
Code: **B**

Description: Broken

Distance (ft): 188.2
Structural Grade: 4

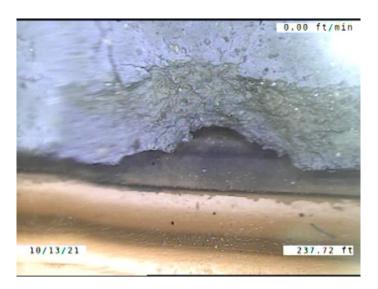
Code: SZ

Description: Surface Damage Other

Remarks: A PIECE CHIPPED AWAY FROM THE

**JOINT**

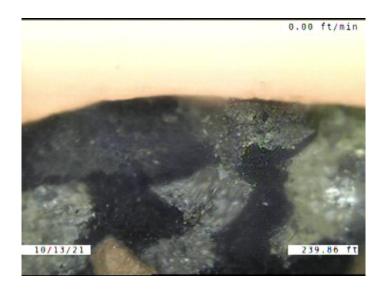
Code: RPPD

Description: Point Repair Patch Patch Defective

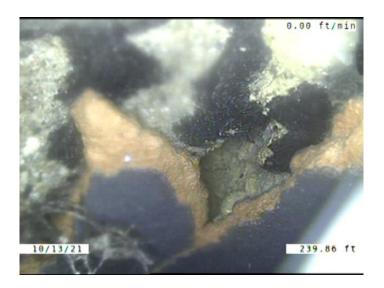
Code: BSV

Description: Broken Soil Visible

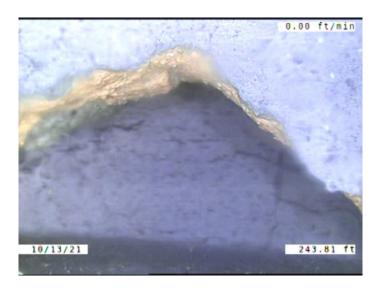
Code: SMW

Description: Surface Damage Missing Wall

Remarks: INSIDE OF THE JOINT

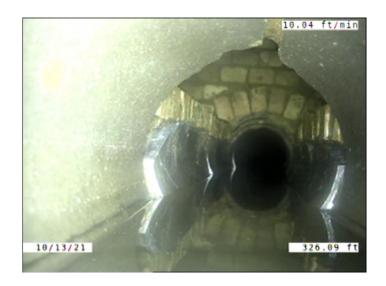
Code: FM

Description: Fracture Multiple

Remarks: Wandering

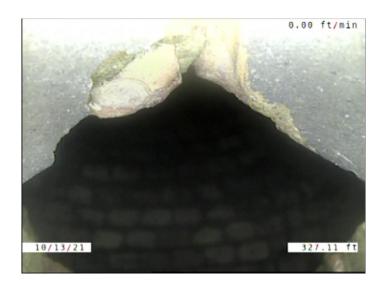
Code: B
Description: Broken

Distance (ft): 327.1
Structural Grade: 4
O&M Grade: 0
Clock Start/From: 12
