Profile/Photo Observation Report

Date:	10/13/2021	Weather:		Coding:	PACP 7.0
Pipe Length (ft):	333.0	Owner:	City of Hobart	Pre Clean:	Heavy Cleaning
P.O.#:	YES502259	Surveyor:	S. Bucklin	PSR:	P-704-019-018
Customer:	City of Hobart	Clean Date:	10/09/2021	Shape:	C

Street:	North Michigan Avenue	Flow Control:	Not Controlled
City:	Hobart, IN	Year Renewed:	
Location:	Local rural streets with light traffic, t	Tape/Media #:	
Purpose:	Routine Assessment	Dia/Height:	8"
Use:	Sanitary Sewage Pipe	Material:	VCP
Drain Area:		Lining:	
Category:	NA		
Comment:			
Location Details:		Direction of Survey:	Upstream
US MH:	M-704-019	DS MH:	M-704-018
		Total Length Surveyed (ft):	21.0

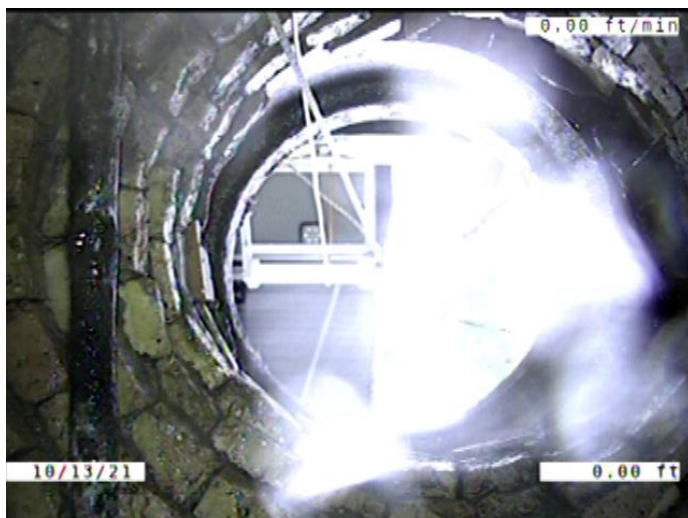
Code: **AMH**
Description: **Manhole**

Distance (ft): **.0**
Structural Grade: **0**
O&M Grade: **0**
Clock Start/From:
Clock To:
1st Value:
2nd Value:
Value Percent:
Continuous Index:
Within 8" of Joint: **NO**
Remarks: **M-704-018**

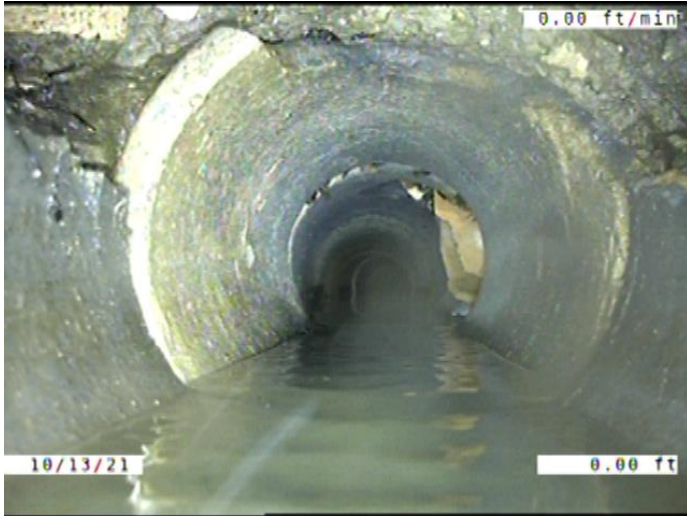
Code: **MWL**
Description: **Miscellaneous Water Level**

Distance (ft): **.0**
Structural Grade: **0**
O&M Grade: **0**
Clock Start/From:
Clock To:
1st Value:
2nd Value:
Value Percent: **10.000**
Continuous Index:
Within 8" of Joint: **NO**
Remarks:

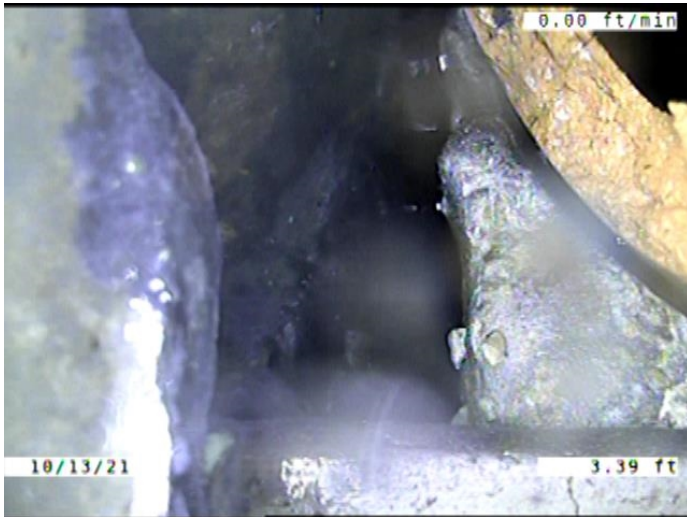
Code: **SMW**
Description: **Surface Damage Missing Wall**

Distance (ft): **3.4**
Structural Grade: **5**
O&M Grade: **0**
Clock Start/From: **12**
Clock To: **2**
1st Value:
2nd Value:
Value Percent:
Continuous Index:
Within 8" of Joint: **YES**
Remarks: **VOID AND SOIL VISIBLE**

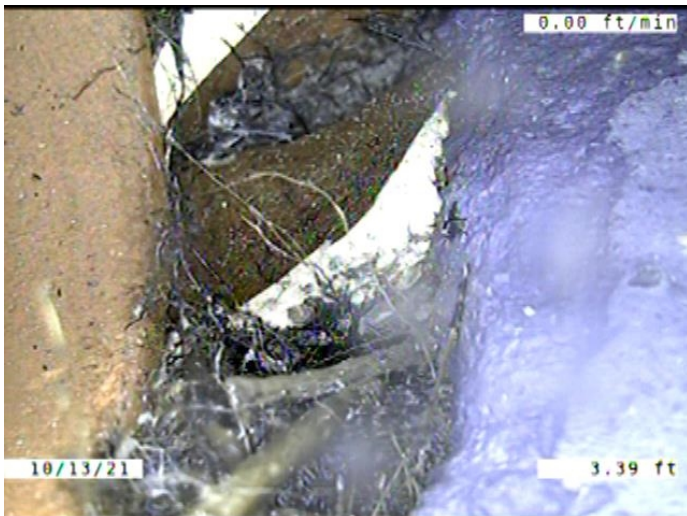
Code: **HVV**
Description: **Hole Void Visible**

Distance (ft): **3.4**
Structural Grade: **5**
O&M Grade: **0**
Clock Start/From: **4**
Clock To: **5**
1st Value:
2nd Value:
Value Percent:
Continuous Index:
Within 8" of Joint: **YES**
Remarks: **SOIL VISIBLE TOO**

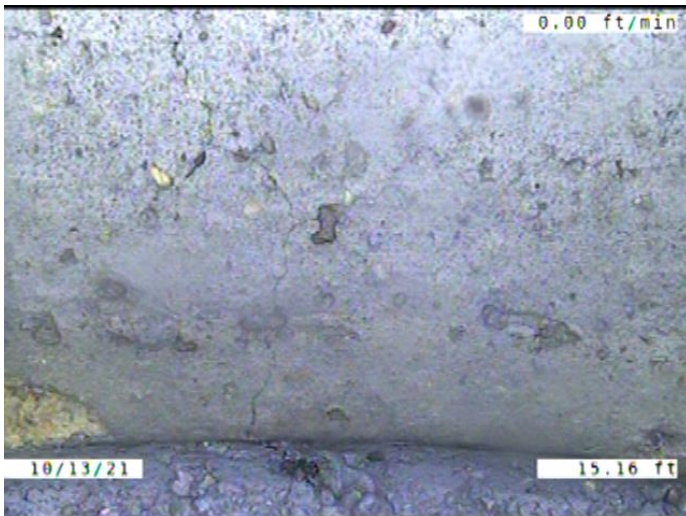
Code: **CL**
 Description: **Crack Longitudinal**

Distance (ft): **15.2**
 Structural Grade: **2**
 O&M Grade: **0**
 Clock Start/From: **12**
 Clock To:
 1st Value:
 2nd Value:
 Value Percent:
 Continuous Index:
 Within 8" of Joint: **YES**
 Remarks:

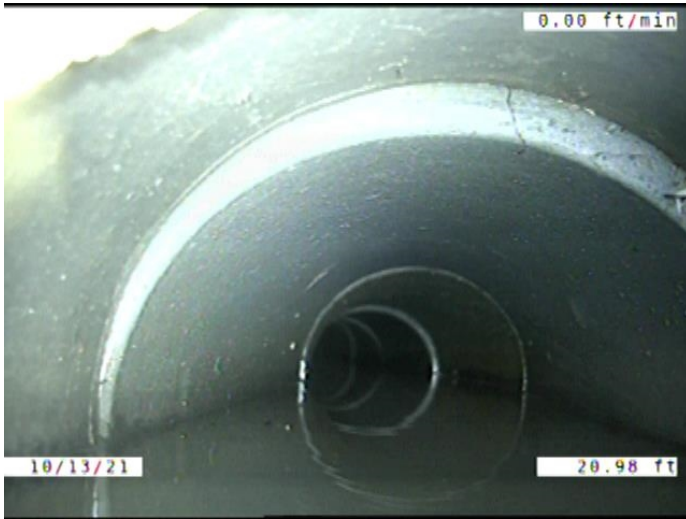
Code: **RFJ**
Description: **Roots Fine Joint**

Distance (ft): **21.0**
Structural Grade: **0**
O&M Grade: **1**
Clock Start/From: **9**
Clock To: **3**
1st Value:
2nd Value:
Value Percent:
Continuous Index: **F01**
Within 8" of Joint: **YES**
Remarks:

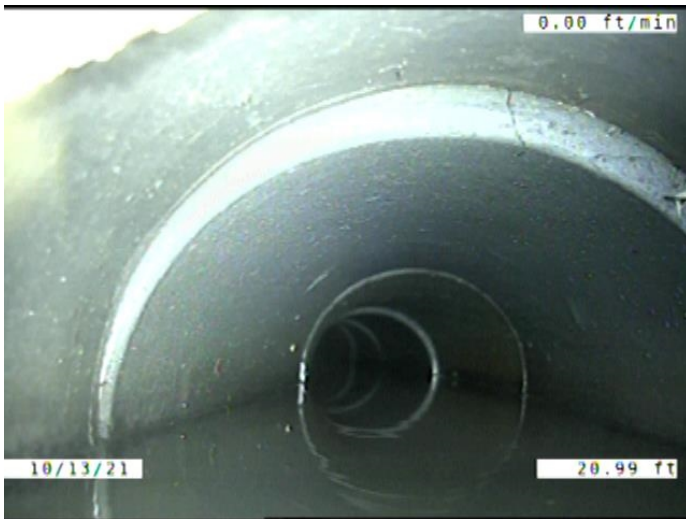
Code: **MSA**
Description: **Miscellaneous Survey Abandoned**

Distance (ft): **21.0**
Structural Grade: **0**
O&M Grade: **0**
Clock Start/From:
Clock To:
1st Value:
2nd Value:
Value Percent:
Continuous Index:
Within 8" of Joint: **NO**
Remarks: **CAMERA CANT MAKE IT PAST
UNKNOWN DEBRIS UNDER THE FLO**
