Profile/Photo Observation Report

Date:	10/13/2021	Weather:		Coding:	PACP 7.0
Pipe Length (ft):	333.0	Owner:	City of Hobart	Pre Clean:	Heavy Cleaning
P.O.#:	YES502259	Surveyor:	S. Bucklin	PSR:	P-704-019-018
Customer:	City of Hobart	Clean Date:	10/09/2021	Shape:	C

Street:	North Michigan Avenue	Flow Control:	Not Controlled
City:	Hobart, IN	Year Renewed:	
Location:	Local rural streets with light traffic, t	Tape/Media #:	
Purpose:	Routine Assessment	Dia/Height:	8"
Use:	Sanitary Sewage Pipe	Material:	VCP
Drain Area:		Lining:	
Category:	NA		
Comment:			
Location Details:		Direction of Survey:	Upstream
US MH:	M-704-019	DS MH:	M-704-018
		Total Length Surveyed (ft):	21.0

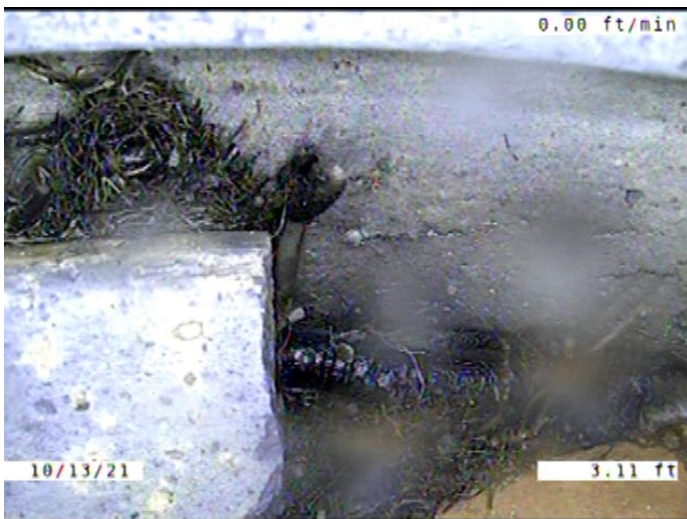
Code: **RFJ**
Description: **Roots Fine Joint**

Distance (ft): **3.1**
Structural Grade: **0**
O&M Grade: **1**
Clock Start/From: **9**
Clock To: **3**
1st Value:
2nd Value:
Value Percent:
Continuous Index: **S01**
Within 8" of Joint: **YES**
Remarks:

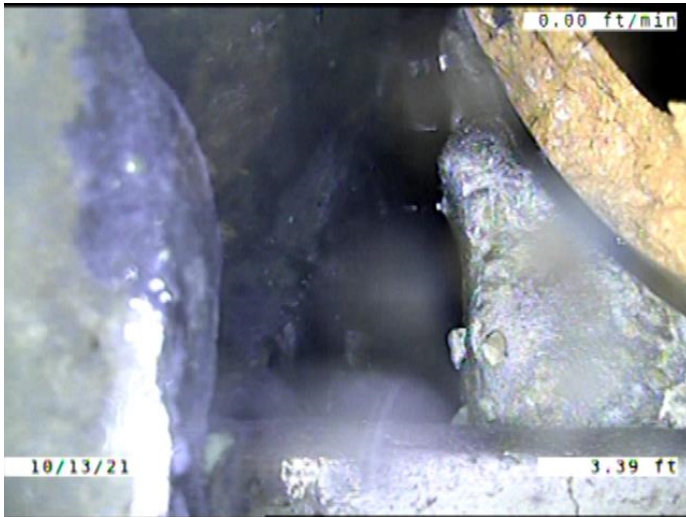
Code: **SMW**
 Description: **Surface Damage Missing Wall**

Distance (ft): **3.4**
 Structural Grade: **5**
 O&M Grade: **0**
 Clock Start/From: **12**
 Clock To: **2**
 1st Value:
 2nd Value:
 Value Percent:
 Continuous Index:
 Within 8" of Joint: **YES**
 Remarks: **VOID AND SOIL VISIBLE**

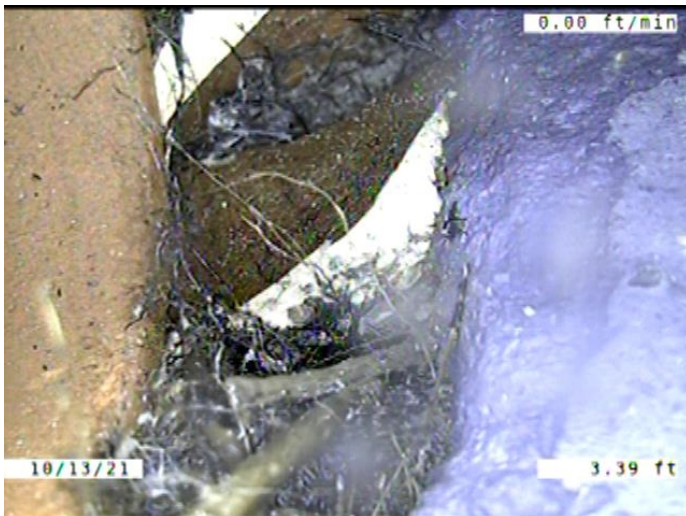
Code: **HVV**
 Description: **Hole Void Visible**

Distance (ft): **3.4**
 Structural Grade: **5**
 O&M Grade: **0**
 Clock Start/From: **4**
 Clock To: **5**
 1st Value:
 2nd Value:
 Value Percent:
 Continuous Index:
 Within 8" of Joint: **YES**
 Remarks: **SOIL VISIBLE TOO**

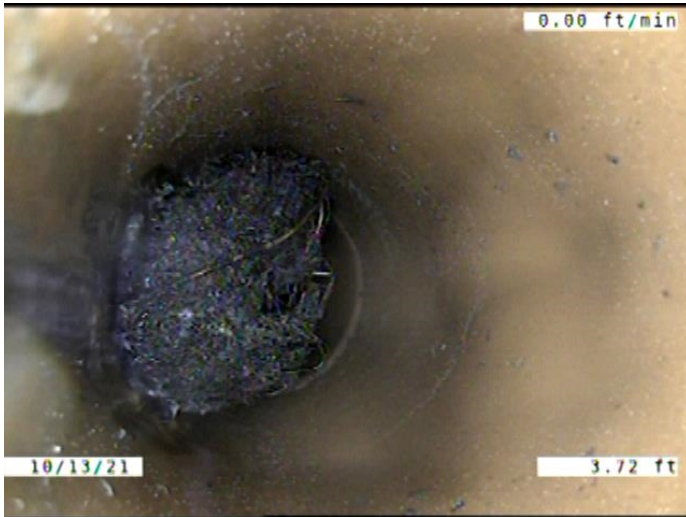
Code: **TBI**
Description: **Tap Break-in Intruding**

Distance (ft): **3.7**
Structural Grade: **0**
O&M Grade: **2**
Clock Start/From: **3**
Clock To:
1st Value: **4.000**
2nd Value: **1.000**
Value Percent:
Continuous Index:
Within 8" of Joint: **YES**
Remarks:

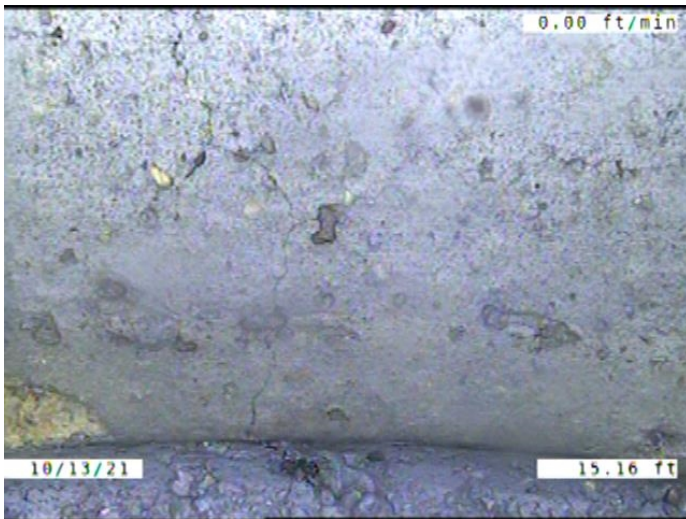
Code: **CL**
 Description: **Crack Longitudinal**

Distance (ft): **15.2**
 Structural Grade: **2**
 O&M Grade: **0**
 Clock Start/From: **12**
 Clock To:
 1st Value:
 2nd Value:
 Value Percent:
 Continuous Index:
 Within 8" of Joint: **YES**
 Remarks:

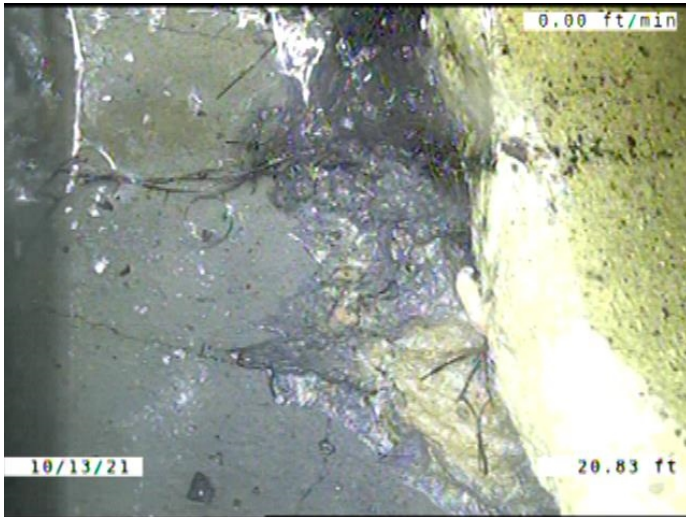
Code:	SSS
Description:	Surface Damage Surface Spalling
Distance (ft):	20.8
Structural Grade:	2
O&M Grade:	0
Clock Start/From:	8
Clock To:	1
1st Value:	
2nd Value:	
Value Percent:	
Continuous Index:	
Within 8" of Joint:	YES
Remarks:

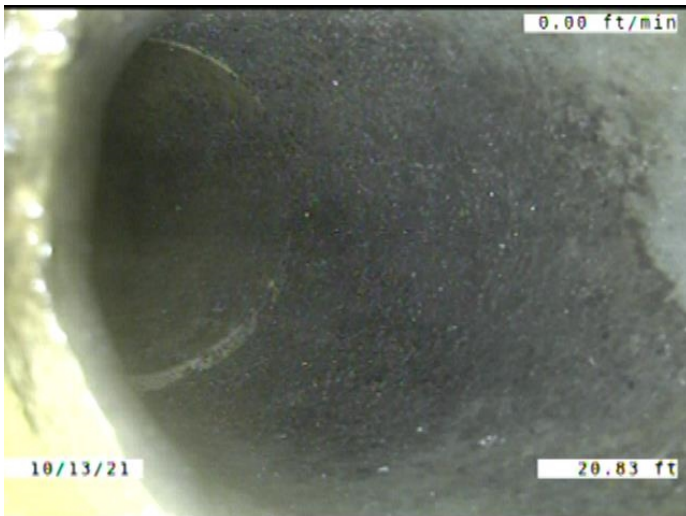
Code:	TBI
Description:	Tap Break-in Intruding
Distance (ft):	20.8
Structural Grade:	0
O&M Grade:	2
Clock Start/From:	10
Clock To:	
1st Value:	4.000
2nd Value:	1.000
Value Percent:	
Continuous Index:	
Within 8" of Joint:	YES
Remarks:

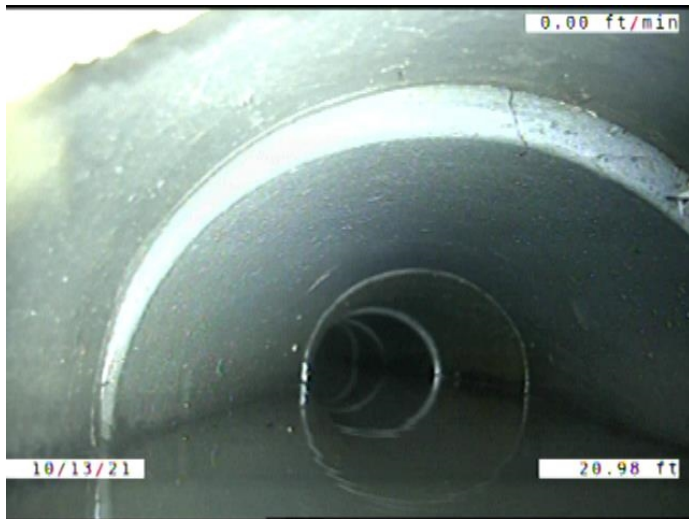
Code: **RFJ**
 Description: **Roots Fine Joint**

Distance (ft): **21.0**
 Structural Grade: **0**
 O&M Grade: **1**
 Clock Start/From: **9**
 Clock To: **3**
 1st Value:
 2nd Value:
 Value Percent:
 Continuous Index: **F01**
 Within 8" of Joint: **YES**
 Remarks:

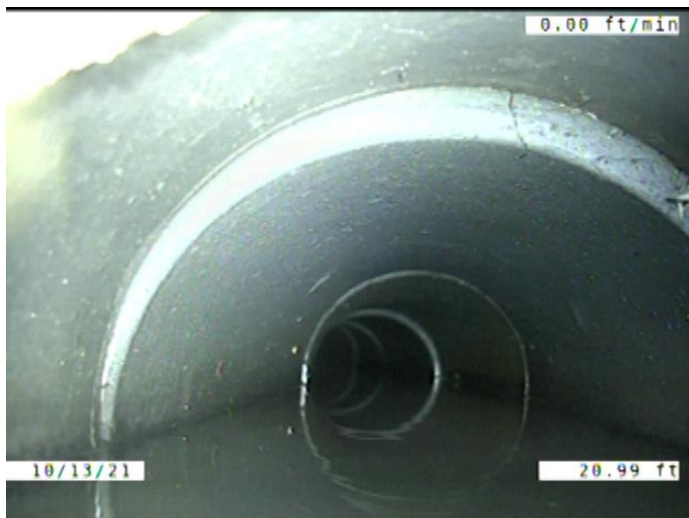
Code: **MSA**
 Description: **Miscellaneous Survey Abandoned**

Distance (ft): **21.0**
 Structural Grade: **0**
 O&M Grade: **0**
 Clock Start/From:
 Clock To:
 1st Value:
 2nd Value:
 Value Percent:
 Continuous Index:
 Within 8" of Joint: **NO**
 Remarks: **CAMERA CANT MAKE IT PAST
 UNKNOWN DEBRIS UNDER THE FLO**
