Profile/Photo Observation Report

Date:	10/15/2021	Weather:		Coding:	PACP 7.0
Pipe Length (ft):	333.0	Owner:	City of Hobart	Pre Clean:	Heavy Cleaning
P.O.#:	YES502259	Surveyor:	S. Bucklin	PSR:	P-704-019-018
Customer:	City of Hobart	Clean Date:	10/09/2021	Shape:	C

Street:	North Michigan Avenue	Flow Control:	Not Controlled
City:	Hobart, IN	Year Renewed:	
Location:	Local rural streets with light traffic, t	Tape/Media #:	
Purpose:	Routine Assessment	Dia/Height:	8"
Use:	Sanitary Sewage Pipe	Material:	VCP
Drain Area:		Lining:	
Category:	NA		
Comment:			
Location Details:		Direction of Survey:	Downstream
US MH:	M-704-019	DS MH:	M-704-018
		Total Length Surveyed (ft):	247.6

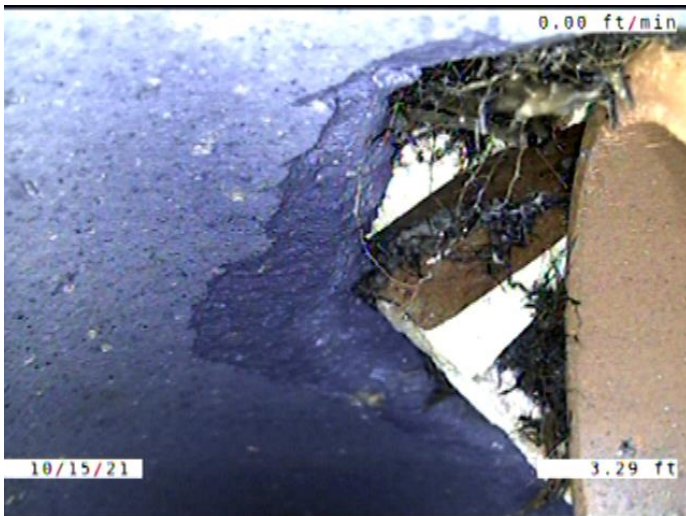
Code: **HVV**
 Description: **Hole Void Visible**

Distance (ft): **3.3**
 Structural Grade: **5**
 O&M Grade: **0**
 Clock Start/From: **3**
 Clock To: **4**
 1st Value:
 2nd Value:
 Value Percent:
 Continuous Index:
 Within 8" of Joint: **YES**
 Remarks: **SOIL AND VOID VISIBLE**

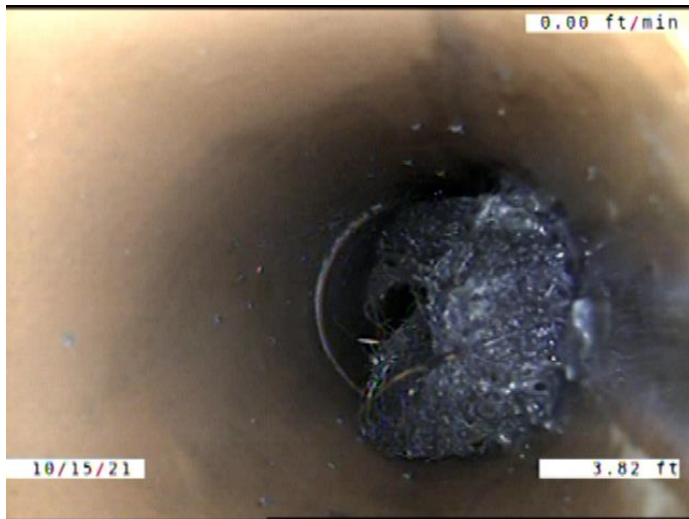
Code: **BVV**
 Description: **Broken Void Visible**

Distance (ft): **3.3**
 Structural Grade: **5**
 O&M Grade: **0**
 Clock Start/From: **11**
 Clock To: **4**
 1st Value:
 2nd Value:
 Value Percent:
 Continuous Index:
 Within 8" of Joint: **YES**
 Remarks: **SOIL VISIBLE TOO**

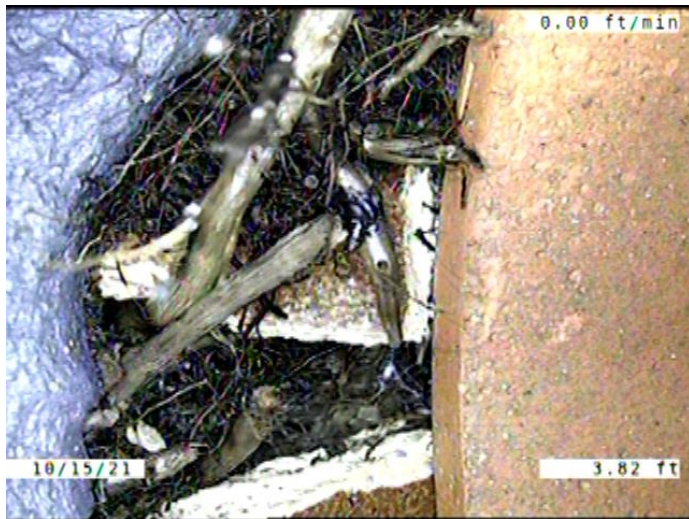
Code: **TBI**
 Description: **Tap Break-in Intruding**

Distance (ft): **3.8**
 Structural Grade: **0**
 O&M Grade: **2**
 Clock Start/From: **3**
 Clock To:
 1st Value: **4.000**
 2nd Value: **1.000**
 Value Percent:
 Continuous Index:
 Within 8" of Joint: **YES**
 Remarks: **CONSTANTLY RUNNING WATER**

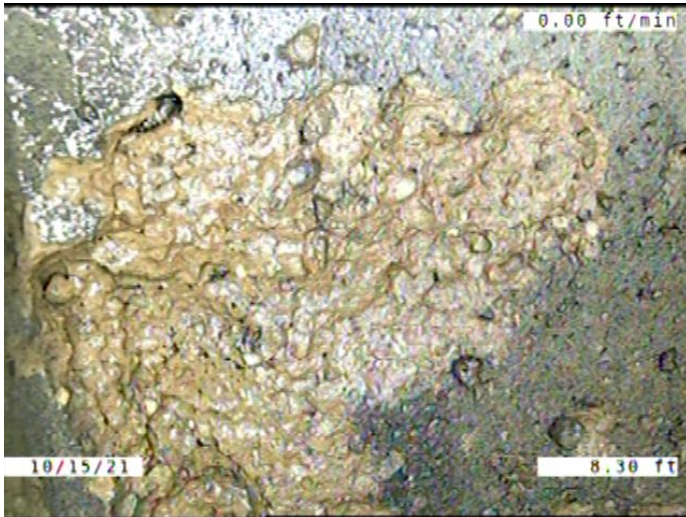
Code: **RFB**
 Description: **Roots Fine Barrel**

Distance (ft): **3.8**
 Structural Grade: **0**
 O&M Grade: **2**
 Clock Start/From: **12**
 Clock To: **4**
 1st Value:
 2nd Value:
 Value Percent:
 Continuous Index:
 Within 8" of Joint: **NO**
 Remarks:

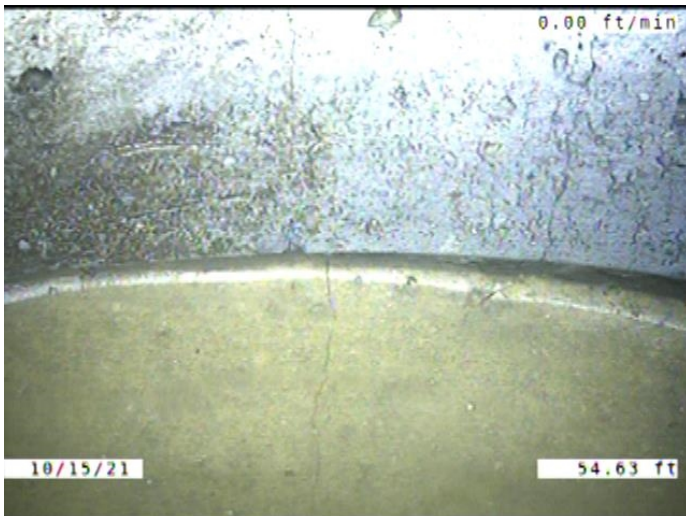
Code: **FM**
 Description: **Fracture Multiple**

Distance (ft): **44.5**
 Structural Grade: **4**
 O&M Grade: **0**
 Clock Start/From: **8**
 Clock To: **4**
 1st Value:
 2nd Value:
 Value Percent:
 Continuous Index:
 Within 8" of Joint: **YES**
 Remarks:

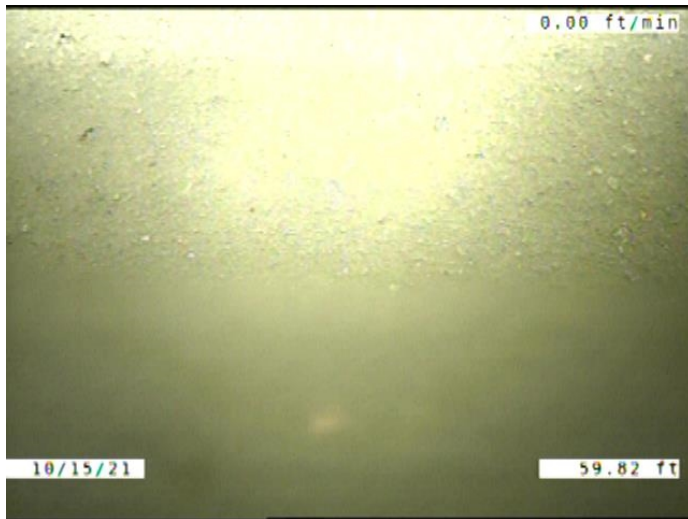
Code: **FM**
 Description: **Fracture Multiple**

Distance (ft): **54.6**
 Structural Grade: **4**
 O&M Grade: **0**
 Clock Start/From: **8**
 Clock To: **4**
 1st Value:
 2nd Value:
 Value Percent:
 Continuous Index: **S04**
 Within 8" of Joint: **YES**
 Remarks:

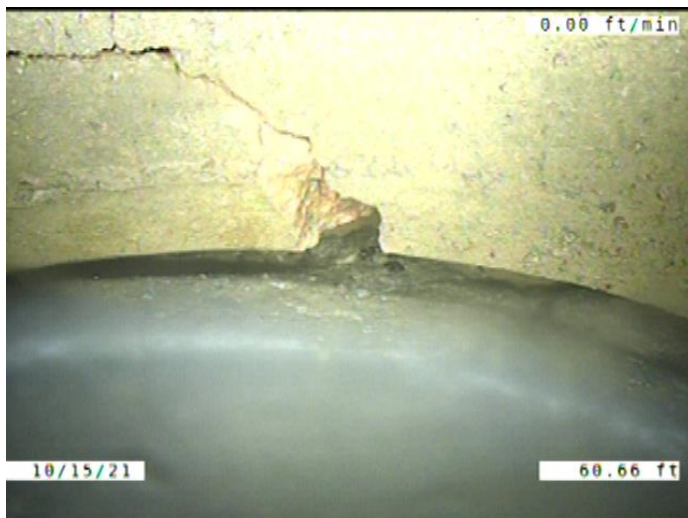
Code: **MWLS**
Description: **Miscellaneous Water Level Sag**

Distance (ft): **59.8**
Structural Grade: **2**
O&M Grade: **0**
Clock Start/From:
Clock To:
1st Value:
2nd Value:
Value Percent: **15.000**
Continuous Index: **S05**
Within 8" of Joint: **NO**
Remarks:

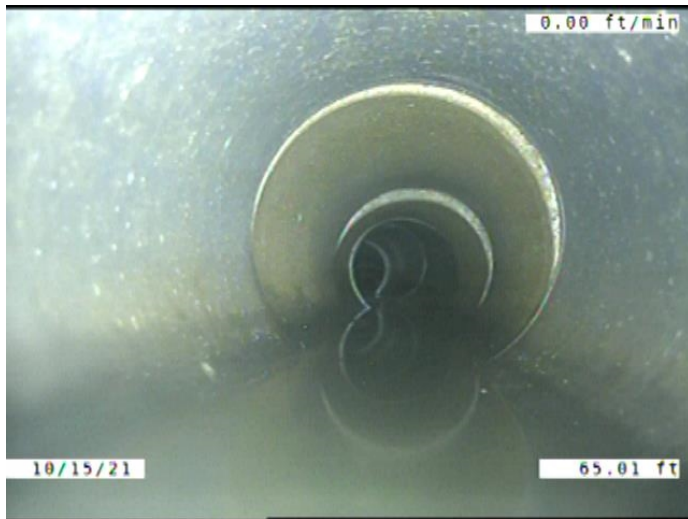
Code: **B**
Description: **Broken**

Distance (ft): **60.7**
Structural Grade: **4**
O&M Grade: **0**
Clock Start/From: **8**
Clock To: **1**
1st Value:
2nd Value:
Value Percent:
Continuous Index:
Within 8" of Joint: **YES**
Remarks:

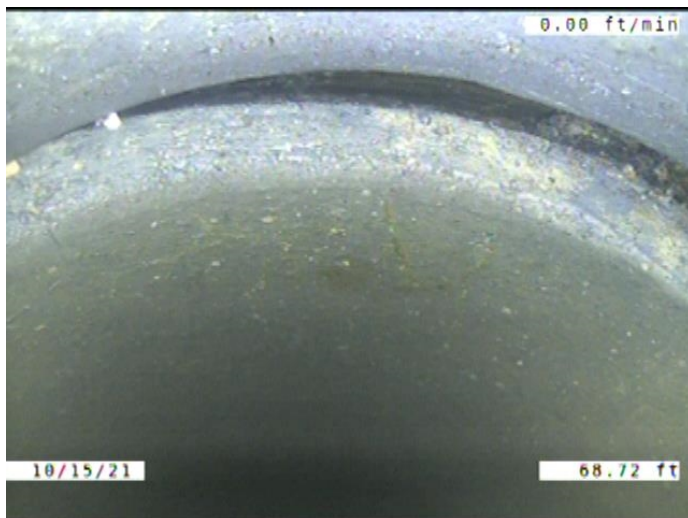
Code: **MWLS**
Description: **Miscellaneous Water Level Sag**

Distance (ft): **65.0**
Structural Grade: **2**
O&M Grade: **0**
Clock Start/From:
Clock To:
1st Value:
2nd Value:
Value Percent: **15.000**
Continuous Index: **F05**
Within 8" of Joint: **NO**
Remarks:

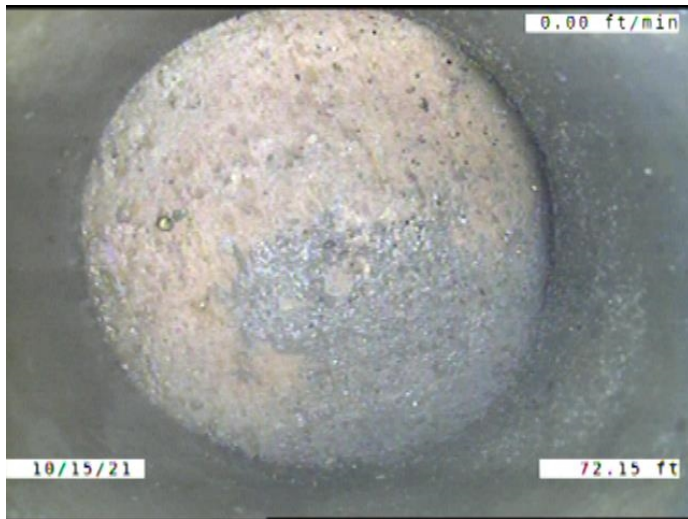
Code: **JOM**
Description: **Joint Offset Medium**

Distance (ft): **68.7**
Structural Grade: **3**
O&M Grade: **0**
Clock Start/From:
Clock To:
1st Value:
2nd Value:
Value Percent:
Continuous Index:
Within 8" of Joint: **NO**
Remarks:

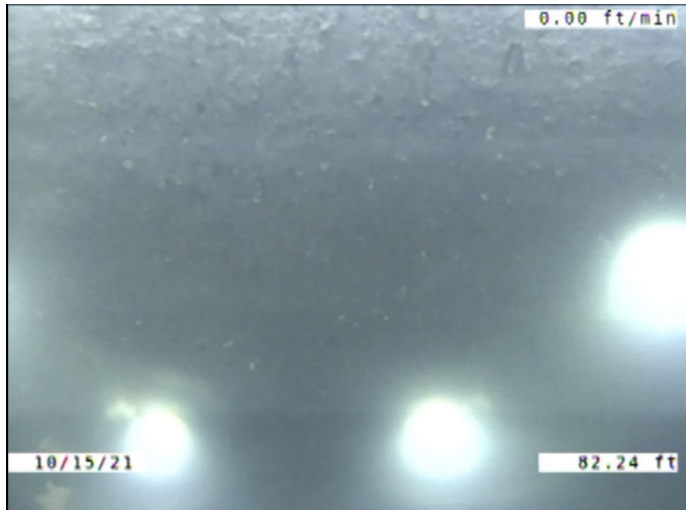
Code: **MCU**
 Description: **Miscellaneous Camera Underwater**

Distance (ft): **82.1**
 Structural Grade: **0**
 O&M Grade: **4**
 Clock Start/From:
 Clock To:
 1st Value:
 2nd Value:
 Value Percent:
 Continuous Index:
 Within 8" of Joint: **NO**
 Remarks: **Out at 83.2**

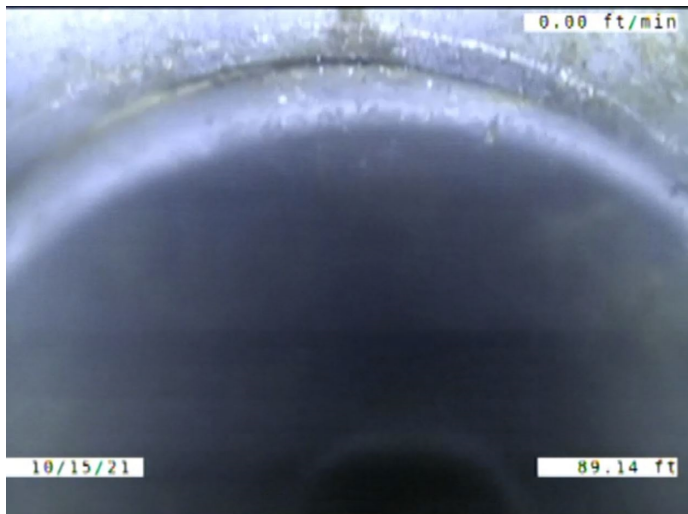
Code: **TB**
 Description: **Tap Break-in/Hammer**

Distance (ft): **89.1**
 Structural Grade: **0**
 O&M Grade: **0**
 Clock Start/From: **10**
 Clock To:
 1st Value: **4.000**
 2nd Value:
 Value Percent:
 Continuous Index:
 Within 8" of Joint: **YES**
 Remarks: **CONSTANTLY RUNNING WATER**

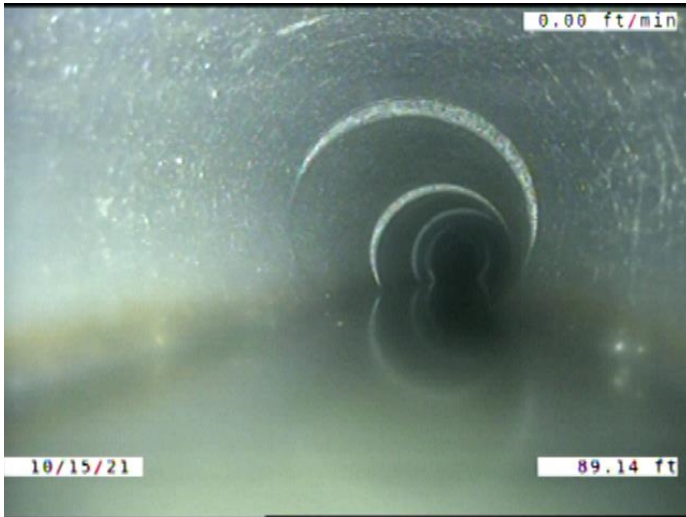
Code: **CM**
 Description: **Crack Multiple**

Distance (ft): **89.1**
 Structural Grade: **3**
 O&M Grade: **0**
 Clock Start/From: **8**
 Clock To: **4**
 1st Value:
 2nd Value:
 Value Percent:
 Continuous Index: **S12**
 Within 8" of Joint: **YES**
 Remarks: **Wandering**

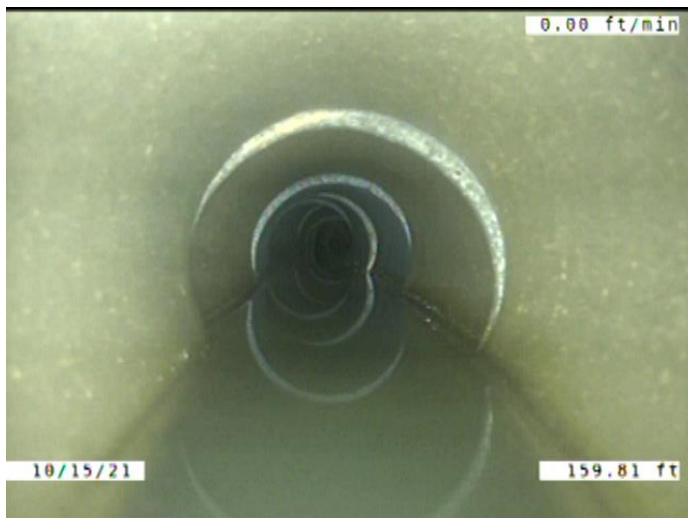
Code: **JAM**
 Description: **Joint Angular Medium**

Distance (ft): **159.8**
 Structural Grade: **3**
 O&M Grade: **0**
 Clock Start/From:
 Clock To:
 1st Value:
 2nd Value:
 Value Percent:
 Continuous Index:
 Within 8" of Joint: **NO**
 Remarks:

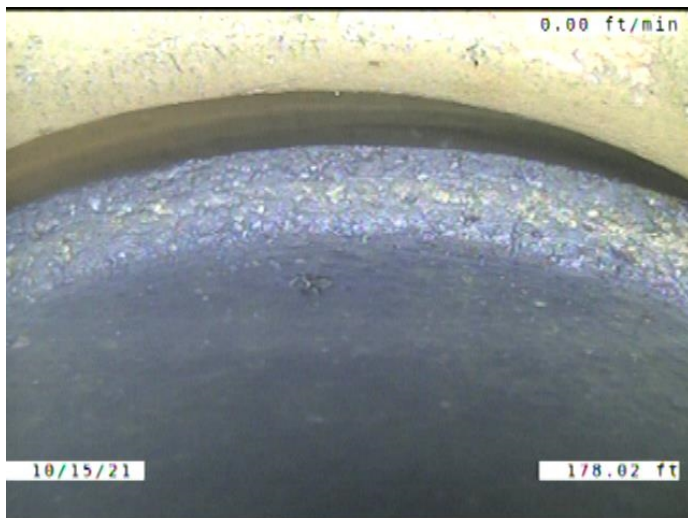
Code: **SSS**
 Description: **Surface Damage Surface Spalling**

Distance (ft): **176.2**
 Structural Grade: **2**
 O&M Grade: **0**
 Clock Start/From: **8**
 Clock To: **4**
 1st Value:
 2nd Value:
 Value Percent:
 Continuous Index:
 Within 8" of Joint: **YES**
 Remarks:

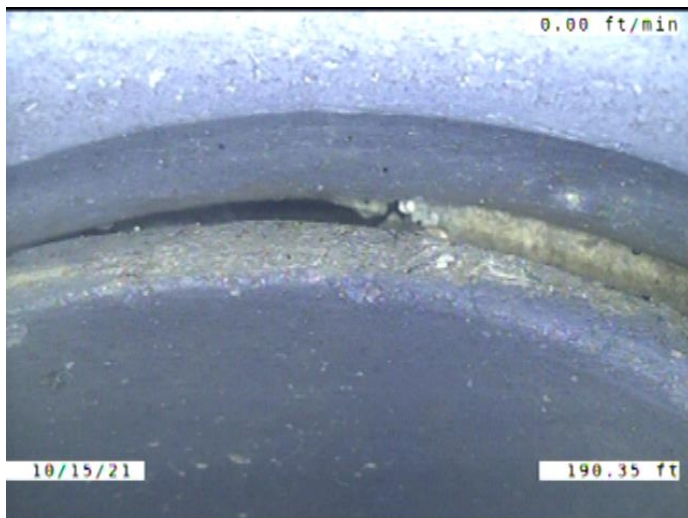
Code: **JOMD**
 Description: **Joint Offset Medium Defective**

Distance (ft): **190.4**
 Structural Grade: **3**
 O&M Grade: **0**
 Clock Start/From:
 Clock To:
 1st Value:
 2nd Value:
 Value Percent:
 Continuous Index:
 Within 8" of Joint: **NO**
 Remarks:

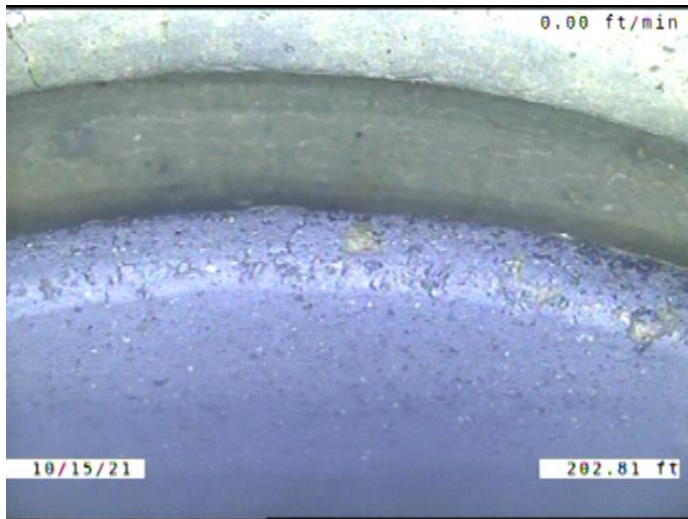
Code: **JAM**
Description: **Joint Angular Medium**

Distance (ft): **201.2**
Structural Grade: **3**
O&M Grade: **0**
Clock Start/From:
Clock To:
1st Value:
2nd Value:
Value Percent:
Continuous Index:
Within 8" of Joint: **NO**
Remarks:

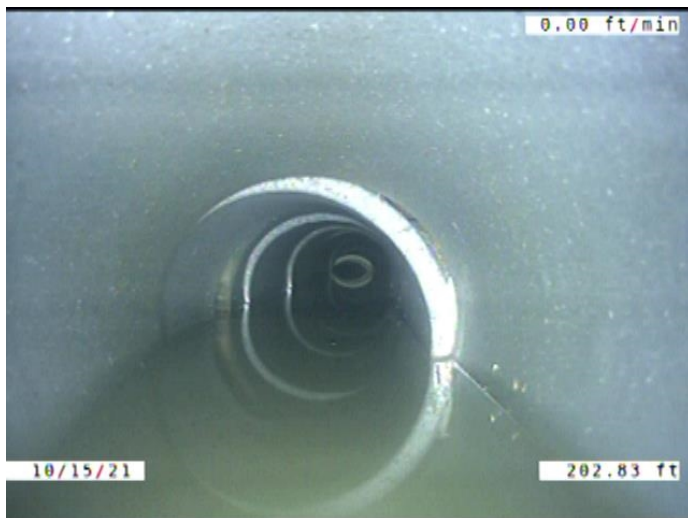
Code: **JOMD**
Description: **Joint Offset Medium Defective**

Distance (ft): **202.8**
Structural Grade: **3**
O&M Grade: **0**
Clock Start/From:
Clock To:
1st Value:
2nd Value:
Value Percent:
Continuous Index: **S09**
Within 8" of Joint: **NO**
Remarks:

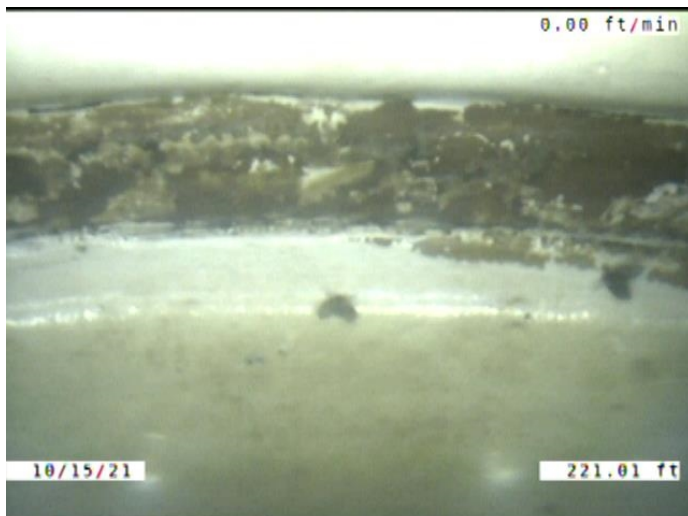
Code: **CM**
 Description: **Crack Multiple**

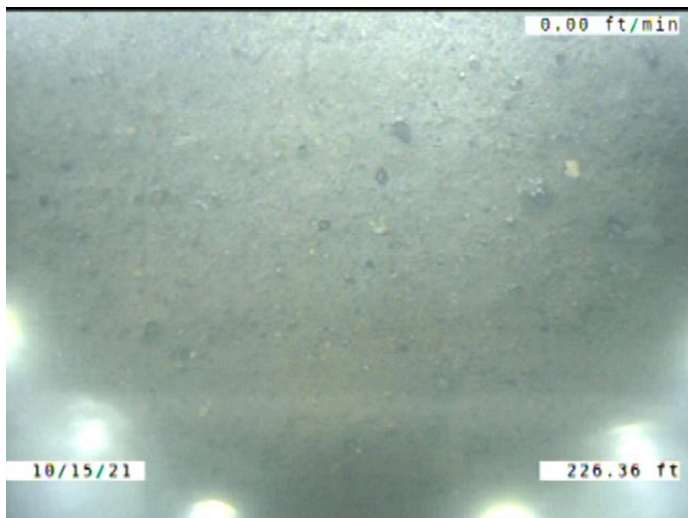
Code: **MCU**
 Description: **Miscellaneous Camera Underwater**

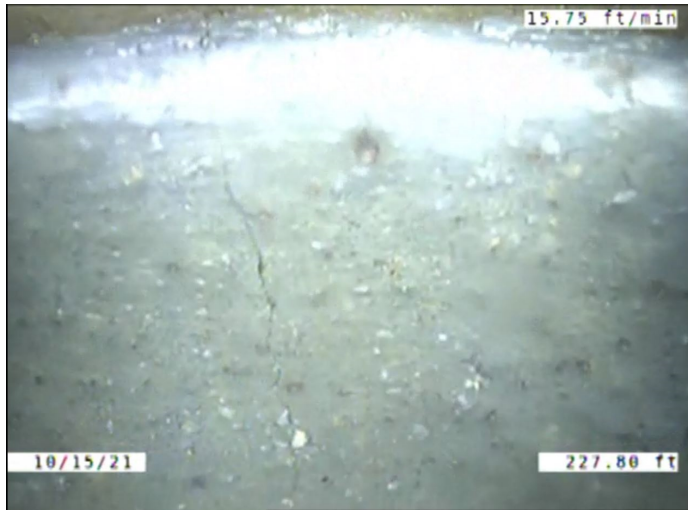
Code: **MCU**
 Description: **Miscellaneous Camera Underwater**

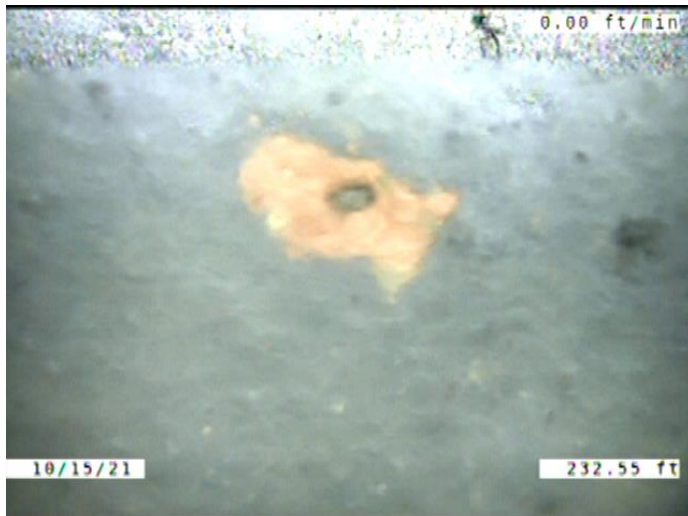
Code: **CM**
 Description: **Crack Multiple**

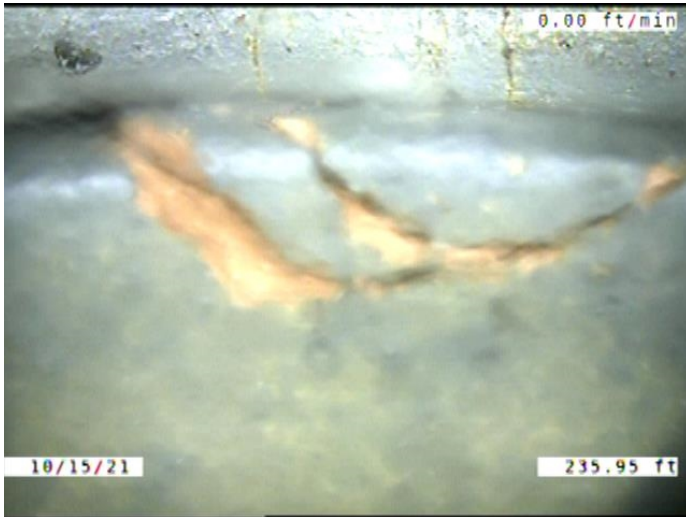
Code: **SSS**
 Description: **Surface Damage Surface Spalling**

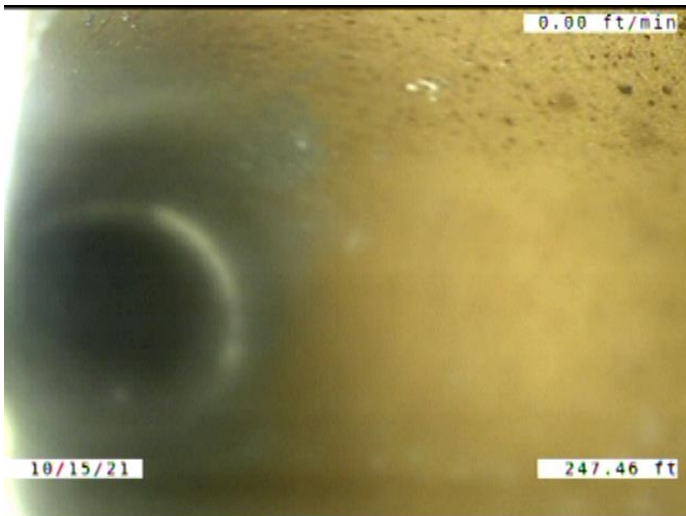
Code: **SSS**
 Description: **Surface Damage Surface Spalling**

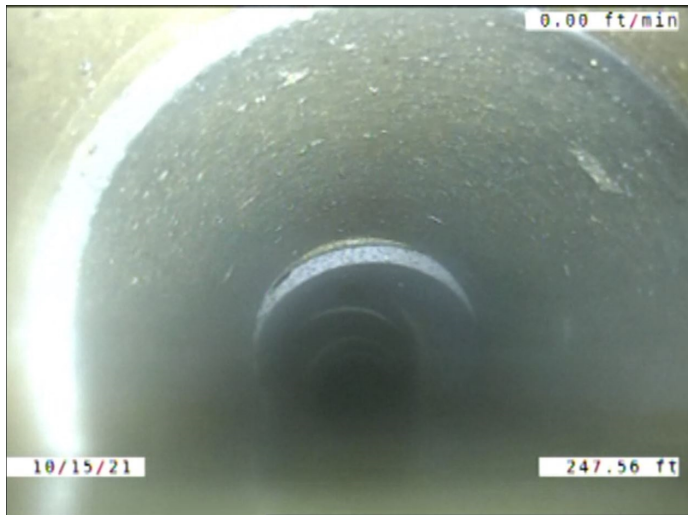
Code: **TBI**
 Description: **Tap Break-in Intruding**

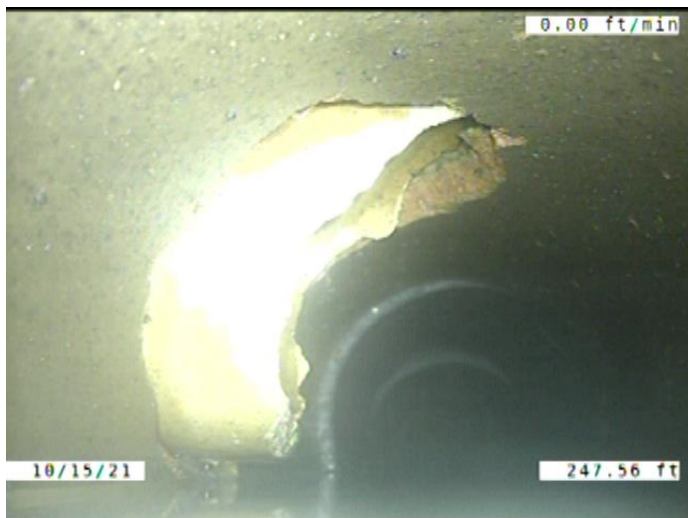
Code: **CM**
 Description: **Crack Multiple**

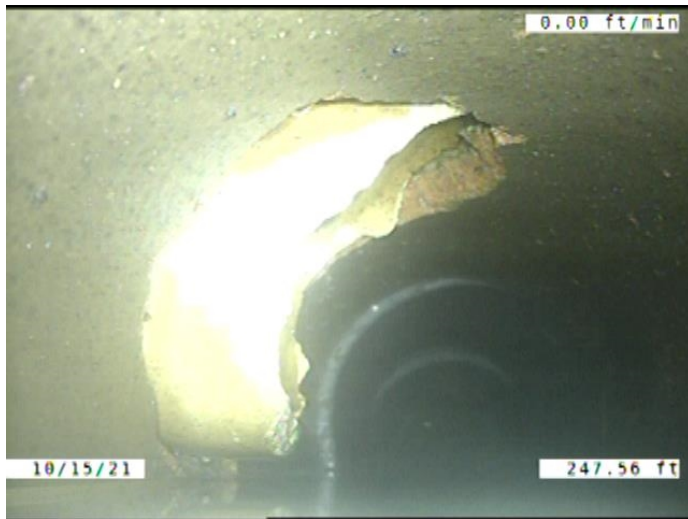
Code: **JOMD**
 Description: **Joint Offset Medium Defective**

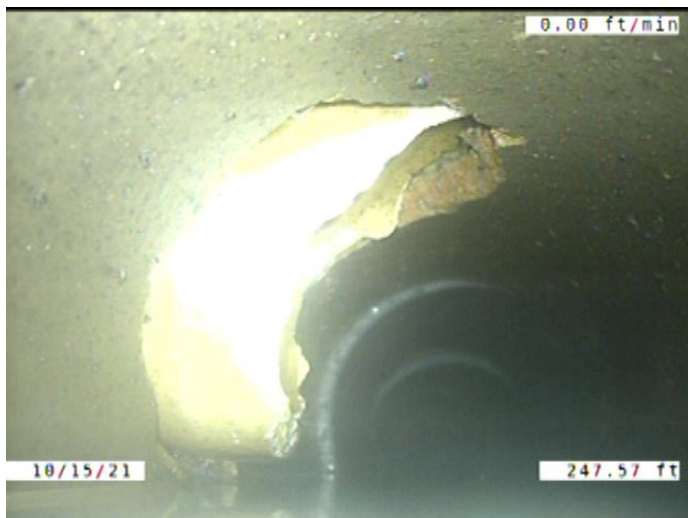
Code: **MWLS**
 Description: **Miscellaneous Water Level Sag**
