## Profile/Photo Observation Report

Date:	<b>04/29/2018</b>	Weather:		Coding:	<b>PACP 6.0</b>
Pipe Length (ft):		Owner:	<b>City of Hobart</b>	Pre Clean:	<b>No Pre-Cleaning</b>
P.O.#:	<b>140</b>	Surveyor:	<b>M. Pielacha</b>	PSR:	<b>P-704-027-021</b>
Customer:	<b>City of Hobart</b>	Clean Date:		Shape:	<b>C</b>

Street:	<b>Off Old Ridge Road</b>	Flow Control:	<b>Not Controlled</b>
City:	<b>Hobart, IN</b>	Year Renewed:	
Location:	<b>Other</b>	Tape/Media #:	<b>DEP 140</b>
Purpose:	<b>Routine Assessment</b>	Dia/Height:	<b>18"</b>
Use:	<b>Sanitary</b>	Material:	<b>VCP</b>
Drain Area:		Lining:	
Category:	<b>NA</b>		
Comment:	<b>5-21-2018</b>		
Location Details:		Direction of Survey:	<b>Downstream</b>
US MH:	<b>M-704-027</b>	DS MH:	<b>M-704-021</b>
		Total Length Surveyed (ft):	<b>.1</b>

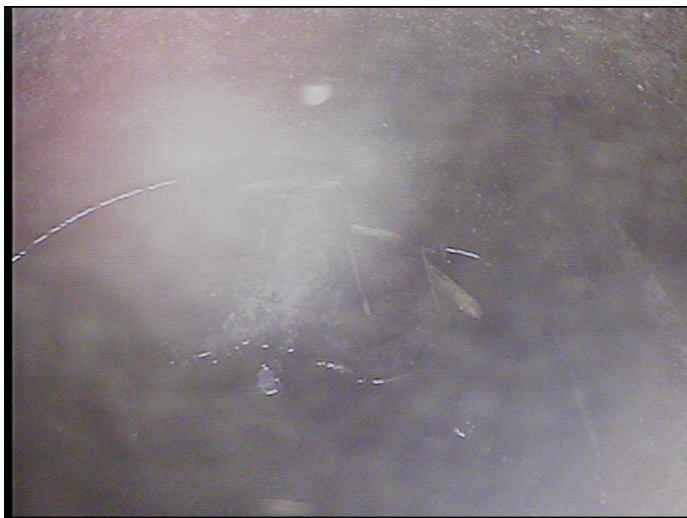
Code: **AMH**  
 Description: **Manhole**

Distance (ft): **.0**  
 Structural Grade: **0**  
 O&M Grade: **0**  
 Clock Start/From:  
 Clock To:  
 1st Value:  
 2nd Value:  
 Value Percent:  
 Continuous Index:  
 Within 8" of Joint: **NO**  
 Remarks: **M-704-027**

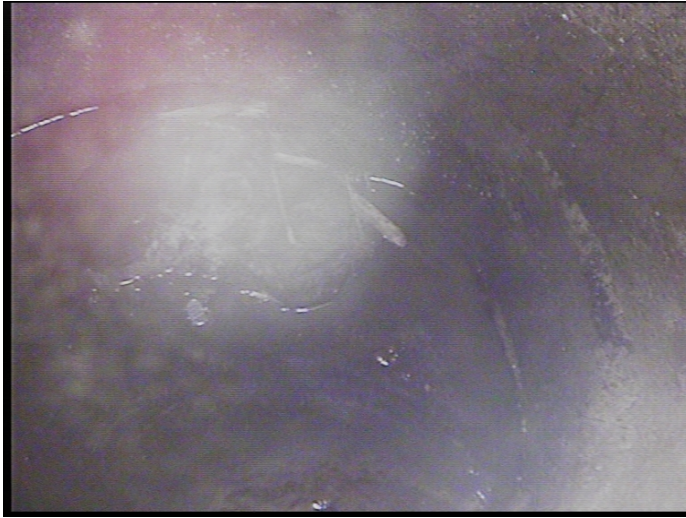
Code: **MWL**  
Description: **Water Level**

Distance (ft): **.0**  
Structural Grade: **0**  
O&M Grade: **0**  
Clock Start/From:  
Clock To:  
1st Value:  
2nd Value:  
Value Percent: **50.000**  
Continuous Index:  
Within 8" of Joint: **NO**  
Remarks:

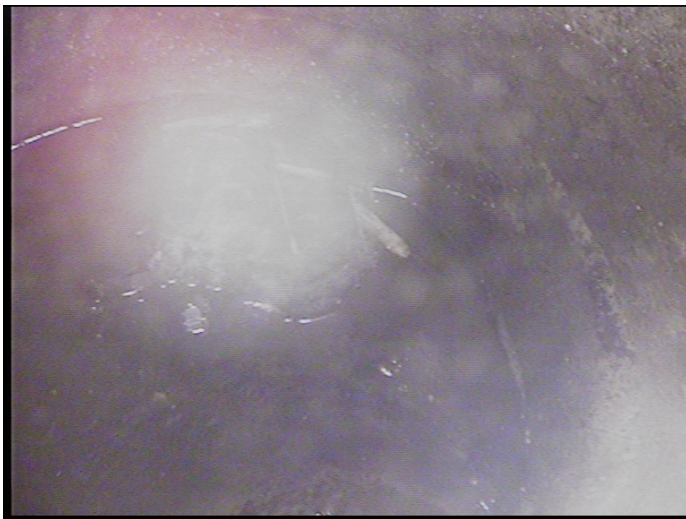
Code: **MSA**  
Description: **Abandoned Survey**

Distance (ft): **.0**  
Structural Grade: **0**  
O&M Grade: **0**  
Clock Start/From:  
Clock To:  
1st Value:  
2nd Value:  
Value Percent:  
Continuous Index:  
Within 8" of Joint: **NO**  
Remarks: **too much debris in MH**
