## **Profile/Photo Observation Report**

| Profile/Photo Observation Report | | | | | | | | |
|--|--|---|---|---|---|---|---|--|
| Date: Pipe Length (ft P.O.#: Customer: | 04/28/2018<br>:):<br>129<br>City of Hobart | Weather:<br>Owner:<br>Surveyor:<br>Clean Date | N | ity of Hobart<br>1. Pielacha | | Coding:<br>Pre Clean:<br>PSR:<br>Shape: | PACP 6.0<br>No Pre-Cleaning<br>P-704-032-031<br>C | |
| Street: | Old Ridge Road | | Flo | w Control: | | Not Controlled | | |
| US MH: | M-704-032 | DS MH: | M-70 | 04-031 | Total Len | gth Surveyed (ft): | 154.9 | |

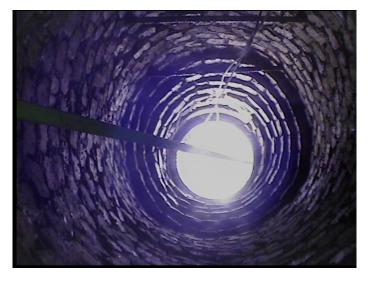
| Description: | Manhole | | |
| Distance (ft): | .0 | | |
| Remarks: | M-704-032 | | |

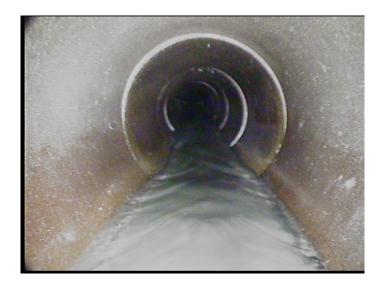
Code: MWL Description: **Water Level**

Distance (ft): .0 Structural Grade: 0 O&M Grade: 0 Clock Start/From:

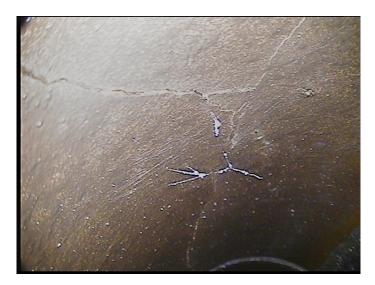
| Positio | n Code | Observation | Video (sec) | Grade |
|---|---|---|---|---|
| 107.3 | CM | Crack Multiple | 198 | S 3 |

Code: CM

Description: **Crack Multiple**

Distance (ft): 107.3 Structural Grade: 3 O&M Grade: 0 Clock Start/From: 12 Clock To: 3 1st Value: 2nd Value: Value Percent:

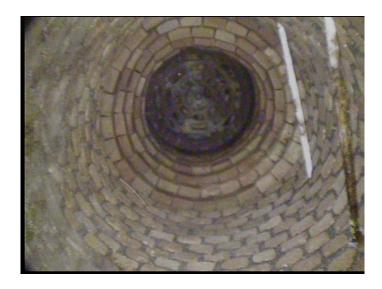
Code: AMH
Description: Manhole

Distance (ft): 154.8
Structural Grade: 0

Remarks: M-704-032.1
