Profile/Photo Observation Report

Street:	Off Victor Drive	Flow Control:	
City:	Hobart, IN	Year Renewed:	
Location:	Yard	Tape/Media #:	891
Purpose:	Routine Assessment	Dia/Height:	8"
Use:	Sanitary	Material:	VCP
Drain Area:		Lining:	
Category:	NA		
Comment:

Location Details:		Direction of Survey:	Downstream
US MH:	M-704-52	DS MH:	M-704-53
		Total Length Surveyed (ft):	44.8

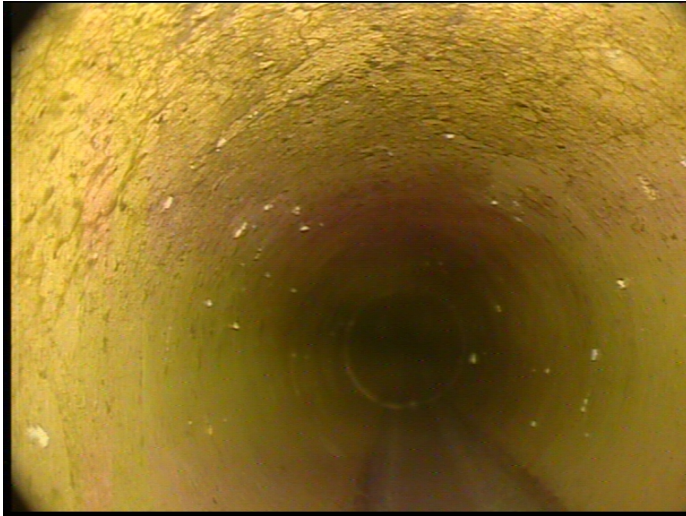
Code:	MWL
Description:	Water Level
Distance (ft):	.0
Structural Grade:	0
O&M Grade:	0
Clock Start/From:	
Clock To:	
1st Value:	
2nd Value:	
Value Percent:	5.000
Continuous Index:	
Within 8" of Joint:	NO
Remarks:

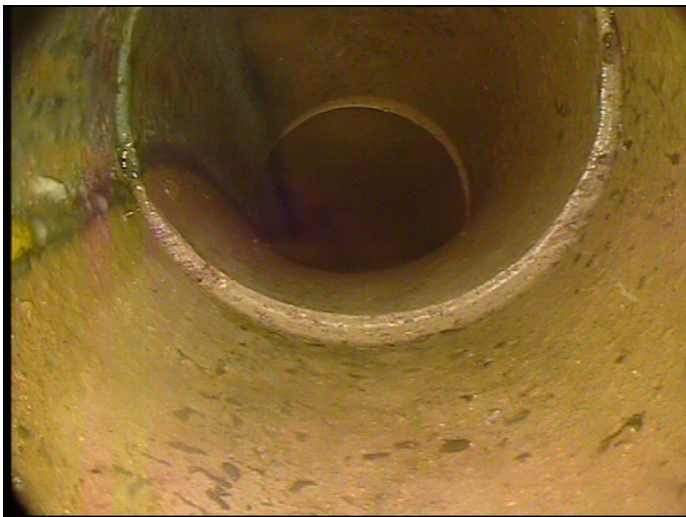
Code:	TF
Description:	Tap Factory
Distance (ft):	12.2
Structural Grade:	0
O&M Grade:	0
Clock Start/From:	9
Clock To:	
1st Value:	4.000
2nd Value:	
Value Percent:	
Continuous Index:	
Within 8" of Joint:	NO
Remarks:

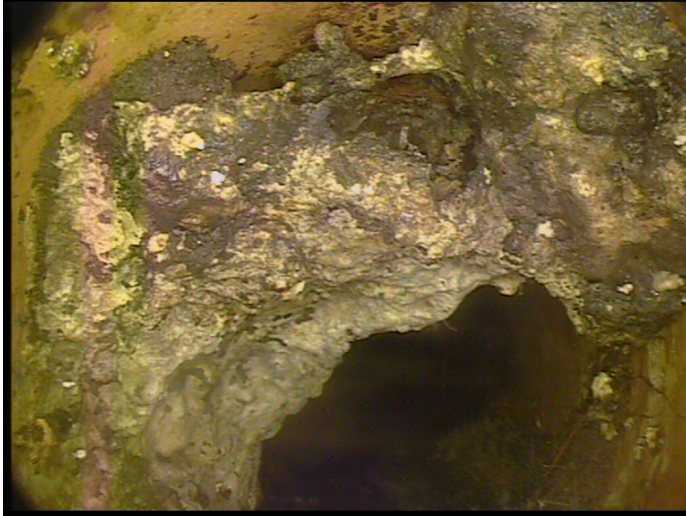
Code:	DAE
Description:	Deposits Attached Encrustation
Distance (ft):	42.7
Structural Grade:	0
O&M Grade:	4
Clock Start/From:	7
Clock To:	2
1st Value:	
2nd Value:	
Value Percent:	30.000
Continuous Index:	
Within 8" of Joint:	NO
Remarks:

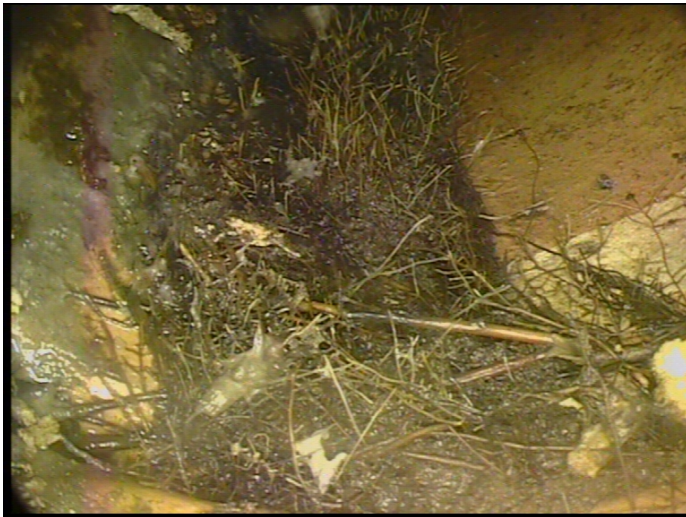
Code:	RMJ
Description:	Roots Medium Joint
Distance (ft):	44.8
Structural Grade:	0
O&M Grade:	3
Clock Start/From:	4
Clock To:	6
1st Value:	
2nd Value:	
Value Percent:	5.000
Continuous Index:	
Within 8" of Joint:	YES
Remarks:

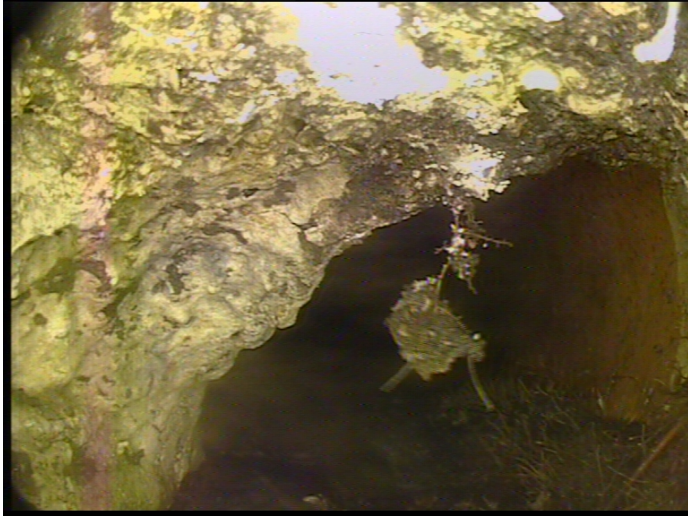
Code:	MSA
Description:	Abandoned Survey
Distance (ft):	44.8
Structural Grade:	0
O&M Grade:	0
Clock Start/From:	
Clock To:	
1st Value:	
2nd Value:	
Value Percent:	
Continuous Index:	
Within 8" of Joint:	NO
Remarks:	encrustation
