Profile/Photo Observation Report

Date:	04/11/2018	Weather:		Coding:	PACP 6.0
Pipe Length (ft):	197.5	Owner:	NA	Pre Clean:	Not Known
P.O.#:		Surveyor:	Jen Costello	PSR:	P-704-054-053
Customer:		Clean Date:	01/01/1900	Shape:	C

Street:	OFF SHORE SIDE DR	Flow Control:	Not Controlled
City:	Hobart, IN	Year Renewed:	
Location:	Other	Tape/Media #:	
Purpose:	Not Known	Dia/Height:	8"
Use:	Sanitary	Material:	VCP
Drain Area:	NA	Lining:	
Category:	NA		
Comment:	NULL - MH-M-704-063 Debris at entrance		
Location Details:		Direction of Survey:	Upstream
US MH:	M-704-053	DS MH:	M-704-054
		Total Length Surveyed (ft):	101.8

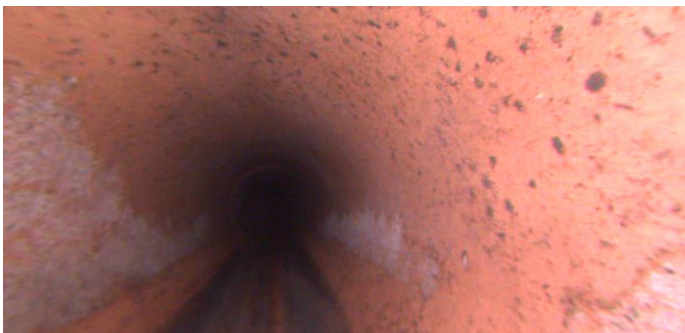
Code: **AMH**
Description: **Manhole**

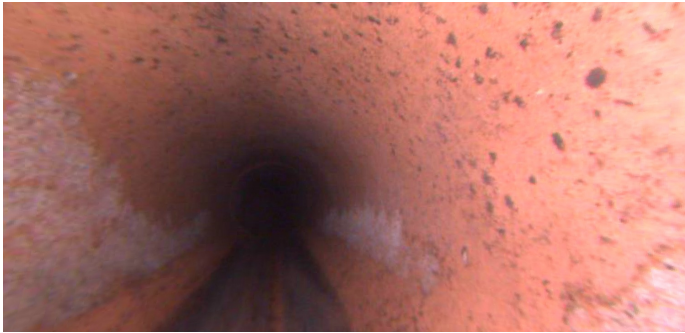
Code:	MWL
Description:	Water Level

Distance (ft):	.0
Structural Grade:	0
O&M Grade:	0
Clock Start/From:	
Clock To:	
1st Value:	
2nd Value:	
Value Percent:	5.000
Continuous Index:	
Within 8" of Joint:	NO
Remarks:

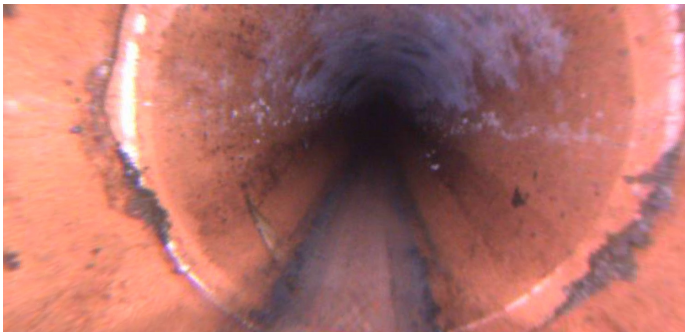
Code:	FS
Description:	Fracture Spiral

Distance (ft):	42.7
Structural Grade:	3
O&M Grade:	0
Clock Start/From:	8
Clock To:	9
1st Value:	
2nd Value:	
Value Percent:	
Continuous Index:	
Within 8" of Joint:	
Remarks:

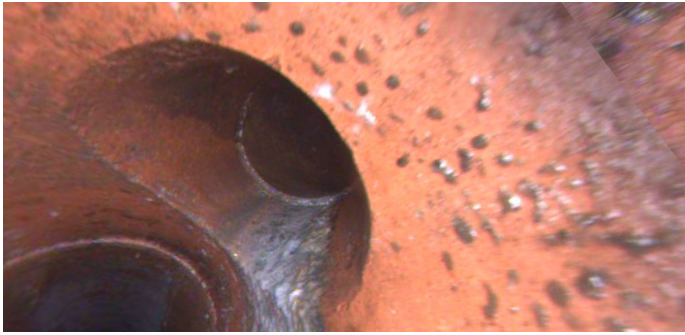
Code: **TF**
Description: **Tap Factory**

Distance (ft): **49.1**
Structural Grade: **0**
O&M Grade: **0**
Clock Start/From: **10**
Clock To:
1st Value: **4.000**
2nd Value:
Value Percent:
Continuous Index:
Within 8" of Joint:
Remarks:

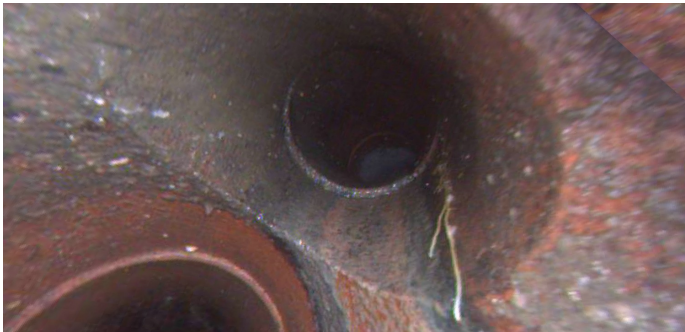
Code: **TFD**
Description: **Tap Factory Defective**

Distance (ft): **61.0**
Structural Grade: **0**
O&M Grade: **2**
Clock Start/From: **11**
Clock To:
1st Value: **4.000**
2nd Value:
Value Percent:
Continuous Index:
Within 8" of Joint:
Remarks: **ROOTS**

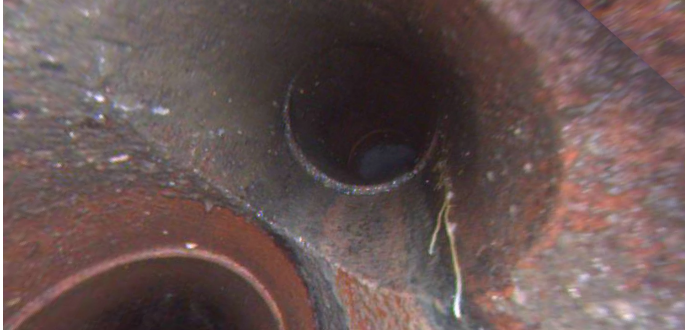
Code: **RFL**
Description: **Roots Fine Lateral**

Distance (ft): **61.0**
Structural Grade: **0**
O&M Grade: **1**
Clock Start/From: **11**
Clock To:
1st Value:
2nd Value:
Value Percent:
Continuous Index:
Within 8" of Joint: **NO**
Remarks:

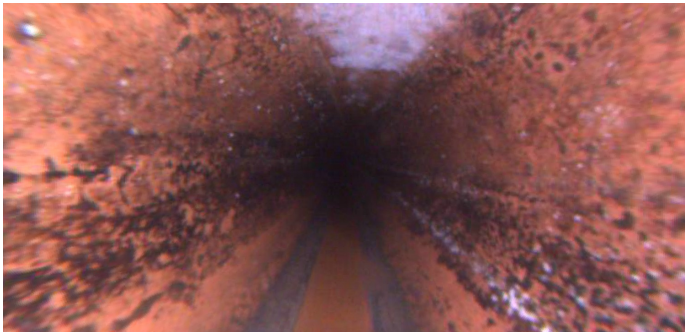
Code: **DAGS**
Description: **Deposits Attached Grease**

Distance (ft): **67.7**
Structural Grade: **0**
O&M Grade: **2**
Clock Start/From: **8**
Clock To: **4**
1st Value:
2nd Value:
Value Percent: **5.000**
Continuous Index: **S01**
Within 8" of Joint: **NO**
Remarks:

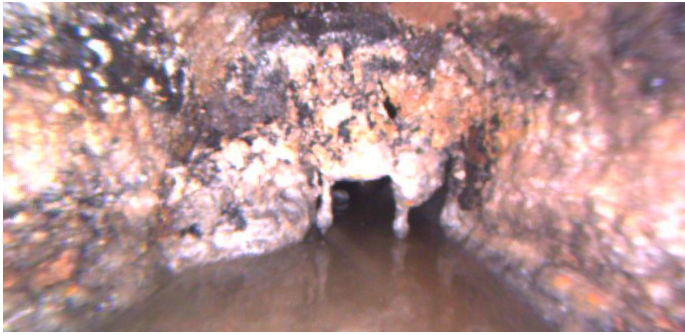
Code: **DAGS**
Description: **Deposits Attached Grease**

Distance (ft): **96.0**
Structural Grade: **0**
O&M Grade: **5**
Clock Start/From: **8**
Clock To: **4**
1st Value:
2nd Value:
Value Percent: **90.000**
Continuous Index:
Within 8" of Joint: **YES**
Remarks:

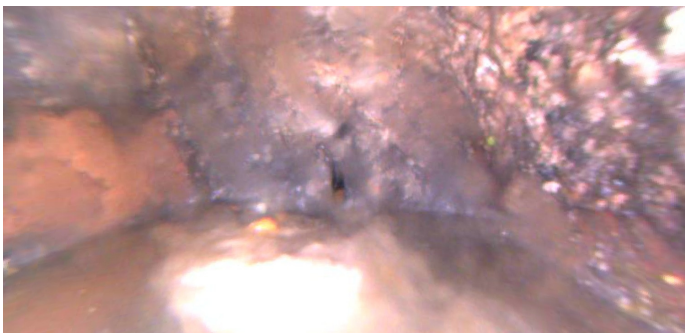
Code: **DAGS**
Description: **Deposits Attached Grease**

Distance (ft): **100.9**
Structural Grade: **0**
O&M Grade: **5**
Clock Start/From: **12**
Clock To: **12**
1st Value:
2nd Value:
Value Percent: **90.000**
Continuous Index:
Within 8" of Joint: **YES**
Remarks:

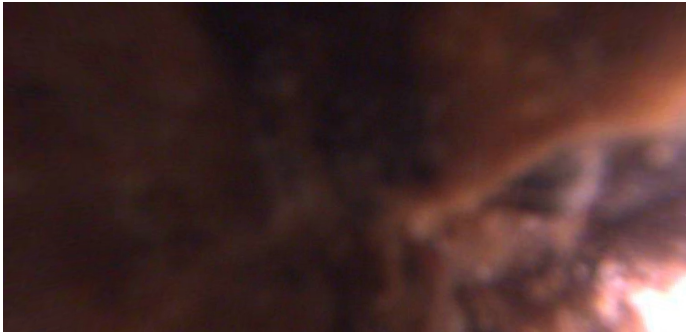
Code: **DAGS**
Description: **Deposits Attached Grease**

Distance (ft): **101.8**
Structural Grade: **0**
O&M Grade: **2**
Clock Start/From: **8**
Clock To: **4**
1st Value:
2nd Value:
Value Percent: **5.000**
Continuous Index: **F01**
Within 8" of Joint: **NO**
Remarks:

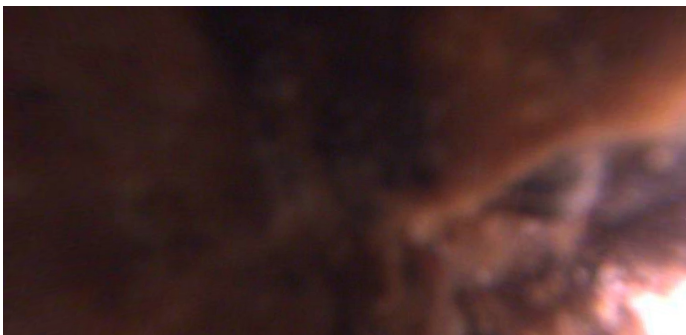
Code: **MSA**
Description: **Abandoned Survey**

Distance (ft): **101.8**
Structural Grade: **0**
O&M Grade: **0**
Clock Start/From:
Clock To:
1st Value:
2nd Value:
Value Percent:
Continuous Index:
Within 8" of Joint: **NO**
Remarks: **DAGS**
