Profile/Photo Observation Report

Date:	04/11/2018	Weather:		Coding:	PACP 6.0
Pipe Length (ft):	197.5	Owner:	NA	Pre Clean:	Not Known
P.O.#:		Surveyor:	Jen Costello	PSR:	P-704-054-053
Customer:		Clean Date:	01/01/1900	Shape:	C

Street:	Ruta Dr.	Flow Control:	Not Controlled
City:	Hobart, IN	Year Renewed:	
Location:	Other	Tape/Media #:	
Purpose:	Not Known	Dia/Height:	8"
Use:	Sanitary	Material:	VCP
Drain Area:	NA	Lining:	
Category:	NA		
Comment:	NULL - MH-M-704-063 Debris at entrance		
Location Details:		Direction of Survey:	Upstream
US MH:	M-704-053	DS MH:	M-704-054
		Total Length Surveyed (ft):	101.8

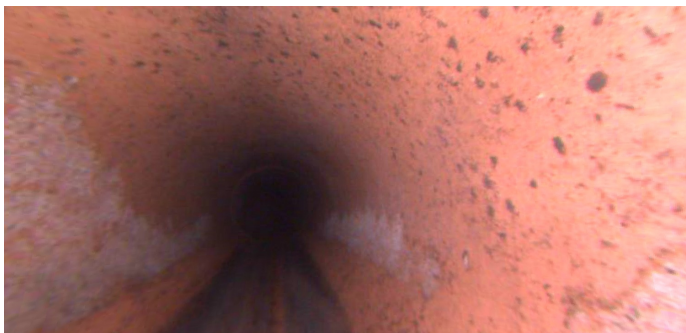
Code: **AMH**
Description: **Manhole**

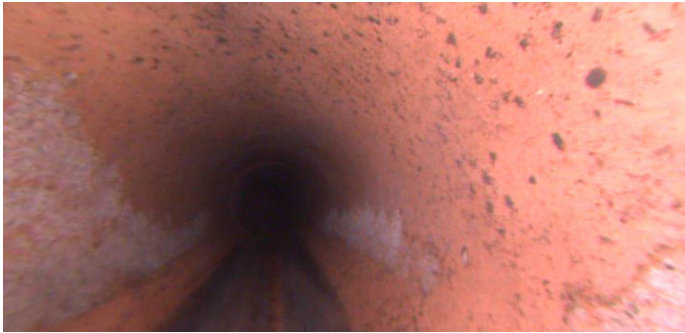
Code:	MWL
Description:	Water Level

Distance (ft):	.0
Structural Grade:	0
O&M Grade:	0
Clock Start/From:	
Clock To:	
1st Value:	
2nd Value:	
Value Percent:	5.000
Continuous Index:	
Within 8" of Joint:	NO
Remarks:

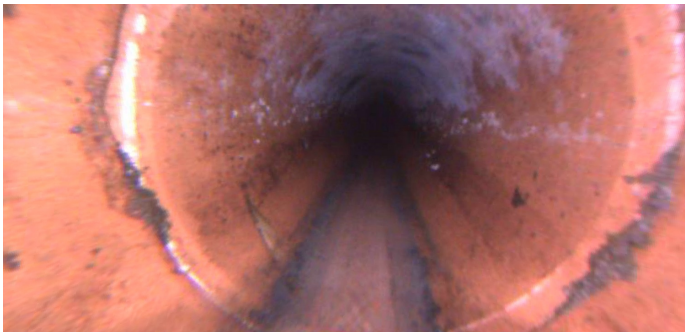
Code:	FS
Description:	Fracture Spiral

Distance (ft):	42.7
Structural Grade:	3
O&M Grade:	0
Clock Start/From:	8
Clock To:	9
1st Value:	
2nd Value:	
Value Percent:	
Continuous Index:	
Within 8" of Joint:	
Remarks:

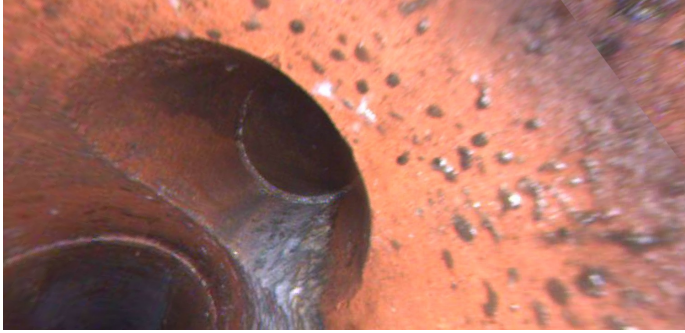
Code: **TF**
Description: **Tap Factory**

Distance (ft): **49.1**
Structural Grade: **0**
O&M Grade: **0**
Clock Start/From: **10**
Clock To:
1st Value: **4.000**
2nd Value:
Value Percent:
Continuous Index:
Within 8" of Joint:
Remarks:

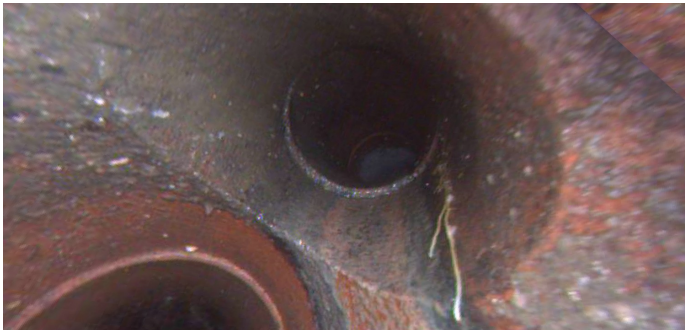
Code: **TFD**
Description: **Tap Factory Defective**

Distance (ft): **61.0**
Structural Grade: **0**
O&M Grade: **2**
Clock Start/From: **11**
Clock To:
1st Value: **4.000**
2nd Value:
Value Percent:
Continuous Index:
Within 8" of Joint:
Remarks: **ROOTS**

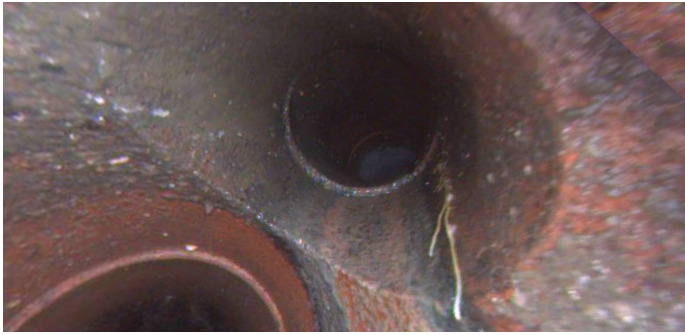
Code: **RFL**
Description: **Roots Fine Lateral**

Distance (ft): **61.0**
Structural Grade: **0**
O&M Grade: **1**
Clock Start/From: **11**
Clock To:
1st Value:
2nd Value:
Value Percent:
Continuous Index:
Within 8" of Joint: **NO**
Remarks:

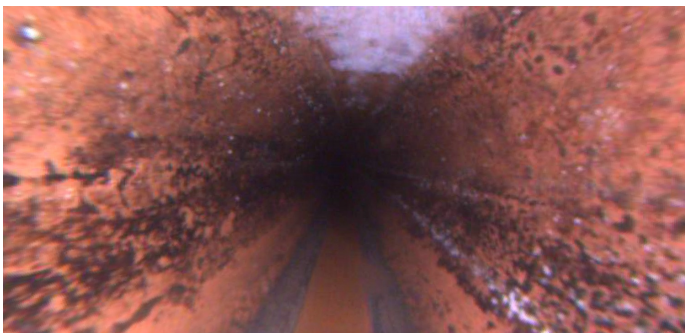
Code: **DAGS**
Description: **Deposits Attached Grease**

Distance (ft): **67.7**
Structural Grade: **0**
O&M Grade: **2**
Clock Start/From: **8**
Clock To: **4**
1st Value:
2nd Value:
Value Percent: **5.000**
Continuous Index: **S01**
Within 8" of Joint: **NO**
Remarks:

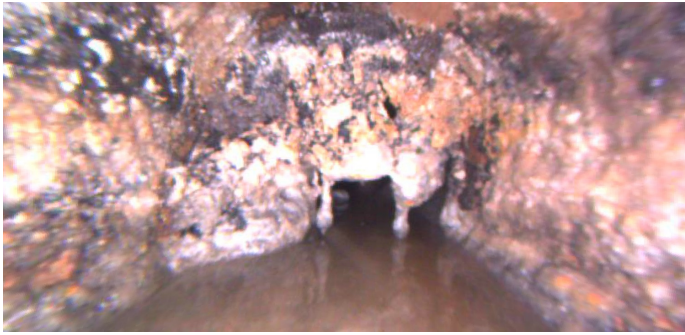
Code: **DAGS**
Description: **Deposits Attached Grease**

Distance (ft): **96.0**
Structural Grade: **0**
O&M Grade: **5**
Clock Start/From: **8**
Clock To: **4**
1st Value:
2nd Value:
Value Percent: **90.000**
Continuous Index:
Within 8" of Joint: **YES**
Remarks:

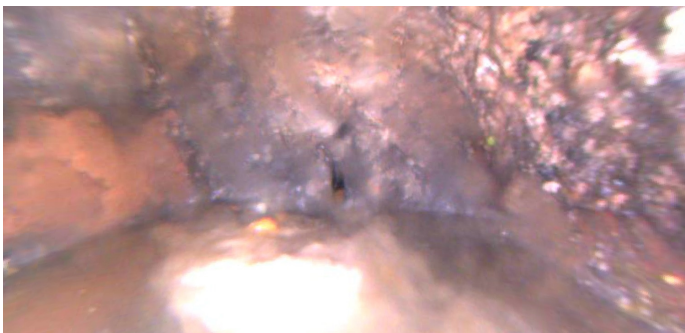
Code: **DAGS**
Description: **Deposits Attached Grease**

Distance (ft): **100.9**
Structural Grade: **0**
O&M Grade: **5**
Clock Start/From: **12**
Clock To: **12**
1st Value:
2nd Value:
Value Percent: **90.000**
Continuous Index:
Within 8" of Joint: **YES**
Remarks:

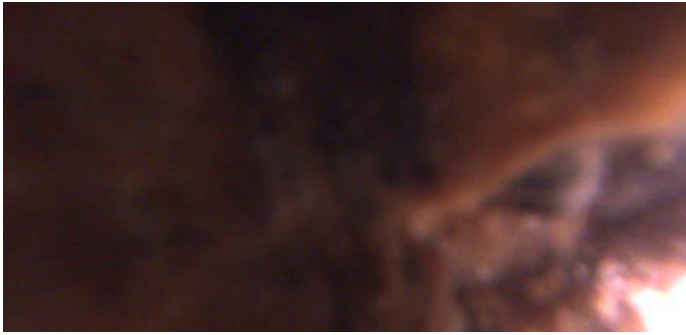
Code: **DAGS**
Description: **Deposits Attached Grease**

Distance (ft): **101.8**
Structural Grade: **0**
O&M Grade: **2**
Clock Start/From: **8**
Clock To: **4**
1st Value:
2nd Value:
Value Percent: **5.000**
Continuous Index: **F01**
Within 8" of Joint: **NO**
Remarks:

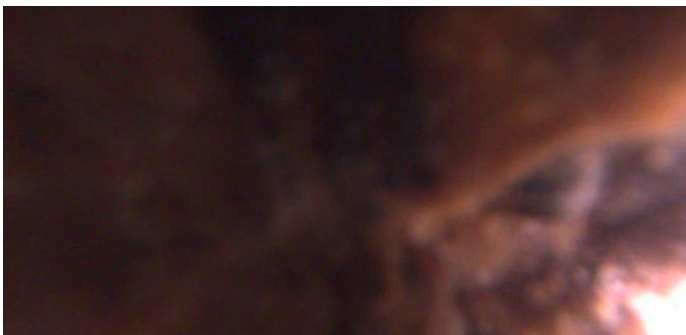
Code: **MSA**
Description: **Abandoned Survey**

Distance (ft): **101.8**
Structural Grade: **0**
O&M Grade: **0**
Clock Start/From:
Clock To:
1st Value:
2nd Value:
Value Percent:
Continuous Index:
Within 8" of Joint: **NO**
Remarks: **DAGS**
