Profile/Photo Observation Report

Date:	04/10/2018	Weather:		Coding:	PACP 6.0
Pipe Length (ft):	303.3	Owner:	NA	Pre Clean:	Not Known
P.O.#:		Surveyor:	Mark Ruby	PSR:	P-704-056-055
Customer:		Clean Date:	01/01/1900	Shape:	C

Street:	OFF RUTA DR	Flow Control:	Not Controlled
City:	Hobart, IN	Year Renewed:	
Location:	Other	Tape/Media #:	
Purpose:	Not Known	Dia/Height:	8"
Use:	Sanitary	Material:	VCP
Drain Area:	NA	Lining:	
Category:	NA		
Comment:

Location Details:		Direction of Survey:	Downstream
US MH:	M-704-056	DS MH:	M-704-055
		Total Length Surveyed (ft):	76.8

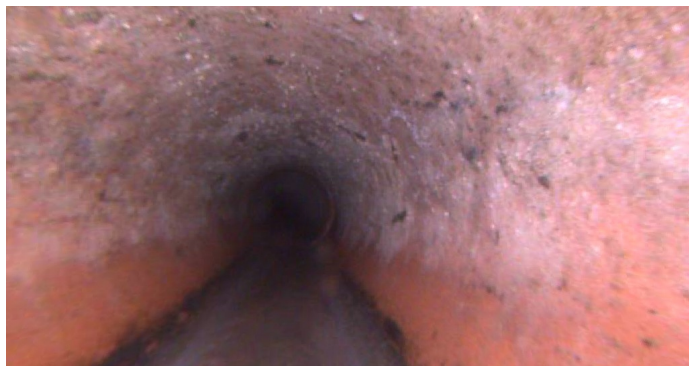
Code: **AMH**
Description: **Manhole**

Distance (ft): **.0**
Structural Grade: **0**
O&M Grade: **0**
Clock Start/From:
Clock To:
1st Value:
2nd Value:
Value Percent:
Continuous Index:
Within 8" of Joint: **NO**
Remarks: **M-704-056**

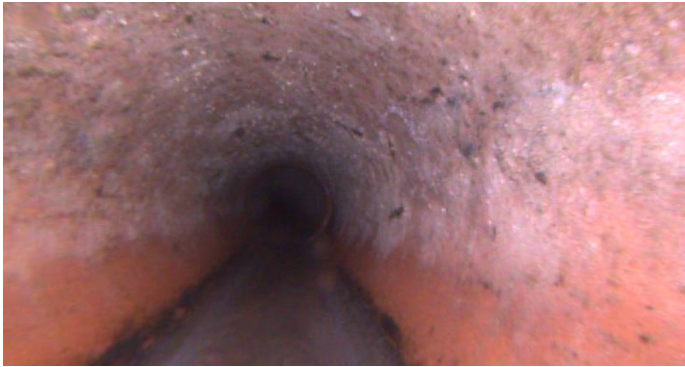
Code:	MWL
Description:	Water Level

Distance (ft):	.0
Structural Grade:	0
O&M Grade:	0
Clock Start/From:	
Clock To:	
1st Value:	
2nd Value:	
Value Percent:	10.000
Continuous Index:	
Within 8" of Joint:	NO
Remarks:

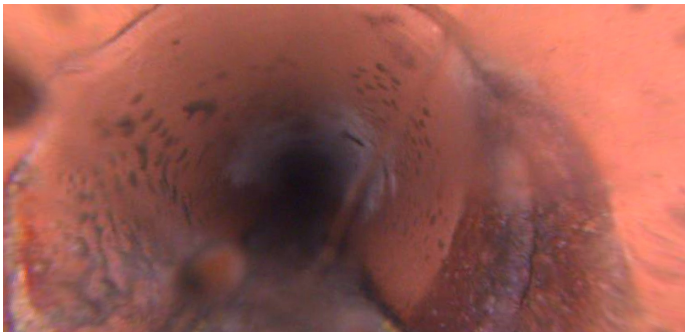
Code:	IW
Description:	Infil Weeper

Distance (ft):	43.4
Structural Grade:	0
O&M Grade:	2
Clock Start/From:	1
Clock To:	4
1st Value:	
2nd Value:	
Value Percent:	
Continuous Index:	
Within 8" of Joint:	YES
Remarks:

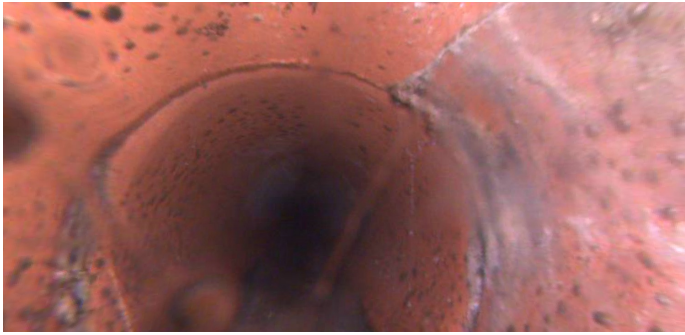
Code: **CM**
Description: **Crack Multiple**

Distance (ft): **58.2**
Structural Grade: **3**
O&M Grade: **0**
Clock Start/From: **8**
Clock To: **1**
1st Value:
2nd Value:
Value Percent:
Continuous Index:
Within 8" of Joint: **YES**
Remarks:

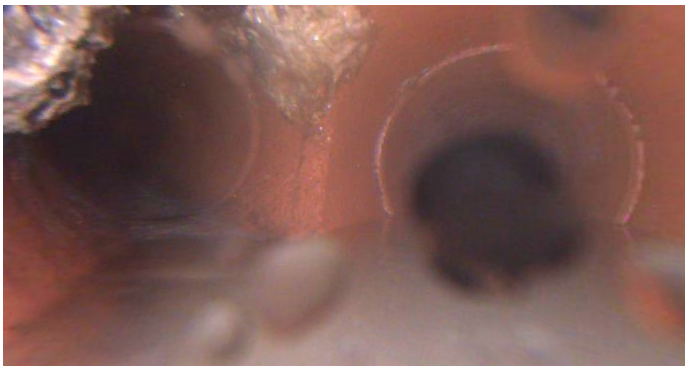
Code: **TF**
Description: **Tap Factory**

Distance (ft): **69.7**
Structural Grade: **0**
O&M Grade: **0**
Clock Start/From: **3**
Clock To:
1st Value: **4.000**
2nd Value:
Value Percent:
Continuous Index:
Within 8" of Joint:
Remarks:

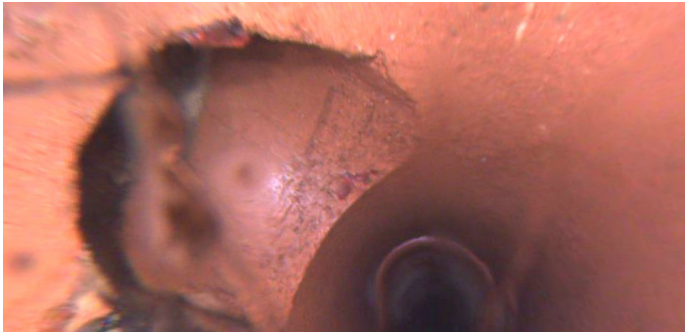
Code: **TFD**
Description: **Tap Factory Defective**

Distance (ft): **76.0**
Structural Grade: **0**
O&M Grade: **2**
Clock Start/From: **9**
Clock To:
1st Value: **4.000**
2nd Value:
Value Percent:
Continuous Index:
Within 8" of Joint:
Remarks: **DAE**

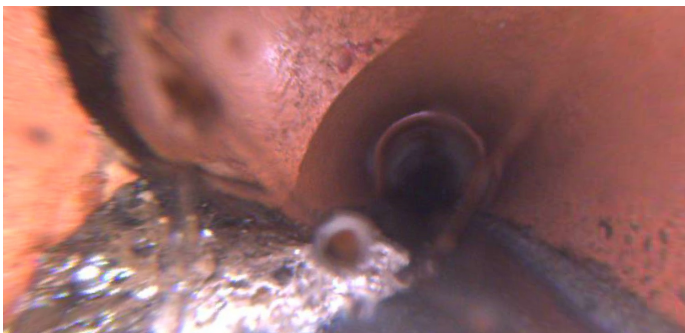
Code: **DAE**
Description: **Deposits Attached Encrustation**

Distance (ft): **76.0**
Structural Grade: **0**
O&M Grade: **2**
Clock Start/From: **7**
Clock To: **9**
1st Value:
2nd Value:
Value Percent: **10.000**
Continuous Index:
Within 8" of Joint: **NO**
Remarks:

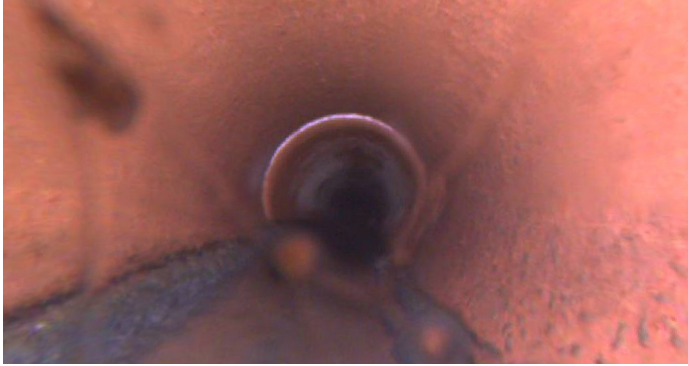
Code:	MSA
Description:	Abandoned Survey
Distance (ft):	76.8
Structural Grade:	0
O&M Grade:	0
Clock Start/From:	
Clock To:	
1st Value:	
2nd Value:	
Value Percent:	
Continuous Index:	
Within 8" of Joint:	NO
Remarks:	No blockage
