## Profile/Photo Observation Report

Date:	<b>04/10/2018</b>	Weather:		Coding:	<b>PACP 6.0</b>
Pipe Length (ft):	<b>303.3</b>	Owner:	<b>NA</b>	Pre Clean:	<b>Not Known</b>
P.O.#:		Surveyor:	<b>Mark Ruby</b>	PSR:	<b>P-704-056-055</b>
Customer:		Clean Date:	<b>01/01/1900</b>	Shape:	<b>C</b>

Street:	<b>Ruta Dr.</b>	Flow Control:	<b>Not Controlled</b>
City:	<b>Hobart, IN</b>	Year Renewed:	
Location:	<b>Other</b>	Tape/Media #:	
Purpose:	<b>Not Known</b>	Dia/Height:	<b>8"</b>
Use:	<b>Sanitary</b>	Material:	<b>VCP</b>
Drain Area:	<b>NA</b>	Lining:	
Category:	<b>NA</b>		
Comment:

Location Details:		Direction of Survey:	<b>Downstream</b>
US MH:	<b>M-704-056</b>	DS MH:	<b>M-704-055</b>
		Total Length Surveyed (ft):	<b>76.8</b>

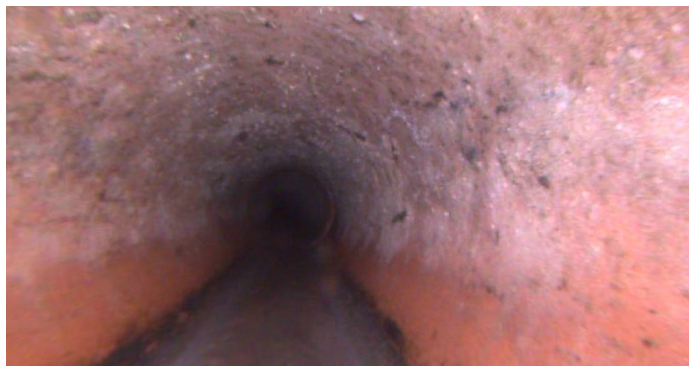
Code: **AMH**  
Description: **Manhole**

Distance (ft): **.0**  
Structural Grade: **0**  
O&M Grade: **0**  
Clock Start/From:  
Clock To:  
1st Value:  
2nd Value:  
Value Percent:  
Continuous Index:  
Within 8" of Joint: **NO**  
Remarks: **M-704-056**

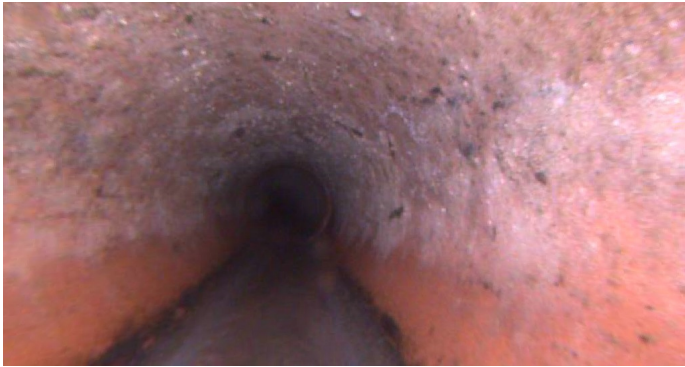
Code:	<b>MWL</b>
Description:	<b>Water Level</b>

Distance (ft):	<b>.0</b>
Structural Grade:	<b>0</b>
O&M Grade:	<b>0</b>
Clock Start/From:	
Clock To:	
1st Value:	
2nd Value:	
Value Percent:	<b>10.000</b>
Continuous Index:	
Within 8" of Joint:	<b>NO</b>
Remarks:

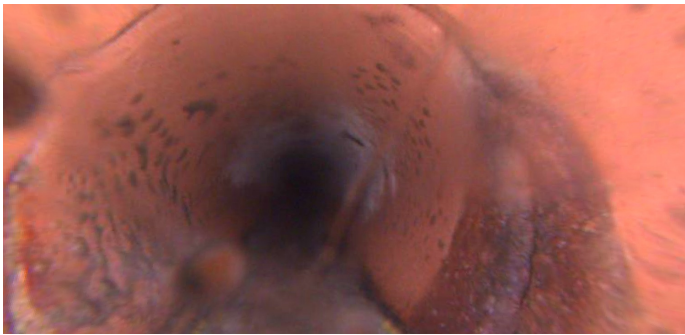
Code:	<b>IW</b>
Description:	<b>Infil Weeper</b>

Distance (ft):	<b>43.4</b>
Structural Grade:	<b>0</b>
O&M Grade:	<b>2</b>
Clock Start/From:	<b>1</b>
Clock To:	<b>4</b>
1st Value:	
2nd Value:	
Value Percent:	
Continuous Index:	
Within 8" of Joint:	<b>YES</b>
Remarks:

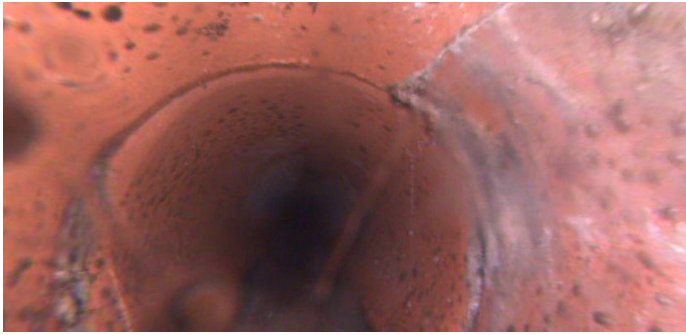
Code: **CM**  
Description: **Crack Multiple**

Distance (ft): **58.2**  
Structural Grade: **3**  
O&M Grade: **0**  
Clock Start/From: **8**  
Clock To: **1**  
1st Value:  
2nd Value:  
Value Percent:  
Continuous Index:  
Within 8" of Joint: **YES**  
Remarks:

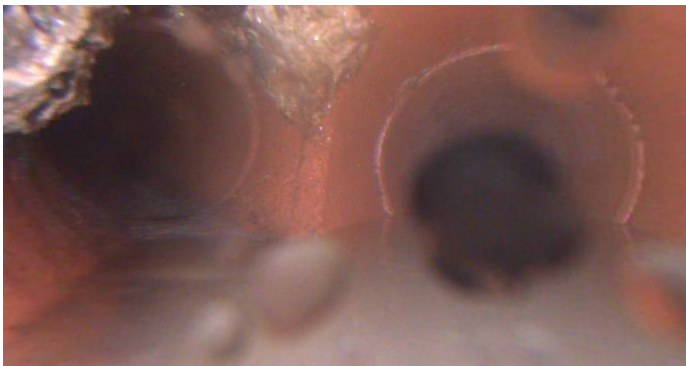
Code: **TF**  
Description: **Tap Factory**

Distance (ft): **69.7**  
Structural Grade: **0**  
O&M Grade: **0**  
Clock Start/From: **3**  
Clock To:  
1st Value: **4.000**  
2nd Value:  
Value Percent:  
Continuous Index:  
Within 8" of Joint:  
Remarks:

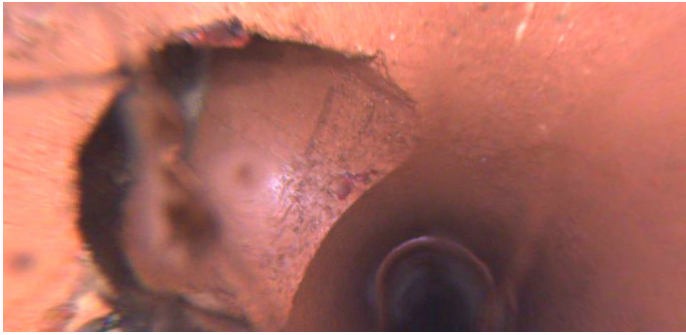
Code: **TFD**  
Description: **Tap Factory Defective**

Distance (ft): **76.0**  
Structural Grade: **0**  
O&M Grade: **2**  
Clock Start/From: **9**  
Clock To:  
1st Value: **4.000**  
2nd Value:  
Value Percent:  
Continuous Index:  
Within 8" of Joint:  
Remarks: **DAE**

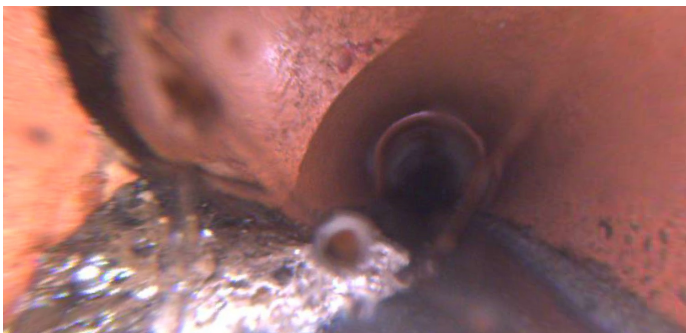
Code: **DAE**  
Description: **Deposits Attached Encrustation**

Distance (ft): **76.0**  
Structural Grade: **0**  
O&M Grade: **2**  
Clock Start/From: **7**  
Clock To: **9**  
1st Value:  
2nd Value:  
Value Percent: **10.000**  
Continuous Index:  
Within 8" of Joint: **NO**  
Remarks:

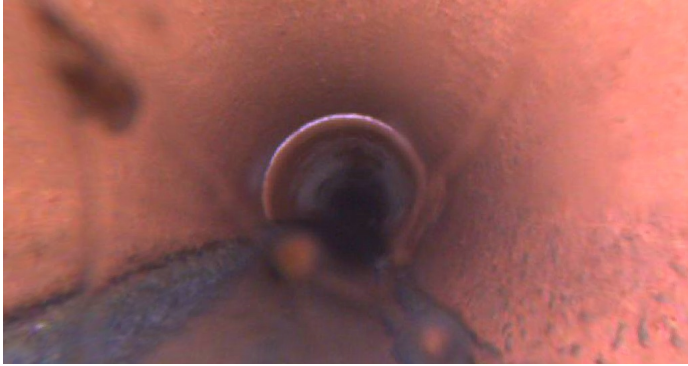
Code:	<b>MSA</b>
Description:	<b>Abandoned Survey</b>
Distance (ft):	<b>76.8</b>
Structural Grade:	<b>0</b>
O&M Grade:	<b>0</b>
Clock Start/From:	
Clock To:	
1st Value:	
2nd Value:	
Value Percent:	
Continuous Index:	
Within 8" of Joint:	<b>NO</b>
Remarks:	<b>No blockage</b>
