## Profile/Photo Observation Report

Street:	<b>OFF VICTOR DR</b>	Flow Control:	<b>Not Controlled</b>
City:	<b>Hobart, IN</b>	Year Renewed:	
Location:	<b>Light Highway</b>	Tape/Media #:	
Purpose:	<b>Not Known</b>	Dia/Height:	<b>8"</b>
Use:	<b>Sanitary</b>	Material:	<b>VCP</b>
Drain Area:	<b>NA</b>	Lining:	
Category:	<b>NA</b>		
Comment:

Location Details:		Direction of Survey:	<b>Downstream</b>
US MH:	<b>M-704-057</b>	DS MH:	<b>M-704-056</b>
		Total Length Surveyed (ft):	<b>135.4</b>

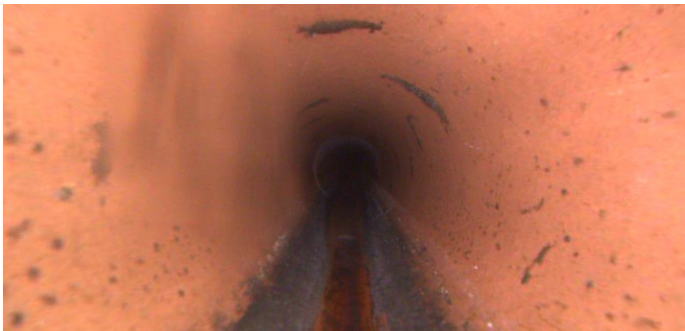
Code: **AMH**  
Description: **Manhole**

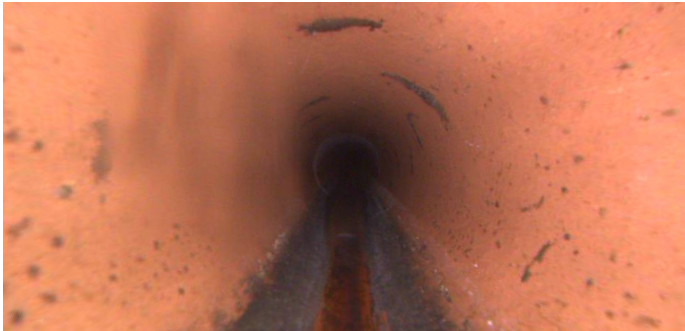
Code:	<b>MWL</b>
Description:	<b>Water Level</b>

Distance (ft):	<b>.0</b>
Structural Grade:	<b>0</b>
O&M Grade:	<b>0</b>
Clock Start/From:	
Clock To:	
1st Value:	
2nd Value:	
Value Percent:	<b>5.000</b>
Continuous Index:	
Within 8" of Joint:	<b>NO</b>
Remarks:

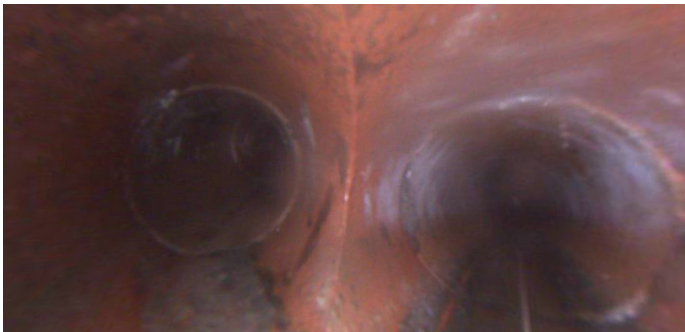
Code:	<b>TFA</b>
Description:	<b>Tap Factory Active</b>

Distance (ft):	<b>49.2</b>
Structural Grade:	<b>0</b>
O&M Grade:	<b>0</b>
Clock Start/From:	<b>3</b>
Clock To:	
1st Value:	<b>4.000</b>
2nd Value:	
Value Percent:	
Continuous Index:	
Within 8" of Joint:	
Remarks:

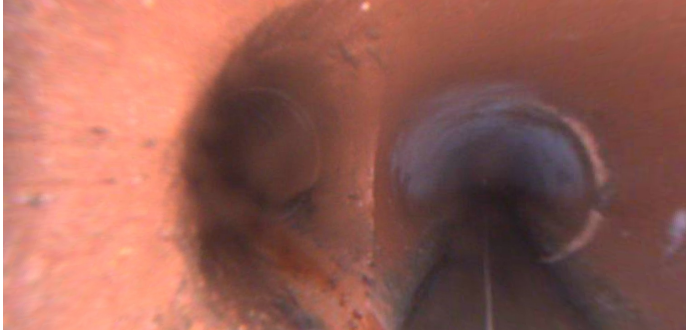
Code: **TFA**  
Description: **Tap Factory Active**

Distance (ft): **56.4**  
Structural Grade: **0**  
O&M Grade: **0**  
Clock Start/From: **3**  
Clock To:  
1st Value: **4.000**  
2nd Value:  
Value Percent:  
Continuous Index:  
Within 8" of Joint:  
Remarks:

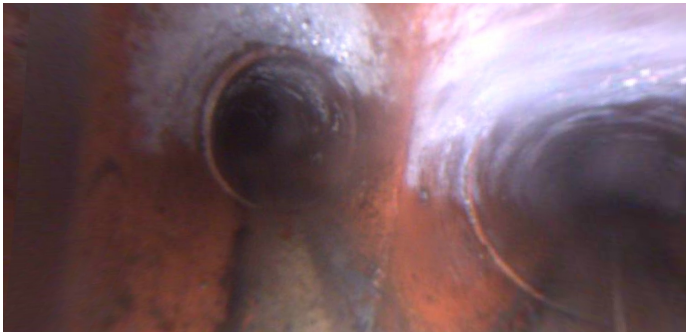
Code: **TFA**  
Description: **Tap Factory Active**

Distance (ft): **98.4**  
Structural Grade: **0**  
O&M Grade: **0**  
Clock Start/From: **3**  
Clock To:  
1st Value: **4.000**  
2nd Value:  
Value Percent:  
Continuous Index:  
Within 8" of Joint:  
Remarks:

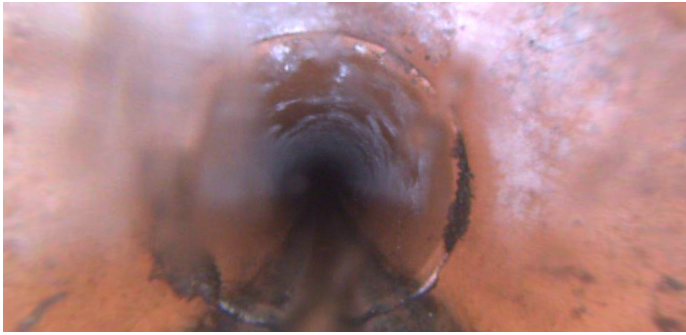
Code: **DAZ**  
Description: **Deposits Attached Other**

Distance (ft): **119.0**  
Structural Grade: **0**  
O&M Grade: **2**  
Clock Start/From: **8**  
Clock To: **4**  
1st Value:  
2nd Value:  
Value Percent: **5.000**  
Continuous Index:  
Within 8" of Joint: **YES**  
Remarks:

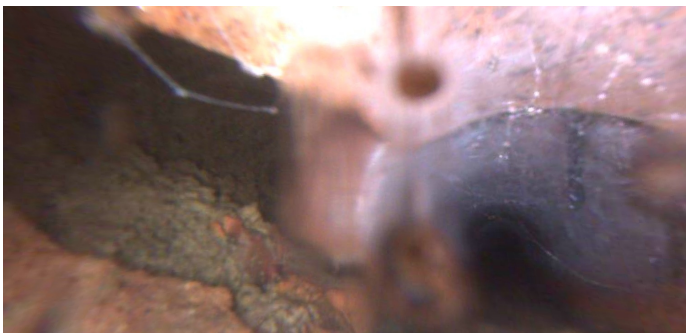
Code: **HVV**  
Description: **Hole Void Visible**

Distance (ft): **134.1**  
Structural Grade: **5**  
O&M Grade: **0**  
Clock Start/From: **8**  
Clock To: **11**  
1st Value:  
2nd Value:  
Value Percent:  
Continuous Index:  
Within 8" of Joint: **YES**  
Remarks:

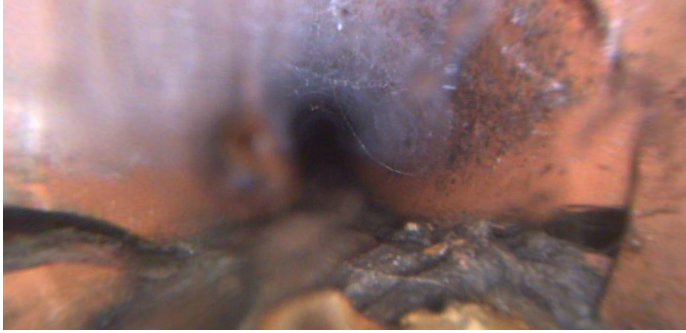
Code: **B**  
Description: **Broken**

Distance (ft): **134.4**  
Structural Grade: **5**  
O&M Grade: **0**  
Clock Start/From: **4**  
Clock To: **8**  
1st Value:  
2nd Value:  
Value Percent:  
Continuous Index:  
Within 8" of Joint: **YES**  
Remarks:

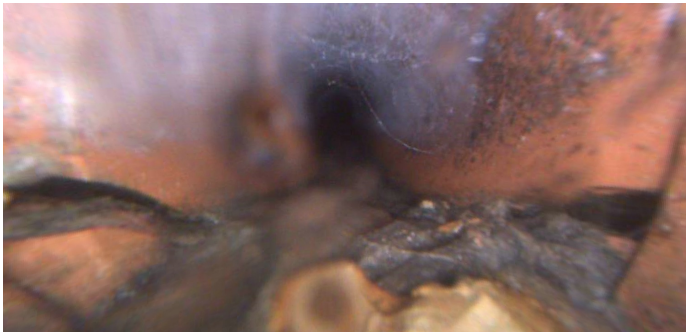
Code: **OBZ**  
Description: **Obstacle Other**

Distance (ft): **134.4**  
Structural Grade: **0**  
O&M Grade: **3**  
Clock Start/From: **4**  
Clock To: **8**  
1st Value:  
2nd Value:  
Value Percent: **20.000**  
Continuous Index:  
Within 8" of Joint: **NO**  
Remarks: **misc**

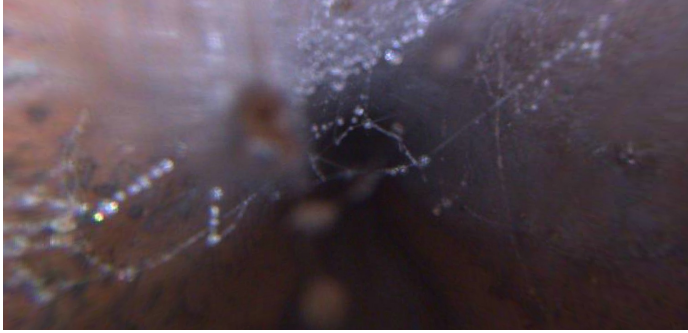
Code:	<b>MSA</b>
Description:	<b>Abandoned Survey</b>
Distance (ft):	<b>135.4</b>
Structural Grade:	<b>0</b>
O&M Grade:	<b>0</b>
Clock Start/From:	
Clock To:	
1st Value:	
2nd Value:	
Value Percent:	
Continuous Index:	
Within 8" of Joint:	<b>NO</b>
Remarks:	<b>obz</b>
