Profile/Photo Observation Report

| Street: | Summerlin | Flow Control: | Not Controlled |
| City: | Hobart, IN | Year Renewed: | |

| US MH: | M-704-057 | DS MH: | M-704-056 |

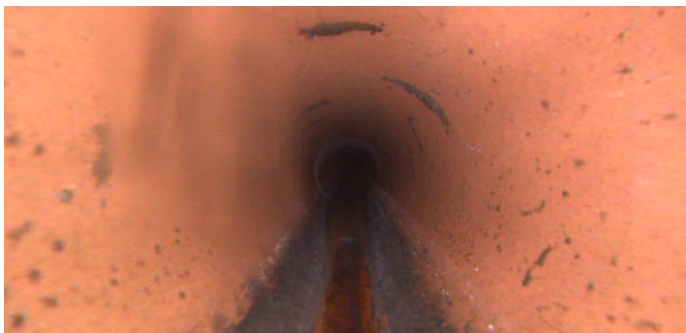
Code: **AMH**
Description: **Manhole**

Distance (ft): **.0**
Structural Grade: **0**
O&M Grade: **0**
Clock Start/From:
Clock To:
1st Value:
2nd Value:
Value Percent:
Continuous Index:
Within 8" of Joint: **NO**
Remarks: **M-704-057**

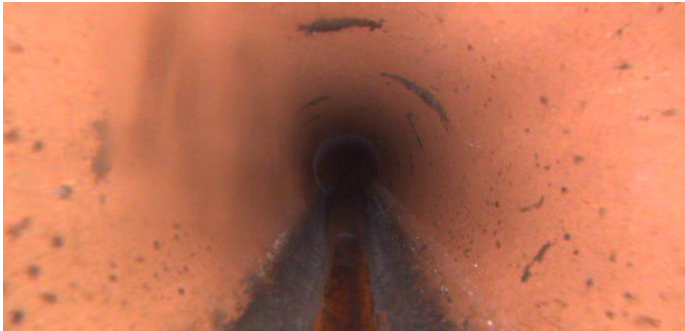
| Code: | MWL |
| Description: | Water Level |

| Value Percent: | 5.000 |

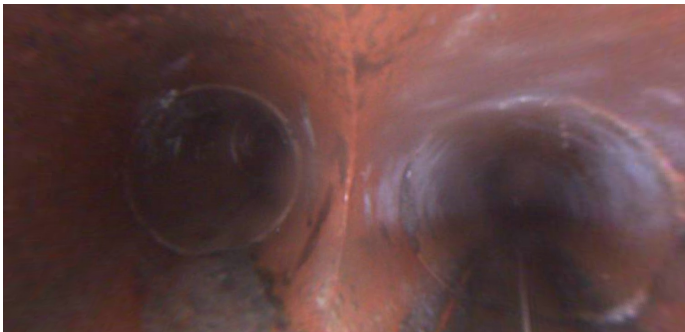
| Code: | TFA |
| Description: | Tap Factory Active |

| Distance (ft): | 49.2 |

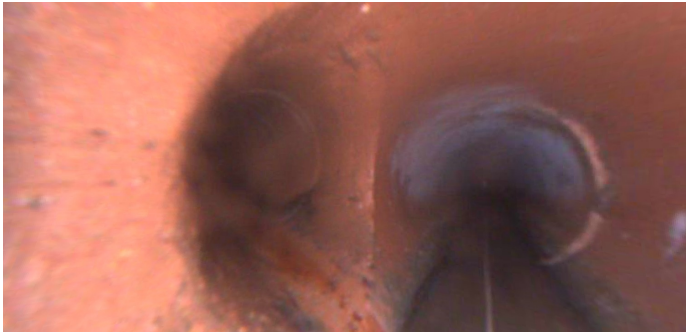
Code: **TFA**
Description: **Tap Factory Active**

Distance (ft): **56.4**
Structural Grade: **0**
O&M Grade: **0**
Clock Start/From: **3**
Clock To:
1st Value: **4.000**
2nd Value:
Value Percent:
Continuous Index:
Within 8" of Joint:
Remarks:

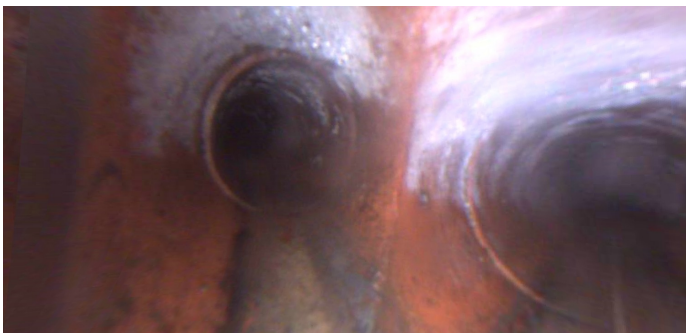
Code: **TFA**
Description: **Tap Factory Active**

Distance (ft): **98.4**
Structural Grade: **0**
O&M Grade: **0**
Clock Start/From: **3**
Clock To:
1st Value: **4.000**
2nd Value:
Value Percent:
Continuous Index:
Within 8" of Joint:
Remarks:

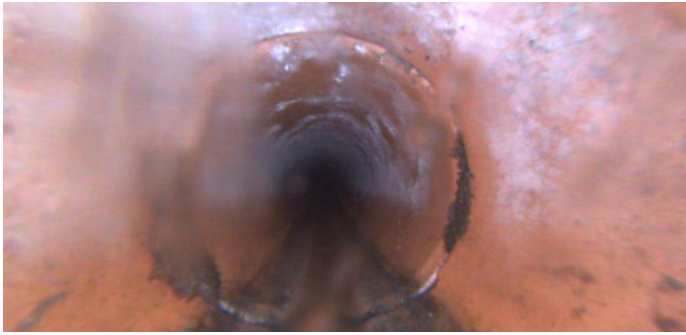
| | Position | Code | Observation | Video (sec) | Grade |
|---|---|---|---|---|---|
| | 119.0 | DAZ | Deposits Attached Other | 314 | M 2 |

Code: **DAZ**
Description: **Deposits Attached Other**

Distance (ft): **119.0**
Structural Grade: **0**
O&M Grade: **2**
Clock Start/From: **8**
Clock To: **4**
1st Value:
2nd Value:
Value Percent: **5.000**
Continuous Index:
Within 8" of Joint: **YES**
Remarks:

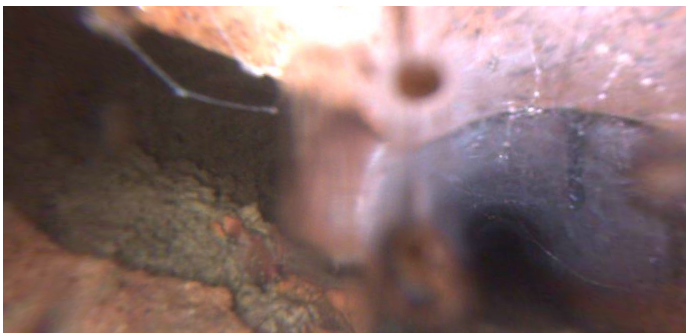
| | Position | Code | Observation | Video (sec) | Grade |
|---|---|---|---|---|---|
| | 134.1 | HVV | Hole Void Visible | 356 | S 5 |

Code: **HVV**
Description: **Hole Void Visible**

Distance (ft): **134.1**
Structural Grade: **5**
O&M Grade: **0**
Clock Start/From: **8**
Clock To: **11**
1st Value:
2nd Value:
Value Percent:
Continuous Index:
Within 8" of Joint: **YES**
Remarks:

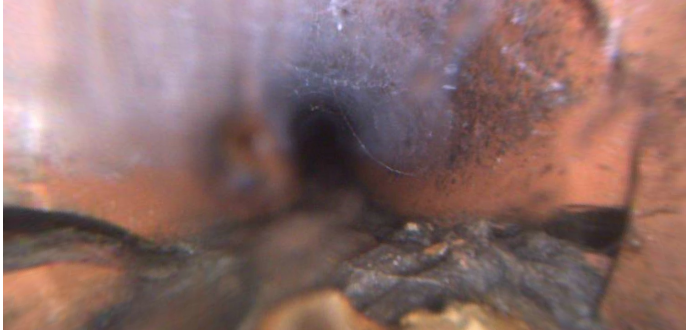
| | Position | Code | Observation | Video (sec) | Grade |
|---|---|---|---|---|---|
| | 134.4 | B | Broken | 368 | S 5 |

Code: **B**
Description: **Broken**

Distance (ft): **134.4**
Structural Grade: **5**
O&M Grade: **0**
Clock Start/From: **4**
Clock To: **8**
1st Value:
2nd Value:
Value Percent:
Continuous Index:
Within 8" of Joint: **YES**
Remarks:

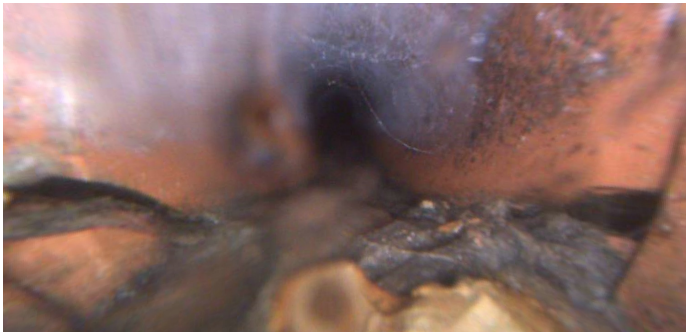
| | Position | Code | Observation | Video (sec) | Grade |
|---|---|---|---|---|---|
| | 134.4 | OBZ | Obstacle Other | 379 | M 3 |

Code: **OBZ**
Description: **Obstacle Other**

Distance (ft): **134.4**
Structural Grade: **0**
O&M Grade: **3**
Clock Start/From: **4**
Clock To: **8**
1st Value:
2nd Value:
Value Percent: **20.000**
Continuous Index:
Within 8" of Joint: **NO**
Remarks: **misc**

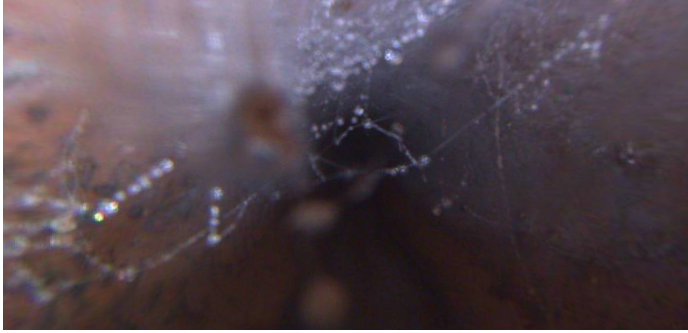
| Code: | MSA |
| Description: | Abandoned Survey |
| Distance (ft): | 135.4 |
| Remarks: | obz |
