Profile/Photo Observation Report

| Street: | OFF RUTA DR | Flow Control: | Not Controlled |
| City: | Hobart, IN | Year Renewed: | |

| US MH: | M-704-058 | DS MH: | M-704-056 |

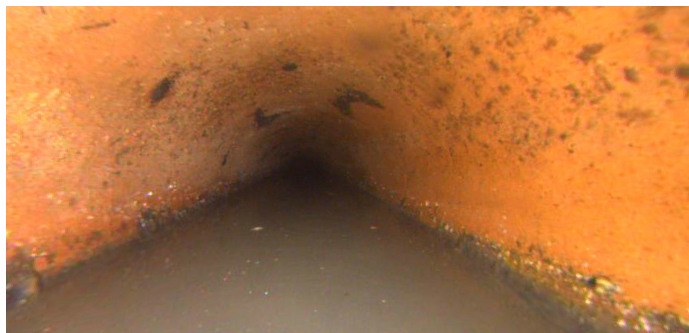
Code: **AMH**
Description: **Manhole**

Distance (ft): **.0**
Structural Grade: **0**
O&M Grade: **0**
Clock Start/From:
Clock To:
1st Value:
2nd Value:
Value Percent:
Continuous Index:
Within 8" of Joint: **NO**
Remarks: **M-704-056**

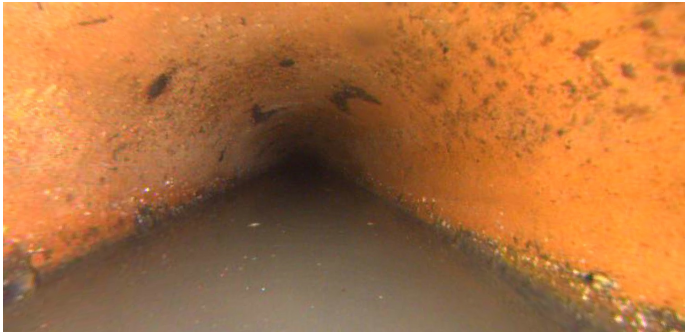
| Code: | MWL |
| Description: | Water Level |

| Value Percent: | 40.000 |

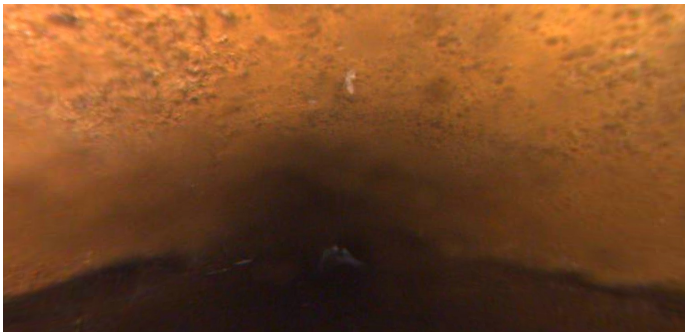
| Code: | MSA |
| Description: | Abandoned Survey |

| Distance (ft): | 5.3 |
| Remarks: | debris under water |
