Profile/Photo Observation Report

| Street: | OFF RUTA DR | Flow Control: | Not Controlled |
| City: | Hobart, IN | Year Renewed: | |

| US MH: | M-704-058 | DS MH: | M-704-056 |

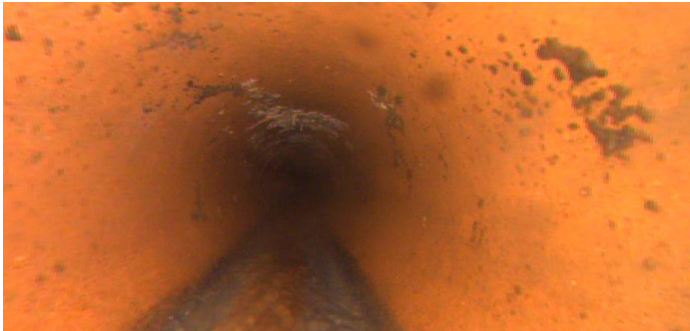
Code: AMH

Description: Manhole

Remarks: M-704-058

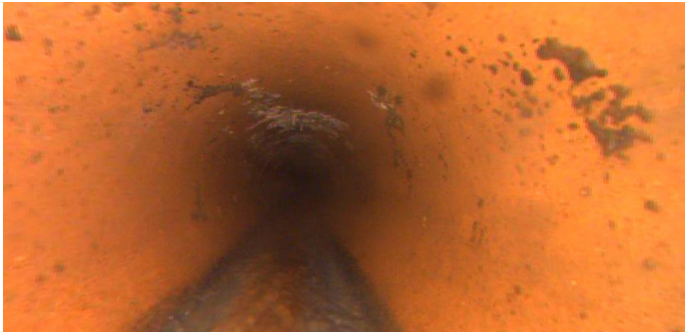
| Code: | MWL |

| Description: | Water Level |

| Value Percent: | 5.000 |

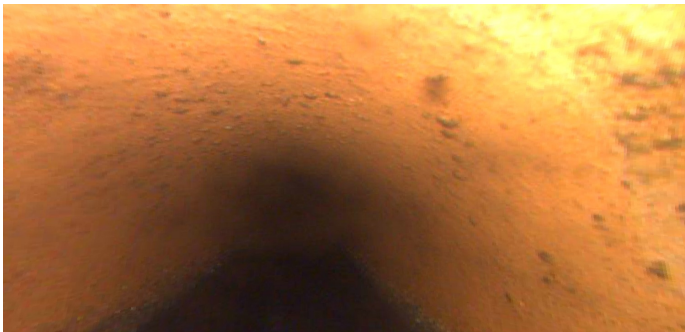
| Code: | MSA |

| Description: | Abandoned Survey |

| Distance (ft): | 38.6 |
| Remarks: | debris under water |
