Profile/Photo Observation Report

Street:	OFF RUTA DR	Flow Control:	Not Controlled
City:	Hobart, IN	Year Renewed:	
Location:	Other	Tape/Media #:	
Purpose:	Not Known	Dia/Height:	8"
Use:	Sanitary	Material:	VCP
Drain Area:	NA	Lining:	
Category:	NA		
Comment:

Location Details:		Direction of Survey:	Downstream
US MH:	M-704-059	DS MH:	M-704-058
		Total Length Surveyed (ft):	8.1

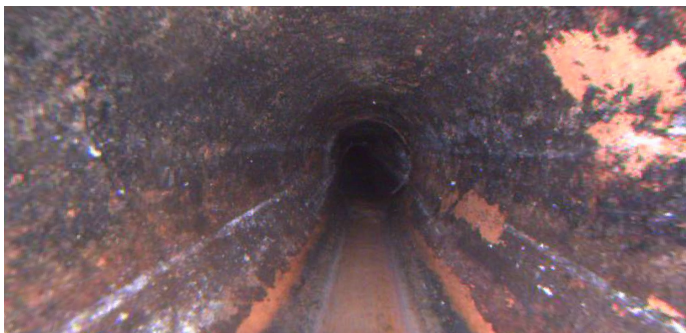
Code: **AMH**
Description: **Manhole**

Distance (ft): **.0**
Structural Grade: **0**
O&M Grade: **0**
Clock Start/From:
Clock To:
1st Value:
2nd Value:
Value Percent:
Continuous Index:
Within 8" of Joint: **NO**
Remarks: **M-704-059**

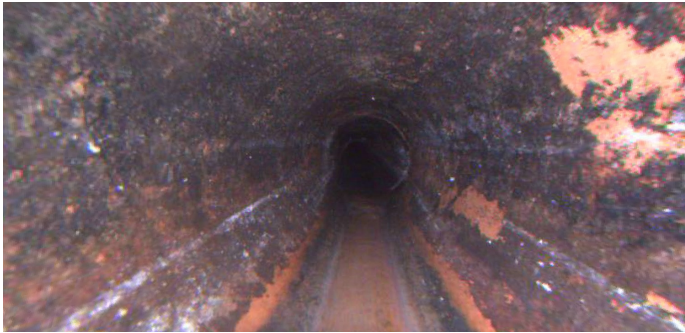
Code:	MWL
Description:	Water Level

Distance (ft):	.0
Structural Grade:	0
O&M Grade:	0
Clock Start/From:	
Clock To:	
1st Value:	
2nd Value:	
Value Percent:	5.000
Continuous Index:	
Within 8" of Joint:	NO
Remarks:

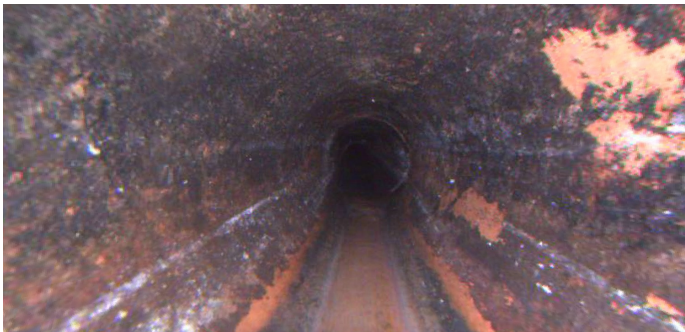
Code:	DAGS
Description:	Deposits Attached Grease

Distance (ft):	.0
Structural Grade:	0
O&M Grade:	2
Clock Start/From:	7
Clock To:	5
1st Value:	
2nd Value:	
Value Percent:	5.000
Continuous Index:	S01
Within 8" of Joint:	NO
Remarks:

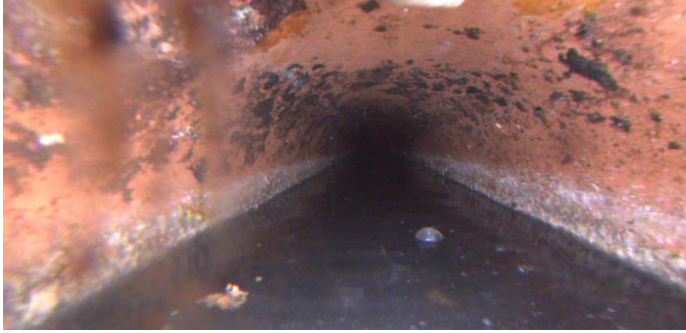
Code: **MWL**
Description: **Water Level**

Distance (ft): **8.1**
Structural Grade: **0**
O&M Grade: **0**
Clock Start/From:
Clock To:
1st Value:
2nd Value:
Value Percent: **30.000**
Continuous Index:
Within 8" of Joint: **NO**
Remarks:

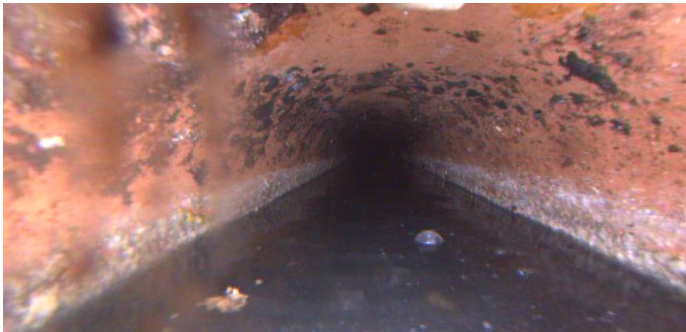
Code: **DAGS**
Description: **Deposits Attached Grease**

Distance (ft): **8.1**
Structural Grade: **0**
O&M Grade: **2**
Clock Start/From: **7**
Clock To: **5**
1st Value:
2nd Value:
Value Percent: **5.000**
Continuous Index: **F01**
Within 8" of Joint: **NO**
Remarks:

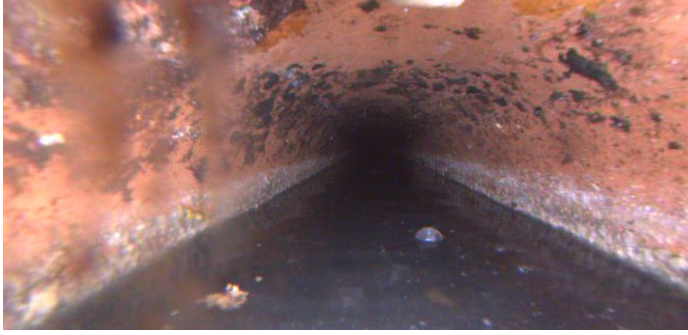
Code:	MSA
Description:	Abandoned Survey
Distance (ft):	8.1
Structural Grade:	0
O&M Grade:	0
Clock Start/From:	
Clock To:	
1st Value:	
2nd Value:	
Value Percent:	
Continuous Index:	
Within 8" of Joint:	NO
Remarks:	debris under water
