Profile/Photo Observation Report

Location Details:		Direction of Survey:	Downstream
US MH:	M-704-059	DS MH:	M-704-058
		Total Length Surveyed (ft):	8.1

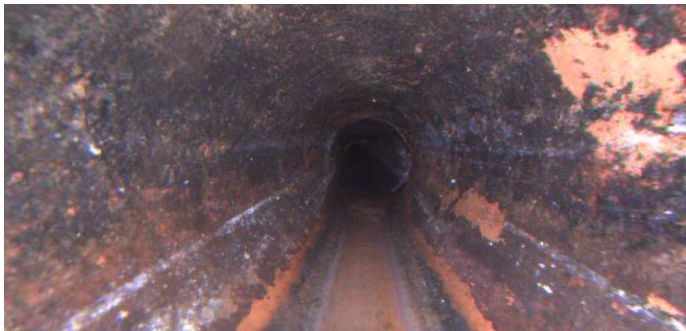
Code: **AMH**
Description: **Manhole**

Distance (ft): **.0**
Structural Grade: **0**
O&M Grade: **0**
Clock Start/From:
Clock To:
1st Value:
2nd Value:
Value Percent:
Continuous Index:
Within 8" of Joint: **NO**
Remarks: **M-704-059**

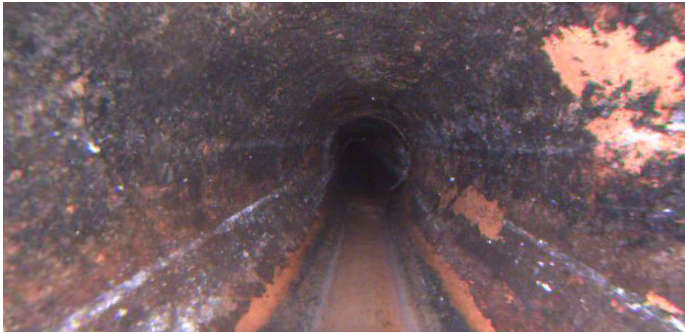
Code:	MWL
Description:	Water Level

Distance (ft):	.0
Structural Grade:	0
O&M Grade:	0
Clock Start/From:	
Clock To:	
1st Value:	
2nd Value:	
Value Percent:	5.000
Continuous Index:	
Within 8" of Joint:	NO
Remarks:

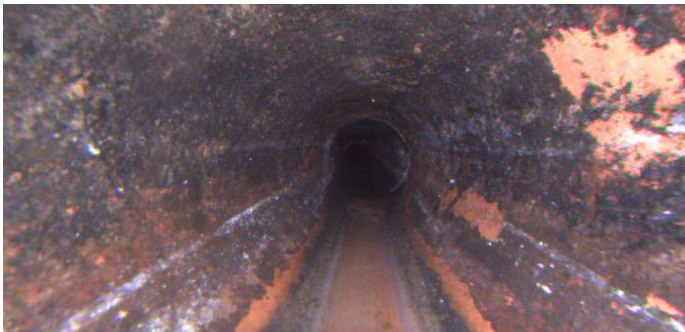
Code:	DAGS
Description:	Deposits Attached Grease

Distance (ft):	.0
Structural Grade:	0
O&M Grade:	2
Clock Start/From:	7
Clock To:	5
1st Value:	
2nd Value:	
Value Percent:	5.000
Continuous Index:	S01
Within 8" of Joint:	NO
Remarks:

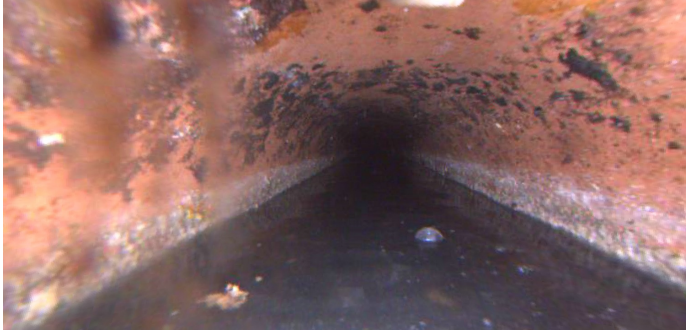
Code: **MWL**
Description: **Water Level**

Distance (ft): **8.1**
Structural Grade: **0**
O&M Grade: **0**
Clock Start/From:
Clock To:
1st Value:
2nd Value:
Value Percent: **30.000**
Continuous Index:
Within 8" of Joint: **NO**
Remarks:

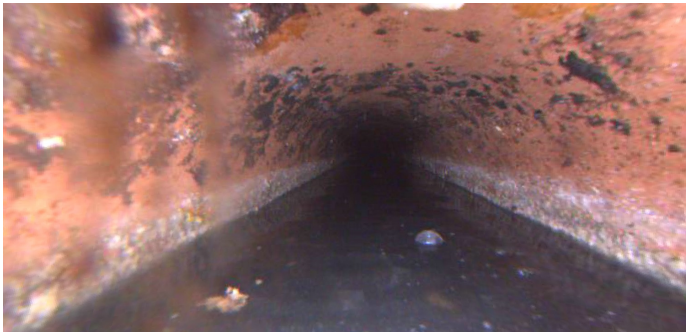
Code: **DAGS**
Description: **Deposits Attached Grease**

Distance (ft): **8.1**
Structural Grade: **0**
O&M Grade: **2**
Clock Start/From: **7**
Clock To: **5**
1st Value:
2nd Value:
Value Percent: **5.000**
Continuous Index: **F01**
Within 8" of Joint: **NO**
Remarks:

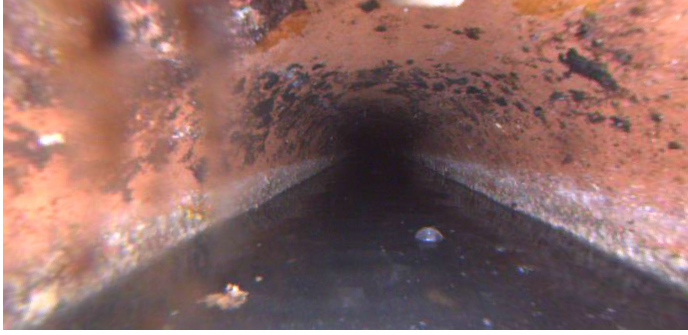
Code:	MSA
Description:	Abandoned Survey
Distance (ft):	8.1
Structural Grade:	0
O&M Grade:	0
Clock Start/From:	
Clock To:	
1st Value:	
2nd Value:	
Value Percent:	
Continuous Index:	
Within 8" of Joint:	NO
Remarks:	debris under water
