Profile/Photo Observation Report

Street:	OFF RUTA DR	Flow Control:	Not Controlled
City:	Hobart, IN	Year Renewed:	
Location:	Other	Tape/Media #:	
Purpose:	Not Known	Dia/Height:	8"
Use:	Sanitary	Material:	VCP
Drain Area:	NA	Lining:	
Category:	NA		
Comment:

Location Details:		Direction of Survey:	Upstream
US MH:	M-704-059	DS MH:	M-704-058
		Total Length Surveyed (ft):	84.3

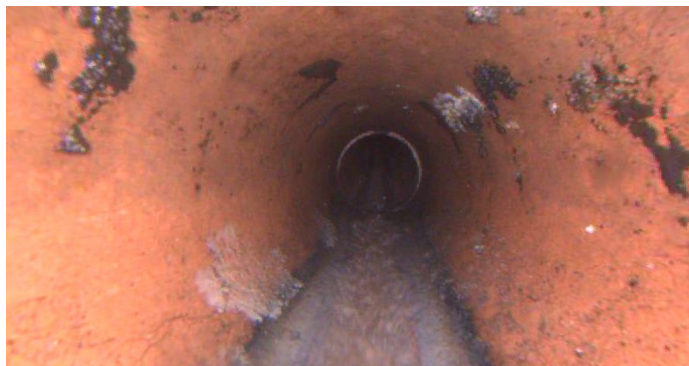
Code: **AMH**
Description: **Manhole**

Distance (ft): **.0**
Structural Grade: **0**
O&M Grade: **0**
Clock Start/From:
Clock To:
1st Value:
2nd Value:
Value Percent:
Continuous Index:
Within 8" of Joint: **NO**
Remarks: **M-704-058**

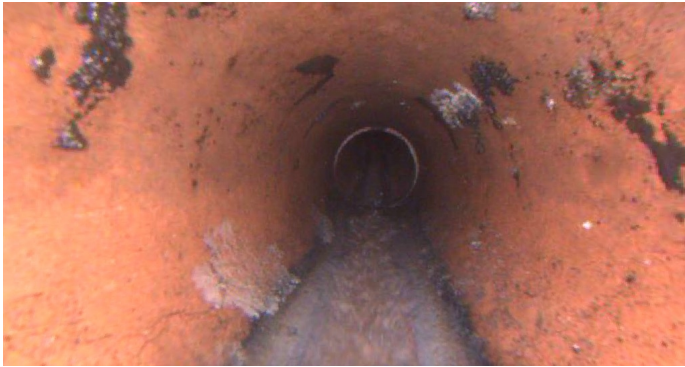
Code:	MWL
Description:	Water Level

Distance (ft):	.0
Structural Grade:	0
O&M Grade:	0
Clock Start/From:	
Clock To:	
1st Value:	
2nd Value:	
Value Percent:	10.000
Continuous Index:	
Within 8" of Joint:	NO
Remarks:

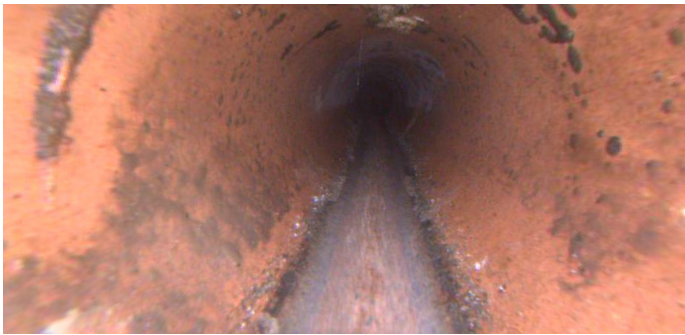
Code:	LU
Description:	Alignment Up

Distance (ft):	3.7
Structural Grade:	0
O&M Grade:	1
Clock Start/From:	
Clock To:	
1st Value:	
2nd Value:	
Value Percent:	5.000
Continuous Index:	
Within 8" of Joint:	NO
Remarks:

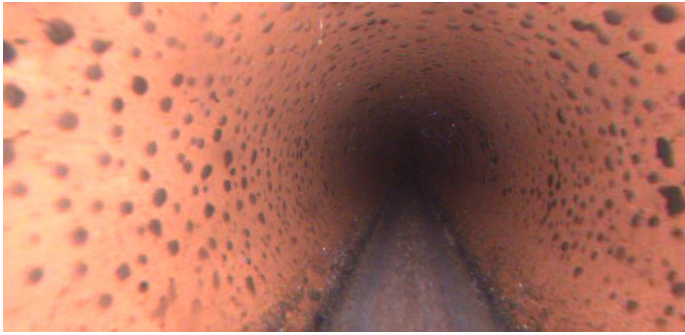
Code: **LL**
Description: **Alignment Left**

Distance (ft): **18.5**
Structural Grade: **0**
O&M Grade: **1**
Clock Start/From:
Clock To:
1st Value:
2nd Value:
Value Percent: **5.000**
Continuous Index:
Within 8" of Joint: **NO**
Remarks:

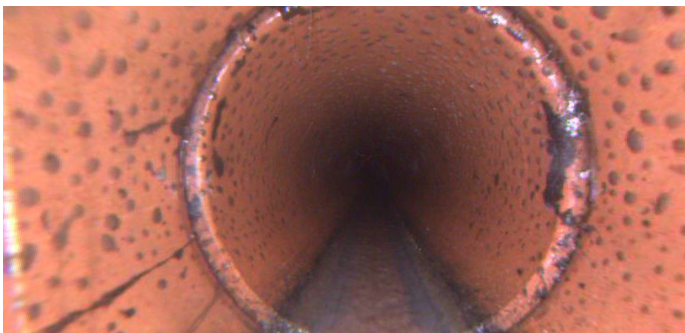
Code: **RFJ**
Description: **Roots Fine Joint**

Distance (ft): **22.9**
Structural Grade: **0**
O&M Grade: **1**
Clock Start/From: **8**
Clock To: **9**
1st Value:
2nd Value:
Value Percent:
Continuous Index:
Within 8" of Joint: **YES**
Remarks:

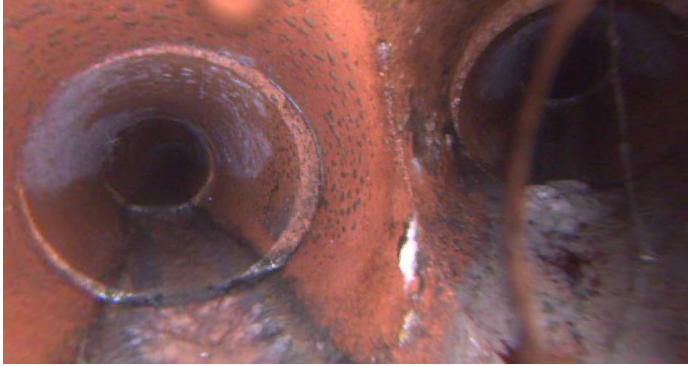
Code: **TF**
Description: **Tap Factory**

Distance (ft): **29.6**
Structural Grade: **0**
O&M Grade: **0**
Clock Start/From: **3**
Clock To:
1st Value: **4.000**
2nd Value:
Value Percent:
Continuous Index:
Within 8" of Joint:
Remarks:

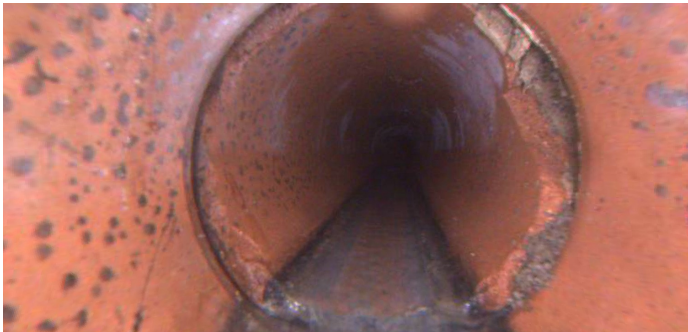
Code: **HVV**
Description: **Hole Void Visible**

Distance (ft): **31.5**
Structural Grade: **5**
O&M Grade: **0**
Clock Start/From: **2**
Clock To: **3**
1st Value:
2nd Value:
Value Percent:
Continuous Index:
Within 8" of Joint: **YES**
Remarks:

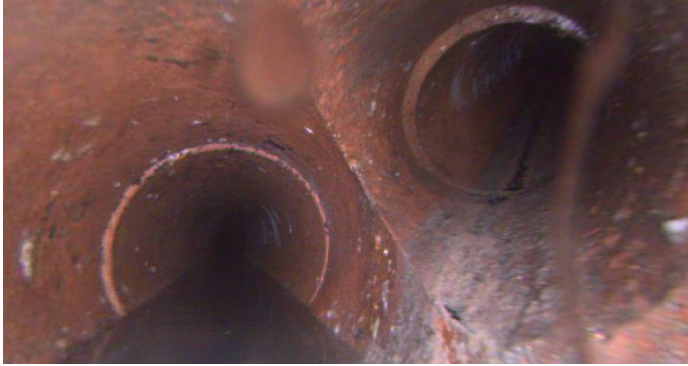
Code: **TF**
Description: **Tap Factory**

Distance (ft): **41.1**
Structural Grade: **0**
O&M Grade: **0**
Clock Start/From: **2**
Clock To:
1st Value: **4.000**
2nd Value:
Value Percent:
Continuous Index:
Within 8" of Joint:
Remarks:

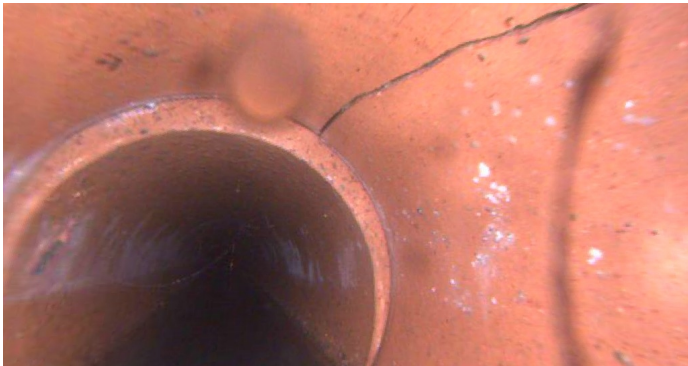
Code: **FS**
Description: **Fracture Spiral**

Distance (ft): **56.3**
Structural Grade: **3**
O&M Grade: **0**
Clock Start/From: **2**
Clock To: **5**
1st Value:
2nd Value:
Value Percent:
Continuous Index:
Within 8" of Joint: **YES**
Remarks:

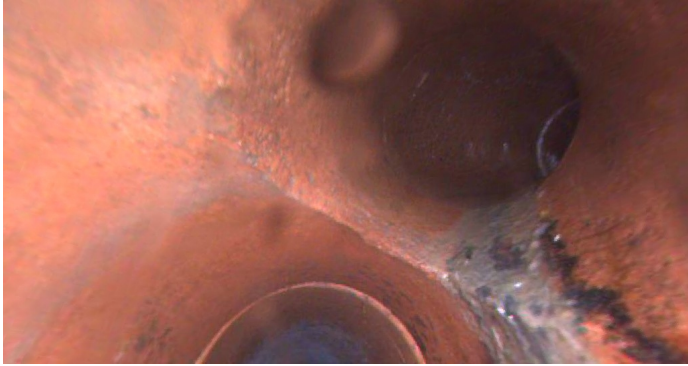
Code: **TF**
Description: **Tap Factory**

Distance (ft): **77.7**
Structural Grade: **0**
O&M Grade: **0**
Clock Start/From: **2**
Clock To:
1st Value: **4.000**
2nd Value:
Value Percent:
Continuous Index:
Within 8" of Joint:
Remarks:

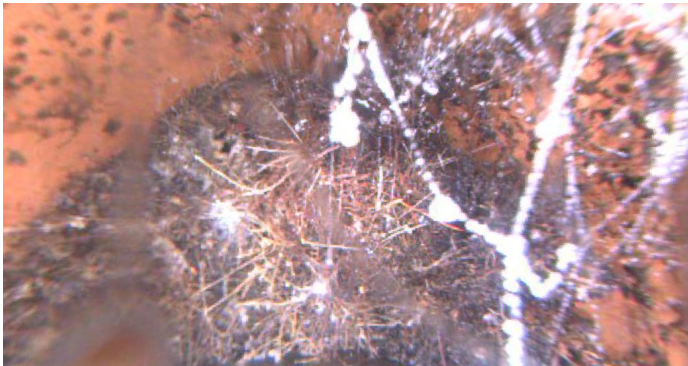
Code: **RBB**
Description: **Roots Ball Barrel**

Distance (ft): **83.0**
Structural Grade: **0**
O&M Grade: **5**
Clock Start/From: **12**
Clock To: **12**
1st Value:
2nd Value:
Value Percent: **60.000**
Continuous Index:
Within 8" of Joint: **NO**
Remarks:

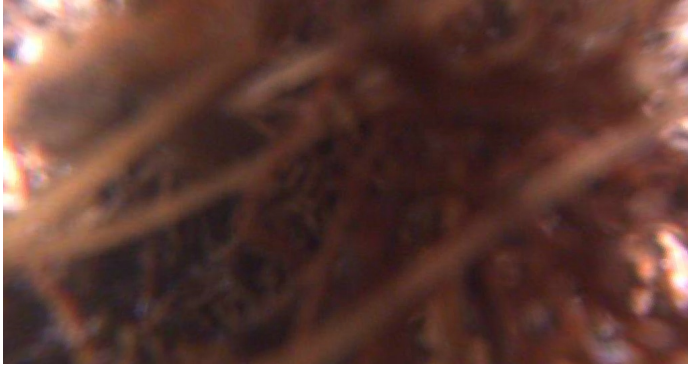
Code:	MSA
Description:	Abandoned Survey
Distance (ft):	84.3
Structural Grade:	0
O&M Grade:	0
Clock Start/From:	
Clock To:	
1st Value:	
2nd Value:	
Value Percent:	
Continuous Index:	
Within 8" of Joint:	NO
Remarks:	RBB
