Profile/Photo Observation Report

Date:	04/10/2018	Weather:		Coding:	PACP 6.0
Pipe Length (ft):	206.6	Owner:	NA	Pre Clean:	Not Known
P.O.#:		Surveyor:	Mark Ruby	PSR:	P-704-059-058
Customer:		Clean Date:	01/01/1900	Shape:	C

Street:	Ruta Dr.	Flow Control:	Not Controlled
City:	Hobart, IN	Year Renewed:	
Location:	Other	Tape/Media #:	
Purpose:	Not Known	Dia/Height:	8"
Use:	Sanitary	Material:	VCP
Drain Area:	NA	Lining:	
Category:	NA		
Comment:

Location Details:		Direction of Survey:	Upstream
US MH:	M-704-059	DS MH:	M-704-058
		Total Length Surveyed (ft):	84.3

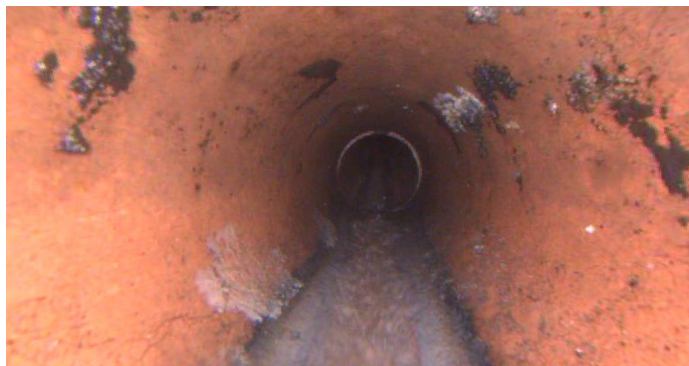
Code: **AMH**
 Description: **Manhole**

Distance (ft): **.0**
 Structural Grade: **0**
 O&M Grade: **0**
 Clock Start/From:
 Clock To:
 1st Value:
 2nd Value:
 Value Percent:
 Continuous Index:
 Within 8" of Joint: **NO**
 Remarks: **M-704-058**

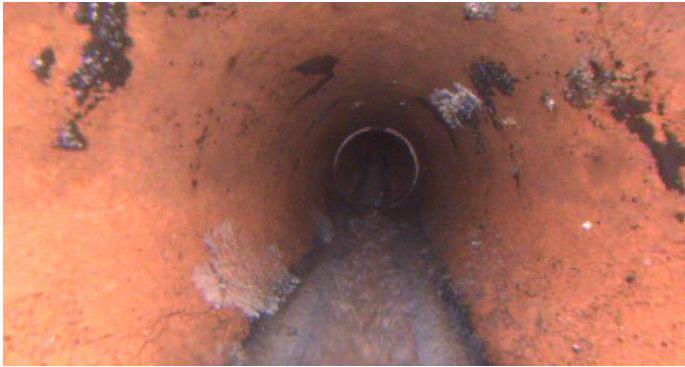
Code:	MWL
Description:	Water Level

Distance (ft):	.0
Structural Grade:	0
O&M Grade:	0
Clock Start/From:	
Clock To:	
1st Value:	
2nd Value:	
Value Percent:	10.000
Continuous Index:	
Within 8" of Joint:	NO
Remarks:

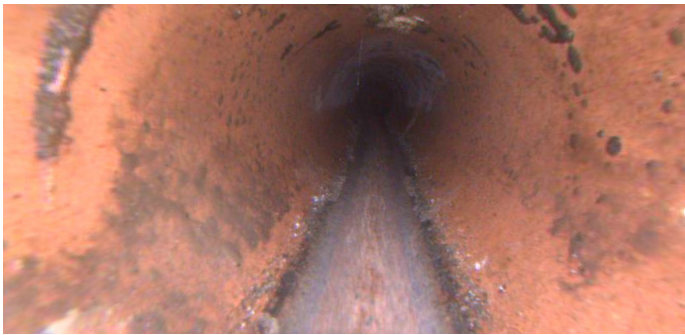
Code:	LU
Description:	Alignment Up

Distance (ft):	3.7
Structural Grade:	0
O&M Grade:	1
Clock Start/From:	
Clock To:	
1st Value:	
2nd Value:	
Value Percent:	5.000
Continuous Index:	
Within 8" of Joint:	NO
Remarks:

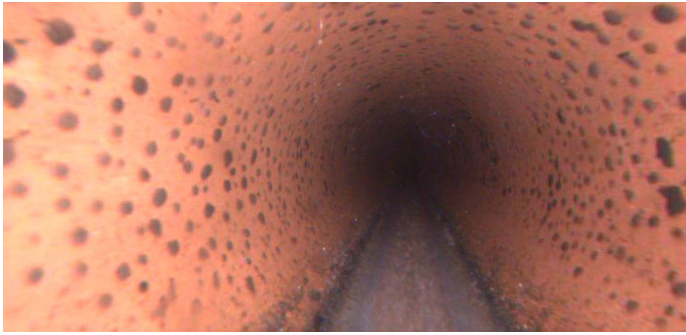
Code: **LL**
Description: **Alignment Left**

Distance (ft): **18.5**
Structural Grade: **0**
O&M Grade: **1**
Clock Start/From:
Clock To:
1st Value:
2nd Value:
Value Percent: **5.000**
Continuous Index:
Within 8" of Joint: **NO**
Remarks:

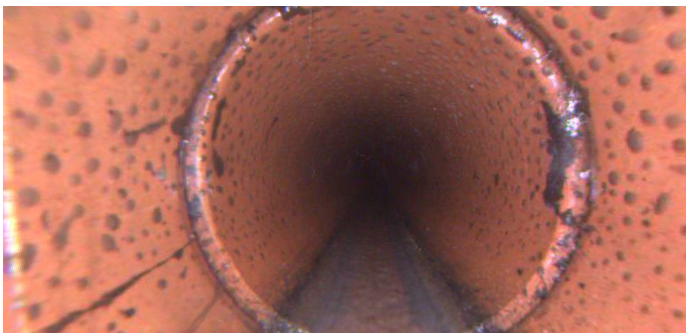
Code: **RFJ**
Description: **Roots Fine Joint**

Distance (ft): **22.9**
Structural Grade: **0**
O&M Grade: **1**
Clock Start/From: **8**
Clock To: **9**
1st Value:
2nd Value:
Value Percent:
Continuous Index:
Within 8" of Joint: **YES**
Remarks:

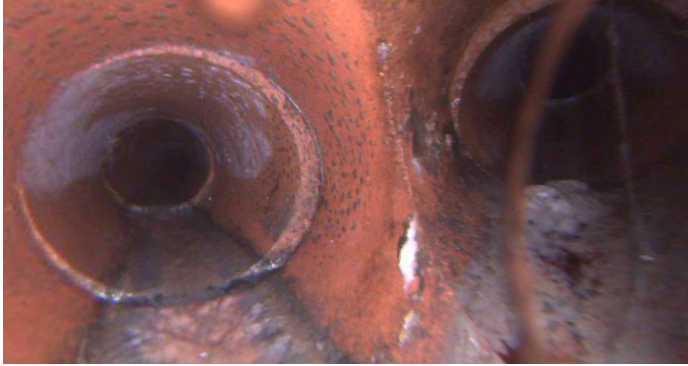
Code: **TF**
Description: **Tap Factory**

Distance (ft): **29.6**
Structural Grade: **0**
O&M Grade: **0**
Clock Start/From: **3**
Clock To:
1st Value: **4.000**
2nd Value:
Value Percent:
Continuous Index:
Within 8" of Joint:
Remarks:

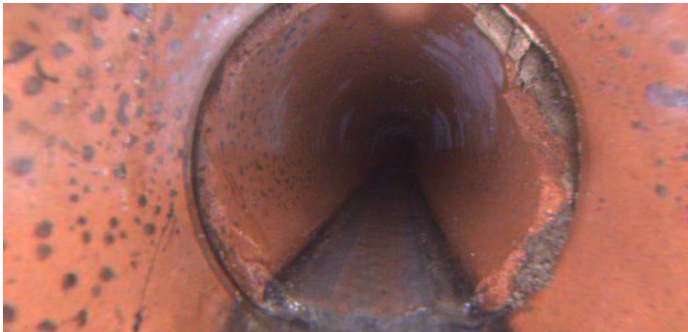
Code: **HVV**
Description: **Hole Void Visible**

Distance (ft): **31.5**
Structural Grade: **5**
O&M Grade: **0**
Clock Start/From: **2**
Clock To: **3**
1st Value:
2nd Value:
Value Percent:
Continuous Index:
Within 8" of Joint: **YES**
Remarks:

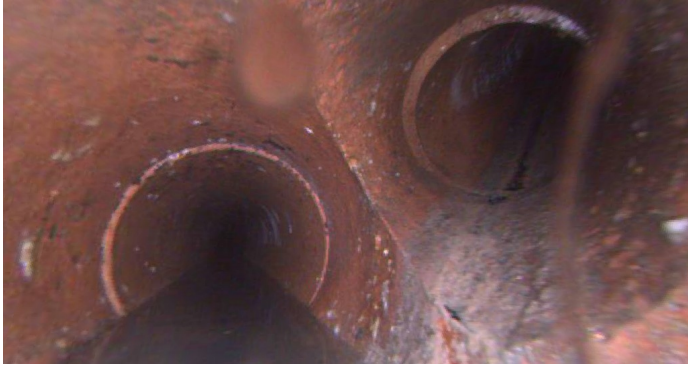
Code: **TF**
Description: **Tap Factory**

Distance (ft): **41.1**
Structural Grade: **0**
O&M Grade: **0**
Clock Start/From: **2**
Clock To:
1st Value: **4.000**
2nd Value:
Value Percent:
Continuous Index:
Within 8" of Joint:
Remarks:

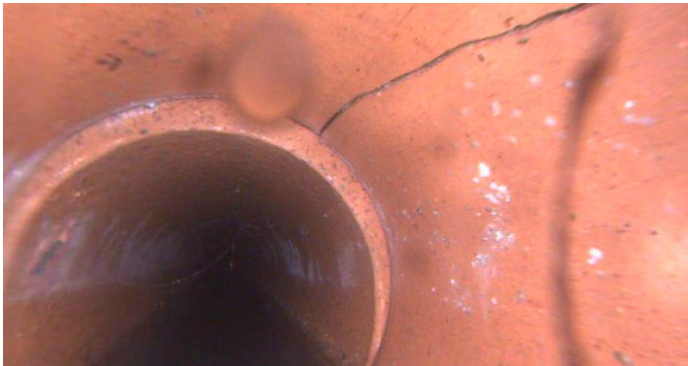
Code: **FS**
Description: **Fracture Spiral**

Distance (ft): **56.3**
Structural Grade: **3**
O&M Grade: **0**
Clock Start/From: **2**
Clock To: **5**
1st Value:
2nd Value:
Value Percent:
Continuous Index:
Within 8" of Joint: **YES**
Remarks:

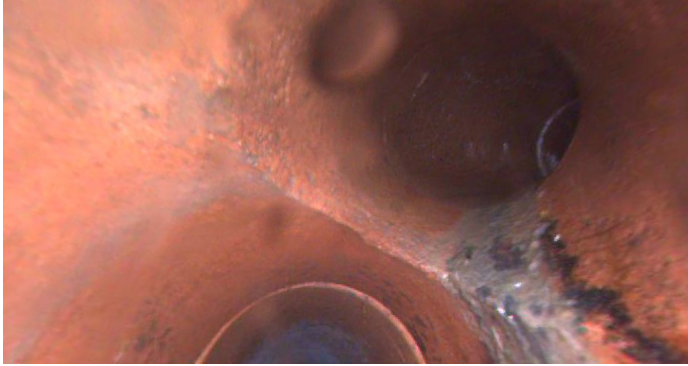
Code: **TF**
Description: **Tap Factory**

Distance (ft): **77.7**
Structural Grade: **0**
O&M Grade: **0**
Clock Start/From: **2**
Clock To:
1st Value: **4.000**
2nd Value:
Value Percent:
Continuous Index:
Within 8" of Joint:
Remarks:

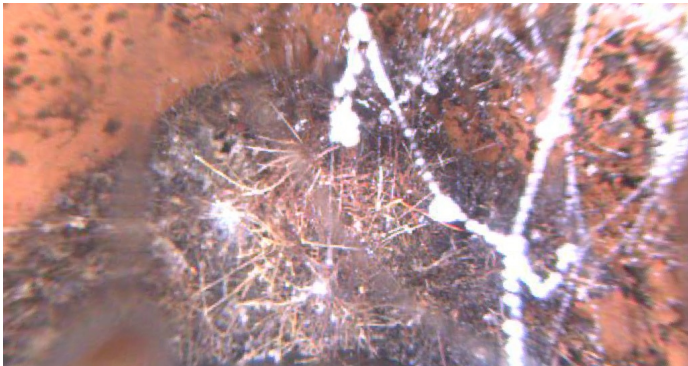
Code: **RBB**
Description: **Roots Ball Barrel**

Distance (ft): **83.0**
Structural Grade: **0**
O&M Grade: **5**
Clock Start/From: **12**
Clock To: **12**
1st Value:
2nd Value:
Value Percent: **60.000**
Continuous Index:
Within 8" of Joint: **NO**
Remarks:

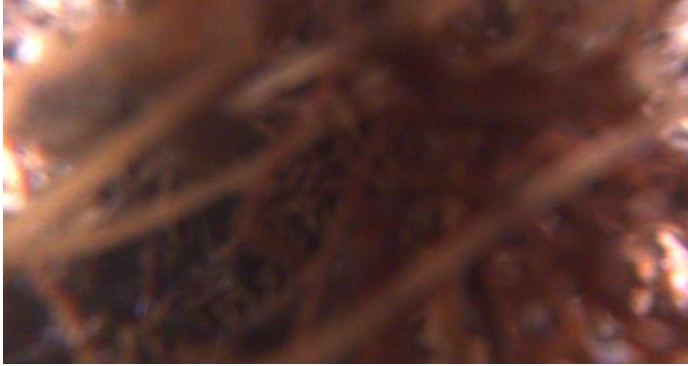
Code:	MSA
Description:	Abandoned Survey
Distance (ft):	84.3
Structural Grade:	0
O&M Grade:	0
Clock Start/From:	
Clock To:	
1st Value:	
2nd Value:	
Value Percent:	
Continuous Index:	
Within 8" of Joint:	NO
Remarks:	RBB
