Profile/Photo Observation Report

Date:	10/19/2021	Weather:		Coding:	PACP 6.0
Pipe Length (ft):		Owner:	Hobart, IN	Pre Clean:	Not Known
P.O.#:	892_1	Surveyor:	M. Pielacha	PSR:	P-704-060-059
Customer:	Hobart, IN	Clean Date:		Shape:	C

Street:	Off Victor Drive	Flow Control:	
City:	Hobart, IN	Year Renewed:	
Location:	Yard	Tape/Media #:	892
Purpose:	Routine Assessment	Dia/Height:	8"
Use:	Sanitary	Material:	VCP
Drain Area:		Lining:	
Category:	NA		
Comment:

Location Details:		Direction of Survey:	Downstream
US MH:	M-704-60	DS MH:	M-704-59
		Total Length Surveyed (ft):	209.5

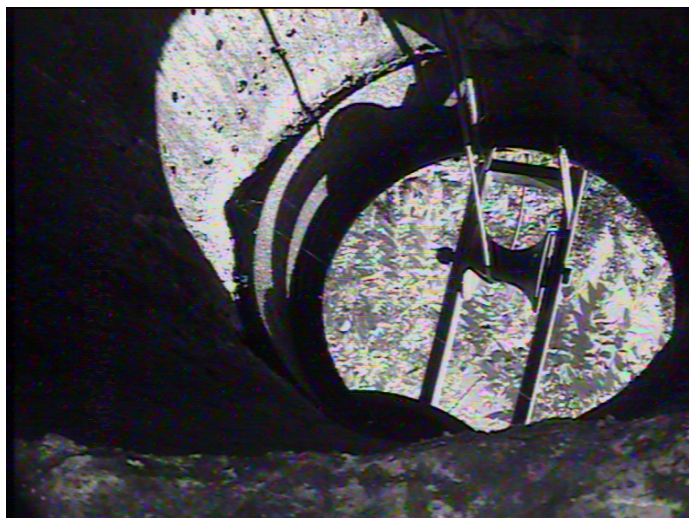
Code: **AMH**
Description: **Manhole**

Distance (ft): **.0**
Structural Grade: **0**
O&M Grade: **0**
Clock Start/From:
Clock To:
1st Value:
2nd Value:
Value Percent:
Continuous Index:
Within 8" of Joint: **NO**
Remarks: **M-704-60**

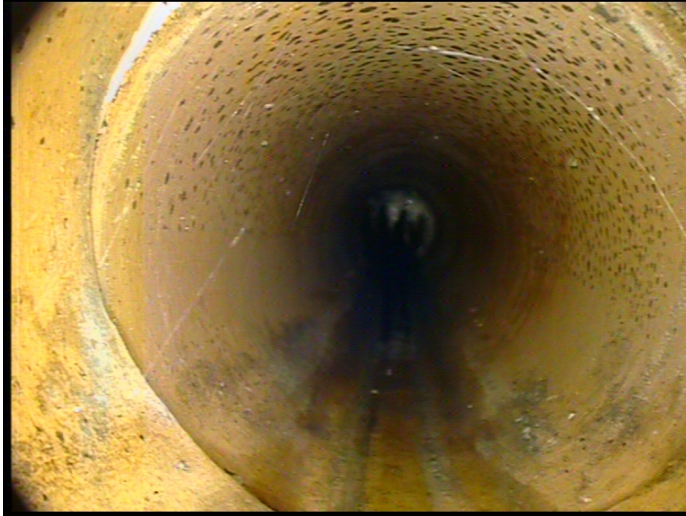
Code: **MWL**
Description: **Water Level**

Distance (ft): **.0**
Structural Grade: **0**
O&M Grade: **0**
Clock Start/From:
Clock To:
1st Value:
2nd Value:
Value Percent: **5.000**
Continuous Index:
Within 8" of Joint: **NO**
Remarks:

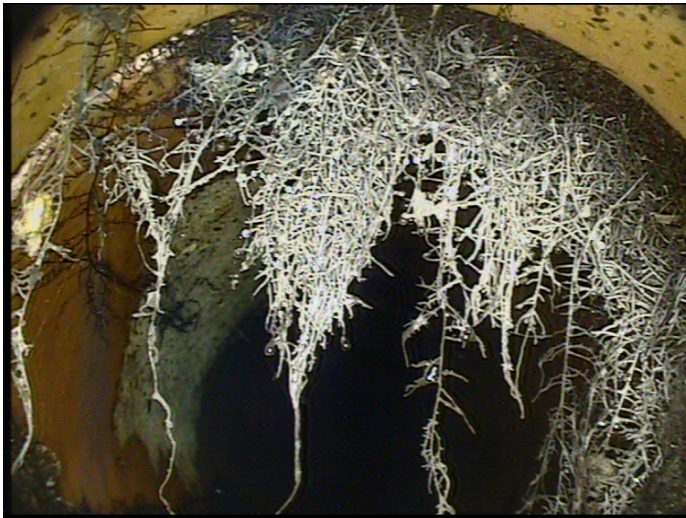
Code: **RMJ**
Description: **Roots Medium Joint**

Distance (ft): **7.6**
Structural Grade: **0**
O&M Grade: **3**
Clock Start/From: **8**
Clock To: **4**
1st Value:
2nd Value:
Value Percent: **5.000**
Continuous Index:
Within 8" of Joint: **YES**
Remarks:

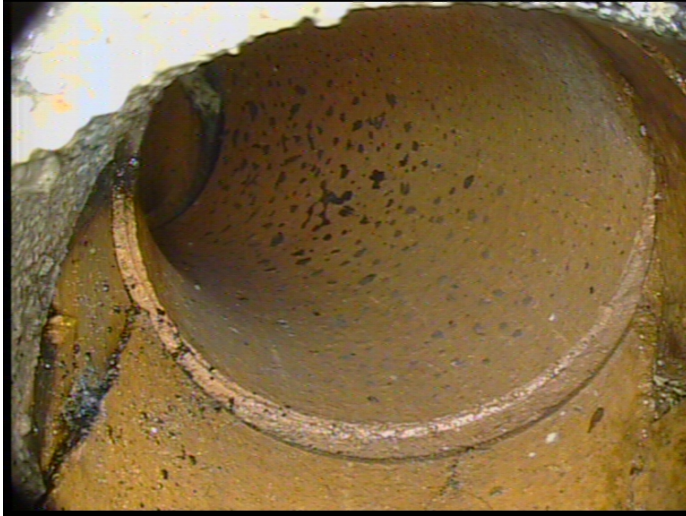
Code: **TF**
Description: **Tap Factory**

Distance (ft): **57.3**
Structural Grade: **0**
O&M Grade: **0**
Clock Start/From: **10**
Clock To:
1st Value: **4.000**
2nd Value:
Value Percent:
Continuous Index:
Within 8" of Joint: **NO**
Remarks:

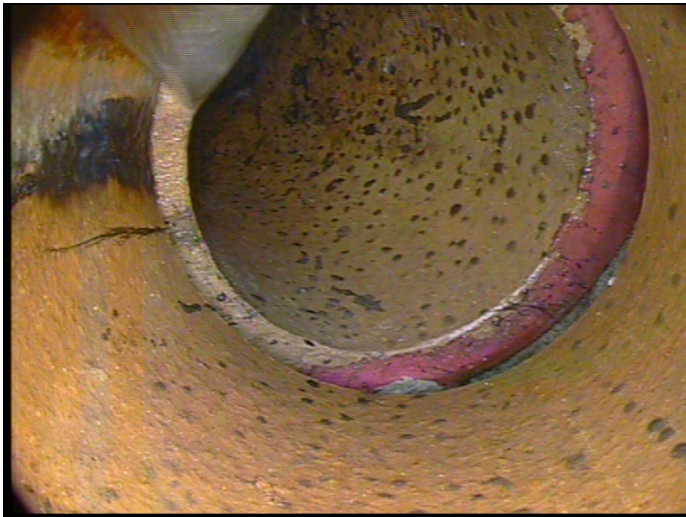
Code: **TFA**
Description: **Tap Factory Active**

Distance (ft): **60.8**
Structural Grade: **0**
O&M Grade: **0**
Clock Start/From: **10**
Clock To:
1st Value: **4.000**
2nd Value:
Value Percent:
Continuous Index:
Within 8" of Joint: **NO**
Remarks:

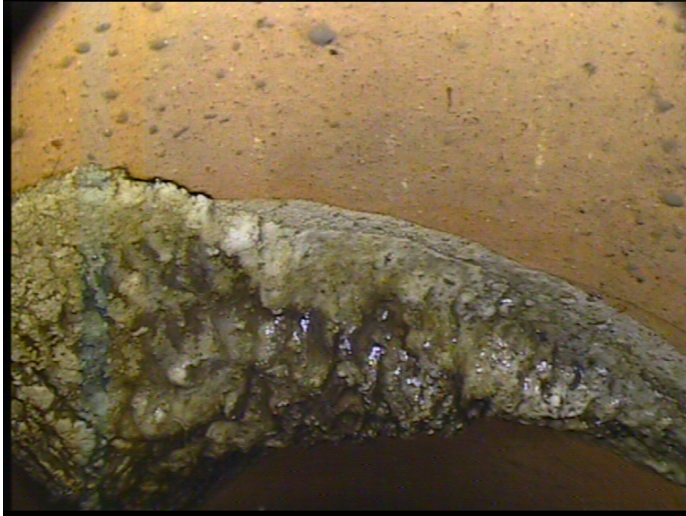
Code:	DAE
Description:	Deposits Attached Encrustation
Distance (ft):	118.4
Structural Grade:	0
O&M Grade:	2
Clock Start/From:	7
Clock To:	10
1st Value:	
2nd Value:	
Value Percent:	5.000
Continuous Index:	
Within 8" of Joint:	YES
Remarks:

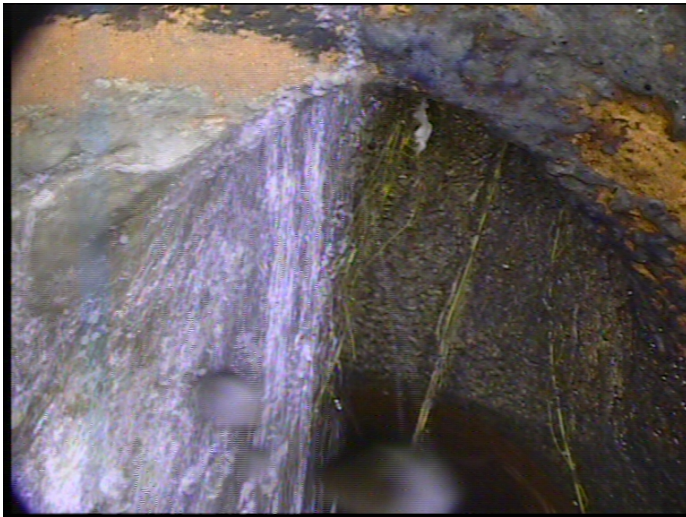
Code:	TFD
Description:	Tap Factory Defective
Distance (ft):	123.9
Structural Grade:	0
O&M Grade:	2
Clock Start/From:	11
Clock To:	
1st Value:	4.000
2nd Value:	
Value Percent:	
Continuous Index:	
Within 8" of Joint:	NO
Remarks:	roots

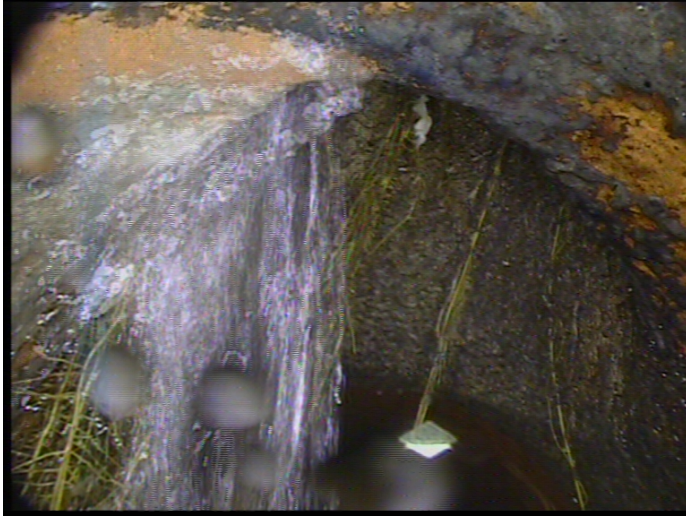
Code: **RFL**
Description: **Roots Fine Lateral**

Distance (ft): **123.9**
Structural Grade: **0**
O&M Grade: **1**
Clock Start/From: **11**
Clock To:
1st Value:
2nd Value:
Value Percent:
Continuous Index:
Within 8" of Joint: **NO**
Remarks:

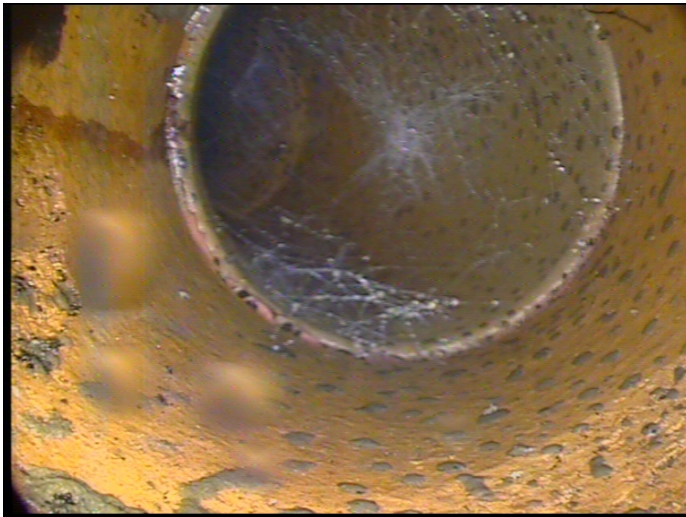
Code: **TF**
Description: **Tap Factory**

Distance (ft): **137.4**
Structural Grade: **0**
O&M Grade: **0**
Clock Start/From: **10**
Clock To:
1st Value: **4.000**
2nd Value:
Value Percent:
Continuous Index:
Within 8" of Joint: **NO**
Remarks:

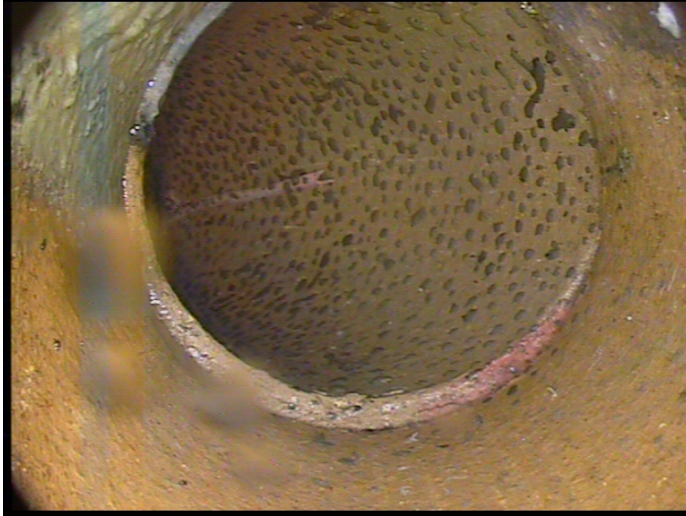
Code: **TF**
Description: **Tap Factory**

Distance (ft): **179.0**
Structural Grade: **0**
O&M Grade: **0**
Clock Start/From: **10**
Clock To:
1st Value: **4.000**
2nd Value:
Value Percent:
Continuous Index:
Within 8" of Joint: **NO**
Remarks:

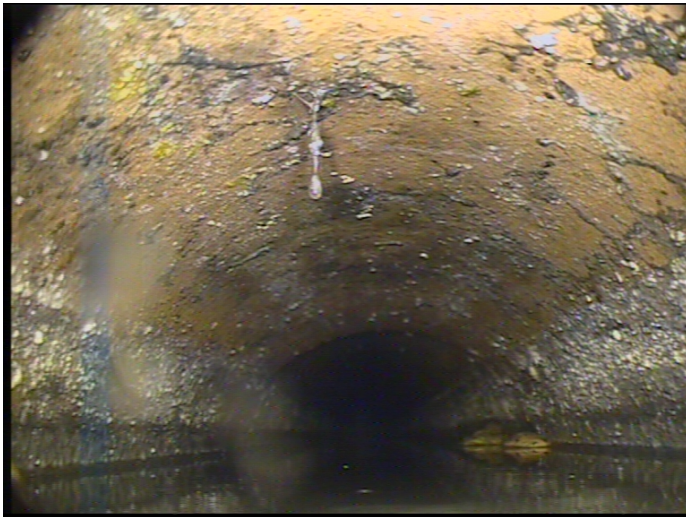
Code: **MWL**
Description: **Water Level**

Distance (ft): **209.5**
Structural Grade: **0**
O&M Grade: **0**
Clock Start/From:
Clock To:
1st Value:
2nd Value:
Value Percent: **45.000**
Continuous Index:
Within 8" of Joint: **NO**
Remarks:

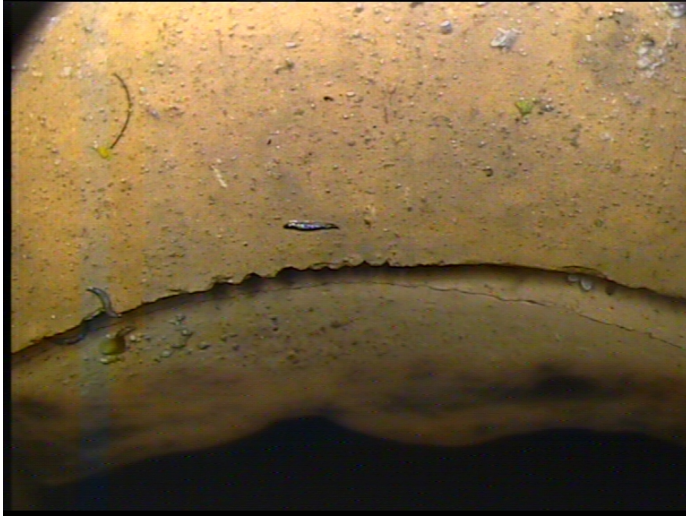
Code: **DSF**
Description: **Deposits Settled Fine**

Distance (ft): **209.5**
Structural Grade: **0**
O&M Grade: **4**
Clock Start/From: **4**
Clock To: **8**
1st Value:
2nd Value:
Value Percent: **30.000**
Continuous Index:
Within 8" of Joint: **NO**
Remarks:

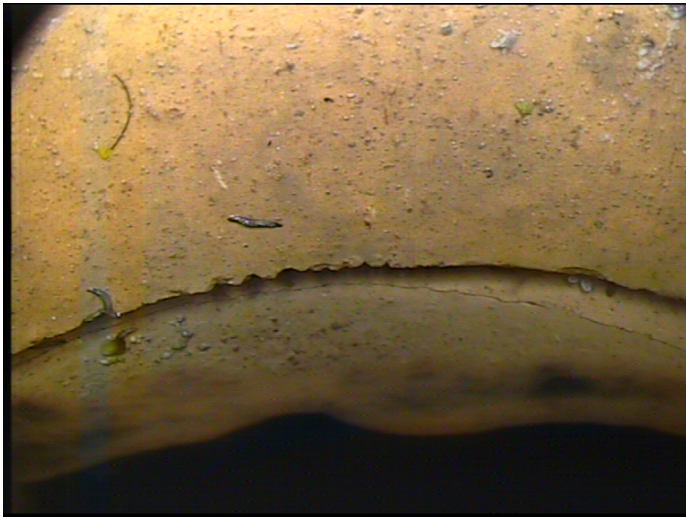
Code: **MSA**
Description: **Abandoned Survey**

Distance (ft): **209.5**
Structural Grade: **0**
O&M Grade: **0**
Clock Start/From:
Clock To:
1st Value:
2nd Value:
Value Percent:
Continuous Index:
Within 8" of Joint: **NO**
Remarks: **deep sediment**
