## Profile/Photo Observation Report

Date:	<b>04/10/2018</b>	Weather:		Coding:	<b>PACP 6.0</b>
Pipe Length (ft):	<b>271.0</b>	Owner:	<b>NA</b>	Pre Clean:	<b>Not Known</b>
P.O.#:		Surveyor:	<b>Byrd Fitzgerald</b>	PSR:	<b>P-704-063-062</b>
Customer:		Clean Date:	<b>01/01/1900</b>	Shape:	<b>C</b>

Street:	<b>OFF EDGEWATER DR</b>	Flow Control:	<b>Not Controlled</b>
City:	<b>Hobart, IN</b>	Year Renewed:	
Location:	<b>Other</b>	Tape/Media #:	
Purpose:	<b>Not Known</b>	Dia/Height:	<b>8"</b>
Use:	<b>Sanitary</b>	Material:	<b>VCP</b>
Drain Area:	<b>NA</b>	Lining:	
Category:	<b>NA</b>		
Comment:

Location Details:		Direction of Survey:	<b>Downstream</b>
US MH:	<b>M-704-062</b>	DS MH:	<b>M-704-063</b>
		Total Length Surveyed (ft):	<b>37.8</b>

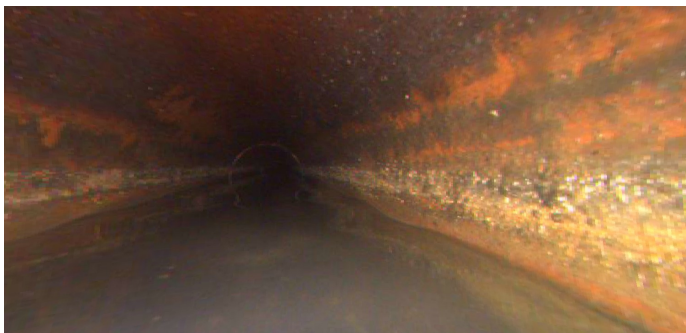
Code: **AMH**  
Description: **Manhole**

Distance (ft): **.0**  
Structural Grade: **0**  
O&M Grade: **0**  
Clock Start/From:  
Clock To:  
1st Value:  
2nd Value:  
Value Percent:  
Continuous Index:  
Within 8" of Joint: **NO**  
Remarks: **M-704-062**

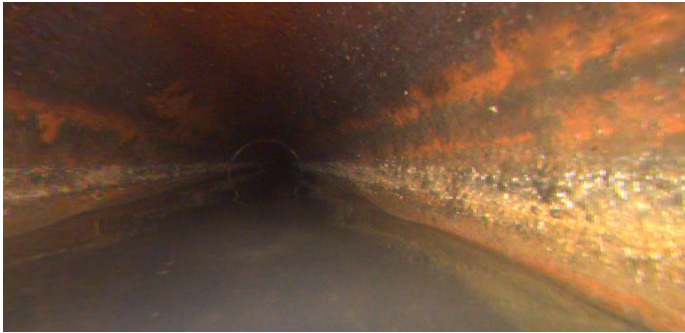
Code:	<b>MWL</b>
Description:	<b>Water Level</b>

Distance (ft):	<b>.0</b>
Structural Grade:	<b>0</b>
O&M Grade:	<b>0</b>
Clock Start/From:	
Clock To:	
1st Value:	
2nd Value:	
Value Percent:	<b>50.000</b>
Continuous Index:	
Within 8" of Joint:	<b>NO</b>
Remarks:

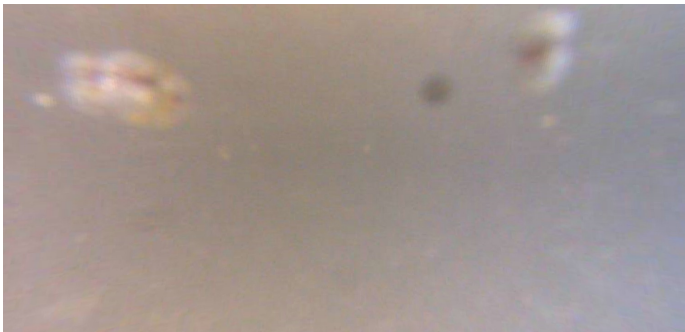
Code:	<b>MCU</b>
Description:	<b>Camera Underwater</b>

Distance (ft):	<b>11.5</b>
Structural Grade:	<b>0</b>
O&M Grade:	<b>4</b>
Clock Start/From:	
Clock To:	
1st Value:	
2nd Value:	
Value Percent:	
Continuous Index:	
Within 8" of Joint:	<b>NO</b>
Remarks:

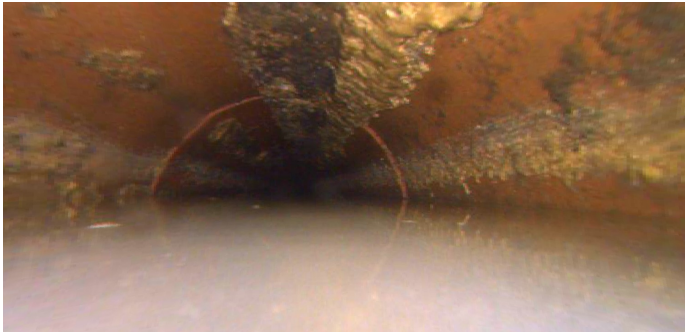
Code: **DAGS**  
Description: **Deposits Attached Grease**

Distance (ft): **20.7**  
Structural Grade: **0**  
O&M Grade: **2**  
Clock Start/From: **12**  
Clock To: **1**  
1st Value:  
2nd Value:  
Value Percent: **5.000**  
Continuous Index: **S01**  
Within 8" of Joint: **NO**  
Remarks: **wandering**

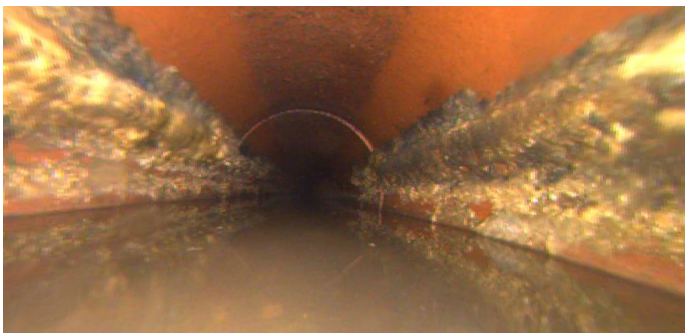
Code: **MSA**  
Description: **Abandoned Survey**

Distance (ft): **37.8**  
Structural Grade: **0**  
O&M Grade: **0**  
Clock Start/From:  
Clock To:  
1st Value:  
2nd Value:  
Value Percent:  
Continuous Index:  
Within 8" of Joint: **NO**  
Remarks: **no blockage**

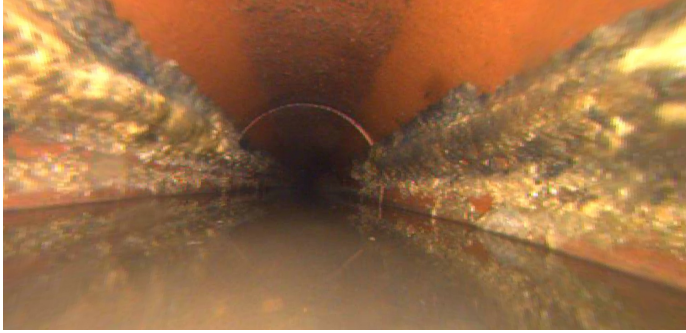
Code:	<b>DAGS</b>
Description:	<b>Deposits Attached Grease</b>
Distance (ft):	<b>37.8</b>
Structural Grade:	<b>0</b>
O&M Grade:	<b>2</b>
Clock Start/From:	<b>12</b>
Clock To:	<b>1</b>
1st Value:	
2nd Value:	
Value Percent:	<b>5.000</b>
Continuous Index:	<b>F01</b>
Within 8" of Joint:	<b>NO</b>
Remarks:	<b>wandering</b>
