Profile/Photo Observation Report

Date:	04/10/2018	Weather:		Coding:	PACP 6.0
Pipe Length (ft):	271.0	Owner:	NA	Pre Clean:	Not Known
P.O.#:		Surveyor:	Byrd Fitzgerald	PSR:	P-704-063-062
Customer:		Clean Date:	01/01/1900	Shape:	C

Street:	Ruta Dr.	Flow Control:	Not Controlled
City:	Hobart, IN	Year Renewed:	
Location:	Other	Tape/Media #:	
Purpose:	Not Known	Dia/Height:	8"
Use:	Sanitary	Material:	VCP
Drain Area:	NA	Lining:	
Category:	NA		
Comment:

Location Details:		Direction of Survey:	Downstream
US MH:	M-704-062	DS MH:	M-704-063
		Total Length Surveyed (ft):	37.8

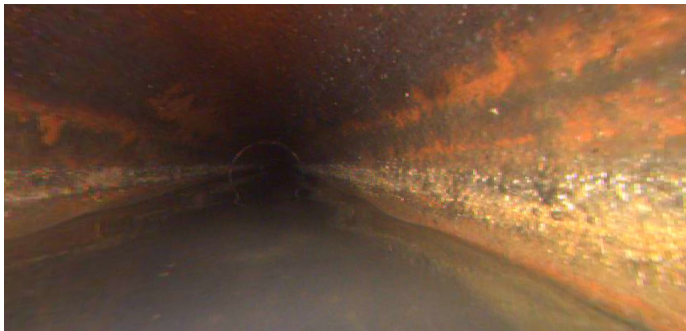
Code: **AMH**
Description: **Manhole**

Distance (ft): **.0**
Structural Grade: **0**
O&M Grade: **0**
Clock Start/From:
Clock To:
1st Value:
2nd Value:
Value Percent:
Continuous Index:
Within 8" of Joint: **NO**
Remarks: **M-704-062**

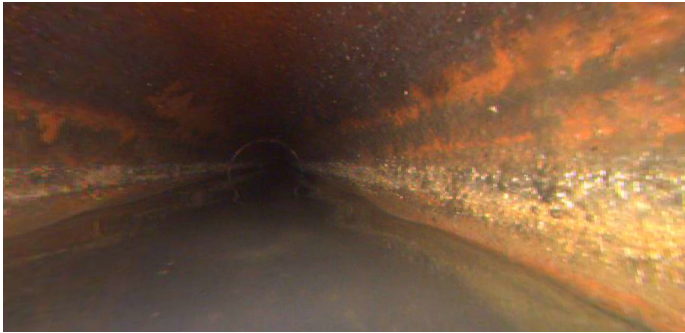
Code:	MWL
Description:	Water Level

Distance (ft):	.0
Structural Grade:	0
O&M Grade:	0
Clock Start/From:	
Clock To:	
1st Value:	
2nd Value:	
Value Percent:	50.000
Continuous Index:	
Within 8" of Joint:	NO
Remarks:

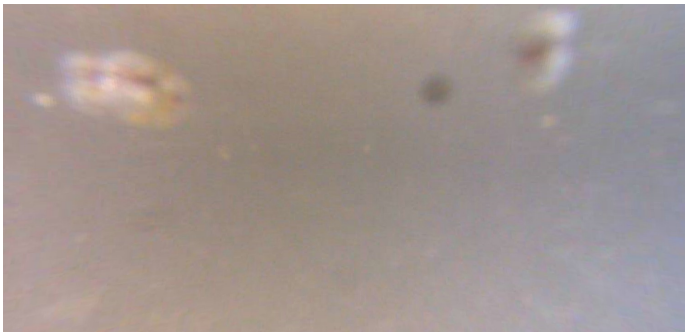
Code:	MCU
Description:	Camera Underwater

Distance (ft):	11.5
Structural Grade:	0
O&M Grade:	4
Clock Start/From:	
Clock To:	
1st Value:	
2nd Value:	
Value Percent:	
Continuous Index:	
Within 8" of Joint:	NO
Remarks:

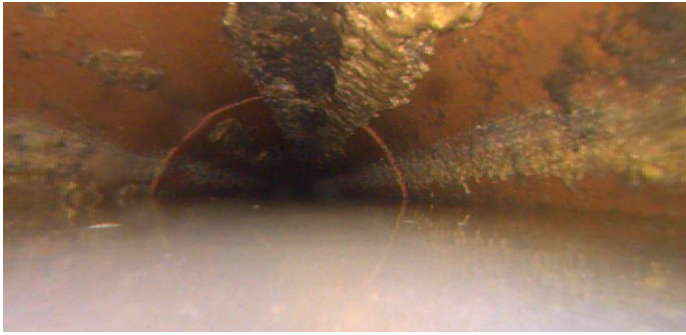
Code: **DAGS**
Description: **Deposits Attached Grease**

Distance (ft): **20.7**
Structural Grade: **0**
O&M Grade: **2**
Clock Start/From: **12**
Clock To: **1**
1st Value:
2nd Value:
Value Percent: **5.000**
Continuous Index: **S01**
Within 8" of Joint: **NO**
Remarks: **wandering**

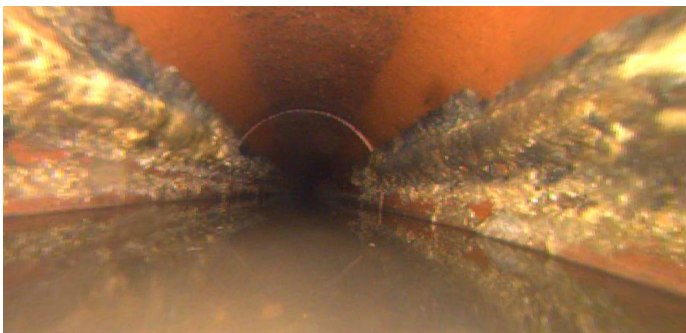
Code: **MSA**
Description: **Abandoned Survey**

Distance (ft): **37.8**
Structural Grade: **0**
O&M Grade: **0**
Clock Start/From:
Clock To:
1st Value:
2nd Value:
Value Percent:
Continuous Index:
Within 8" of Joint: **NO**
Remarks: **no blockage**

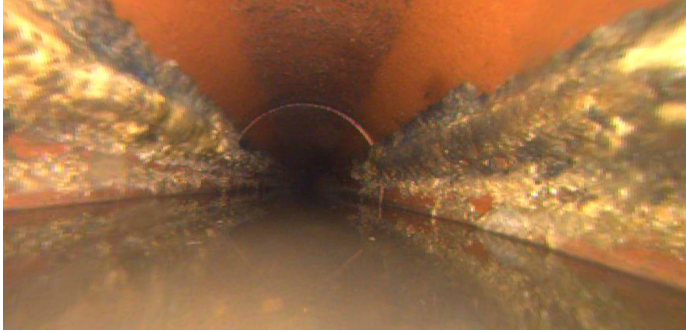
Code:	DAGS
Description:	Deposits Attached Grease
Distance (ft):	37.8
Structural Grade:	0
O&M Grade:	2
Clock Start/From:	12
Clock To:	1
1st Value:	
2nd Value:	
Value Percent:	5.000
Continuous Index:	F01
Within 8" of Joint:	NO
Remarks:	wandering
