Profile/Photo Observation Report

Date:	04/10/2018	Weather:		Coding:	PACP 6.0
Pipe Length (ft):	218.9	Owner:	NA	Pre Clean:	Not Known
P.O.#:		Surveyor:	Mark Ruby	PSR:	P-704-064-062
Customer:		Clean Date:	01/01/1900	Shape:	C

Street:	OFF RUTA DR	Flow Control:	Not Controlled
City:	Hobart, IN	Year Renewed:	
Location:	Other	Tape/Media #:	
Purpose:	Not Known	Dia/Height:	8"
Use:	Sanitary	Material:	VCP
Drain Area:	NA	Lining:	
Category:	NA		
Comment:

Location Details:		Direction of Survey:	Upstream
US MH:	M-704-062	DS MH:	M-704-064
		Total Length Surveyed (ft):	91.0

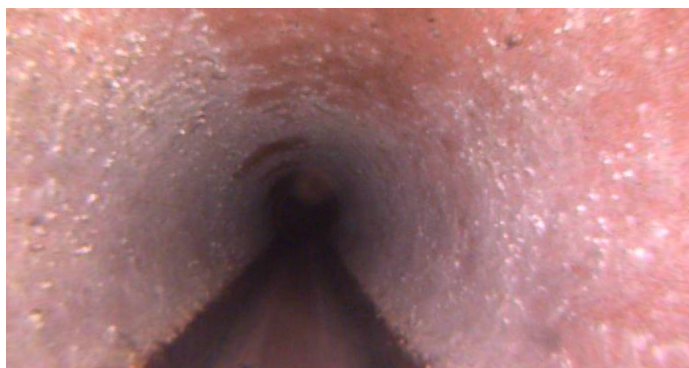
Code: **AMH**
Description: **Manhole**

Distance (ft): **.0**
Structural Grade: **0**
O&M Grade: **0**
Clock Start/From:
Clock To:
1st Value:
2nd Value:
Value Percent:
Continuous Index:
Within 8" of Joint: **NO**
Remarks: **M-704-064**

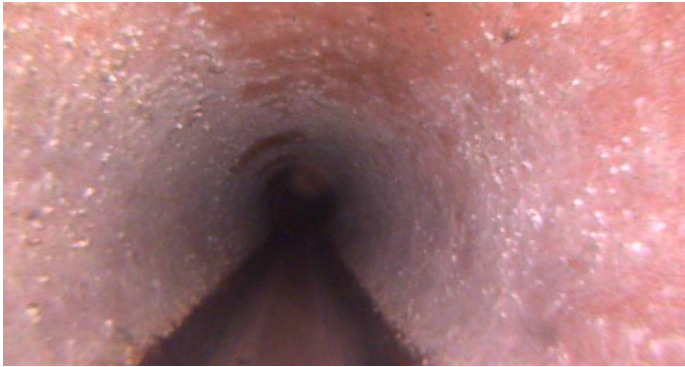
Code:	MWL
Description:	Water Level

Distance (ft):	.0
Structural Grade:	0
O&M Grade:	0
Clock Start/From:	
Clock To:	
1st Value:	
2nd Value:	
Value Percent:	10.000
Continuous Index:	
Within 8" of Joint:	NO
Remarks:

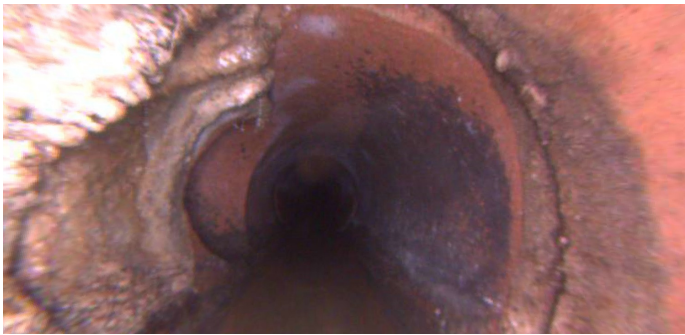
Code:	DAE
Description:	Deposits Attached Encrustation

Distance (ft):	19.4
Structural Grade:	0
O&M Grade:	2
Clock Start/From:	7
Clock To:	12
1st Value:	
2nd Value:	
Value Percent:	10.000
Continuous Index:	
Within 8" of Joint:	YES
Remarks:

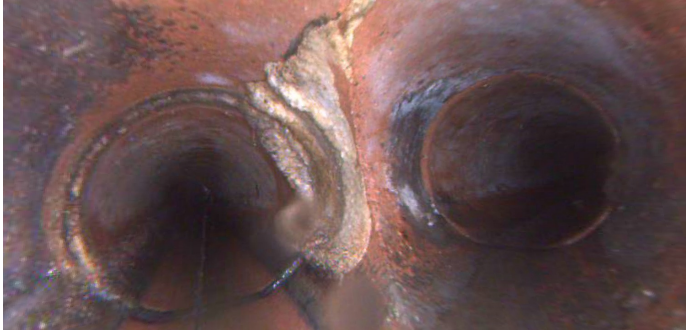
Code: **TFA**
Description: **Tap Factory Active**

Distance (ft): **20.7**
Structural Grade: **0**
O&M Grade: **0**
Clock Start/From: **9**
Clock To:
1st Value: **4.000**
2nd Value:
Value Percent:
Continuous Index:
Within 8" of Joint:
Remarks:

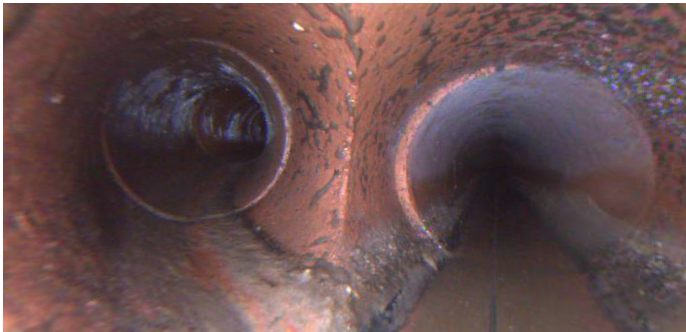
Code: **TF**
Description: **Tap Factory**

Distance (ft): **37.7**
Structural Grade: **0**
O&M Grade: **0**
Clock Start/From: **3**
Clock To:
1st Value: **4.000**
2nd Value:
Value Percent:
Continuous Index:
Within 8" of Joint:
Remarks:

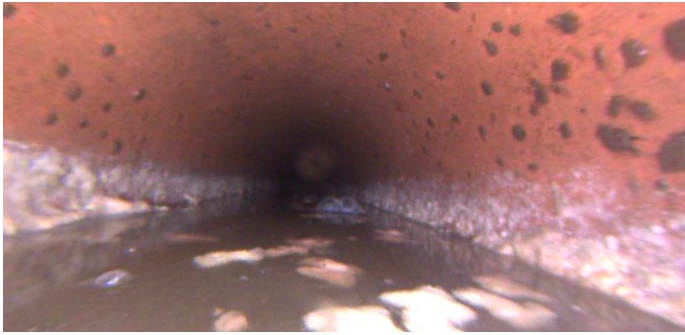
Code: **MWL**
Description: **Water Level**

Distance (ft): **45.1**
Structural Grade: **0**
O&M Grade: **0**
Clock Start/From:
Clock To:
1st Value:
2nd Value:
Value Percent: **40.000**
Continuous Index:
Within 8" of Joint: **NO**
Remarks:

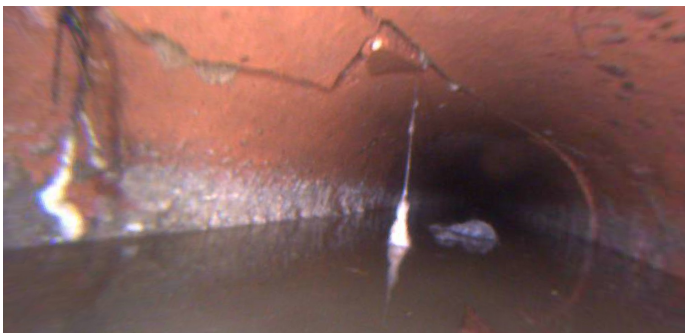
Code: **RFB**
Description: **Roots Fine Barrel**

Distance (ft): **50.0**
Structural Grade: **0**
O&M Grade: **2**
Clock Start/From: **10**
Clock To: **12**
1st Value:
2nd Value:
Value Percent:
Continuous Index:
Within 8" of Joint: **NO**
Remarks:

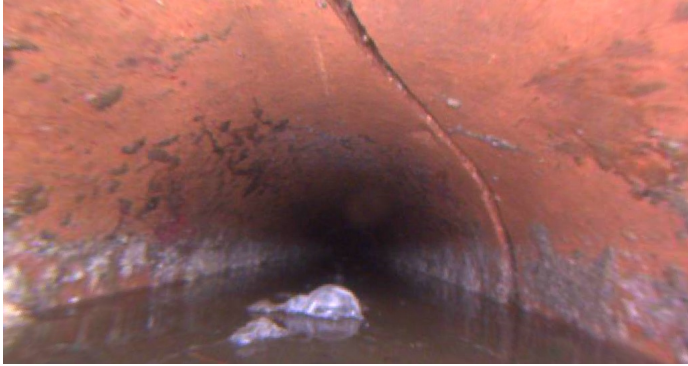
Code: **FS**
Description: **Fracture Spiral**

Distance (ft): **50.5**
Structural Grade: **3**
O&M Grade: **0**
Clock Start/From: **7**
Clock To: **5**
1st Value:
2nd Value:
Value Percent:
Continuous Index:
Within 8" of Joint:
Remarks:

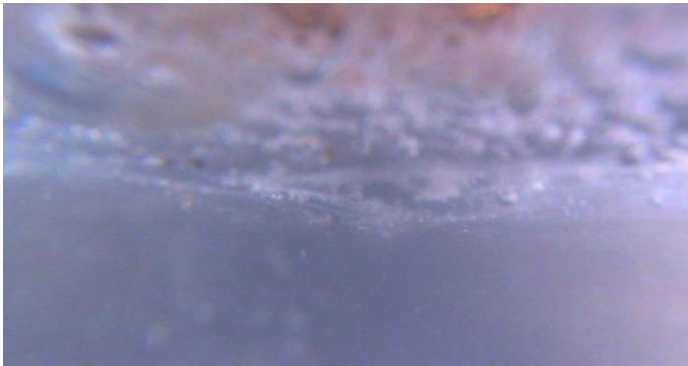
Code: **MCU**
Description: **Camera Underwater**

Distance (ft): **62.0**
Structural Grade: **0**
O&M Grade: **4**
Clock Start/From:
Clock To:
1st Value:
2nd Value:
Value Percent:
Continuous Index: **S01**
Within 8" of Joint: **NO**
Remarks:
