Profile/Photo Observation Report

Date:	04/10/2018	Weather:		Coding:	PACP 6.0
Pipe Length (ft):	218.9	Owner:	NA	Pre Clean:	Not Known
P.O.#:		Surveyor:	Mark Ruby	PSR:	P-704-064-062
Customer:		Clean Date:	01/01/1900	Shape:	C

Street:	Ruta Dr.	Flow Control:	Not Controlled
City:	Hobart, IN	Year Renewed:	
Location:	Other	Tape/Media #:	
Purpose:	Not Known	Dia/Height:	8"
Use:	Sanitary	Material:	VCP
Drain Area:	NA	Lining:	
Category:	NA		
Comment:

Location Details:		Direction of Survey:	Upstream
US MH:	M-704-062	DS MH:	M-704-064
		Total Length Surveyed (ft):	91.0

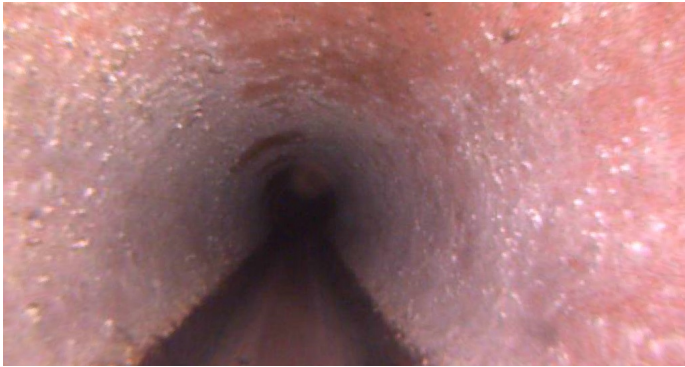
Code:	MWL
Description:	Water Level

Distance (ft):	.0
Structural Grade:	0
O&M Grade:	0
Clock Start/From:	
Clock To:	
1st Value:	
2nd Value:	
Value Percent:	10.000
Continuous Index:	
Within 8" of Joint:	NO
Remarks:

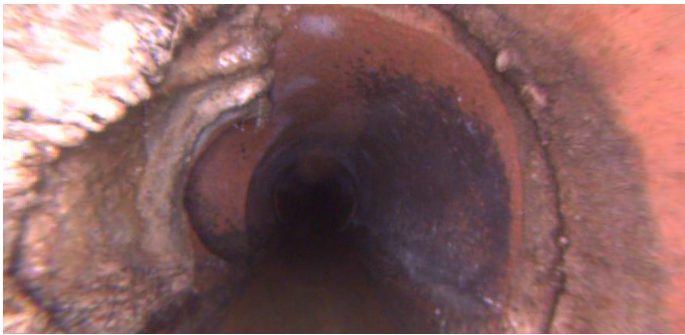
Code:	DAE
Description:	Deposits Attached Encrustation

Distance (ft):	19.4
Structural Grade:	0
O&M Grade:	2
Clock Start/From:	7
Clock To:	12
1st Value:	
2nd Value:	
Value Percent:	10.000
Continuous Index:	
Within 8" of Joint:	YES
Remarks:

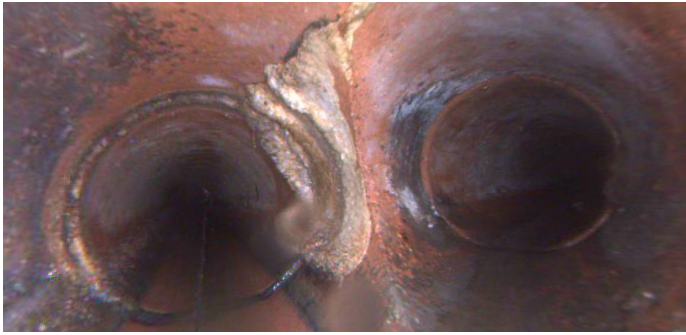
Code: **TFA**
Description: **Tap Factory Active**

Distance (ft): **20.7**
Structural Grade: **0**
O&M Grade: **0**
Clock Start/From: **9**
Clock To:
1st Value: **4.000**
2nd Value:
Value Percent:
Continuous Index:
Within 8" of Joint:
Remarks:

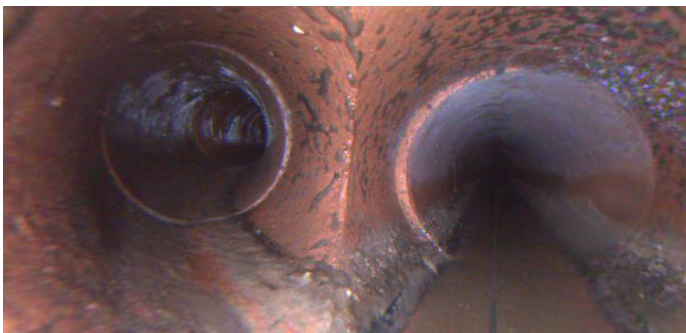
Code: **TF**
Description: **Tap Factory**

Distance (ft): **37.7**
Structural Grade: **0**
O&M Grade: **0**
Clock Start/From: **3**
Clock To:
1st Value: **4.000**
2nd Value:
Value Percent:
Continuous Index:
Within 8" of Joint:
Remarks:

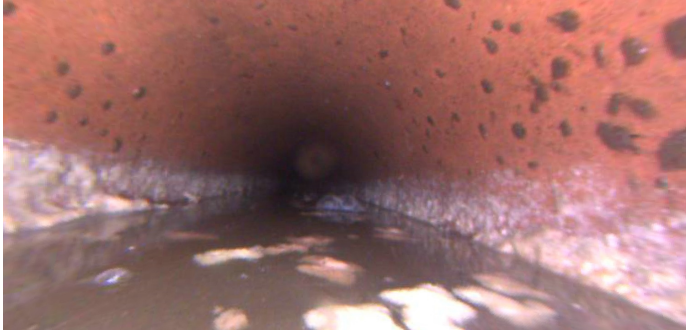
Code: **MWL**
Description: **Water Level**

Distance (ft): **45.1**
Structural Grade: **0**
O&M Grade: **0**
Clock Start/From:
Clock To:
1st Value:
2nd Value:
Value Percent: **40.000**
Continuous Index:
Within 8" of Joint: **NO**
Remarks:

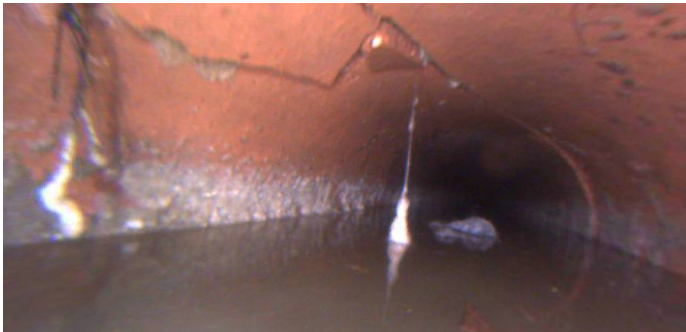
Code: **RFB**
Description: **Roots Fine Barrel**

Distance (ft): **50.0**
Structural Grade: **0**
O&M Grade: **2**
Clock Start/From: **10**
Clock To: **12**
1st Value:
2nd Value:
Value Percent:
Continuous Index:
Within 8" of Joint: **NO**
Remarks:

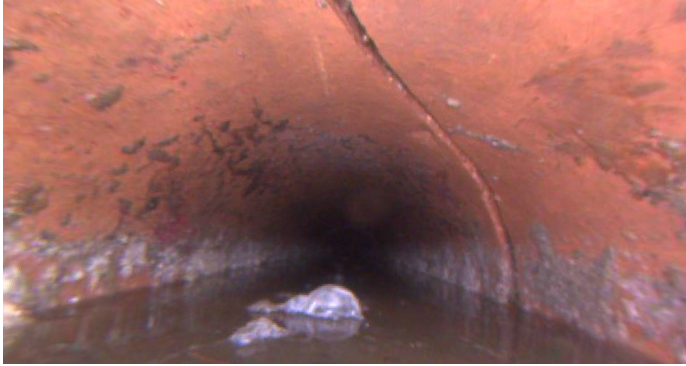
Code: **FS**
Description: **Fracture Spiral**

Distance (ft): **50.5**
Structural Grade: **3**
O&M Grade: **0**
Clock Start/From: **7**
Clock To: **5**
1st Value:
2nd Value:
Value Percent:
Continuous Index:
Within 8" of Joint:
Remarks:

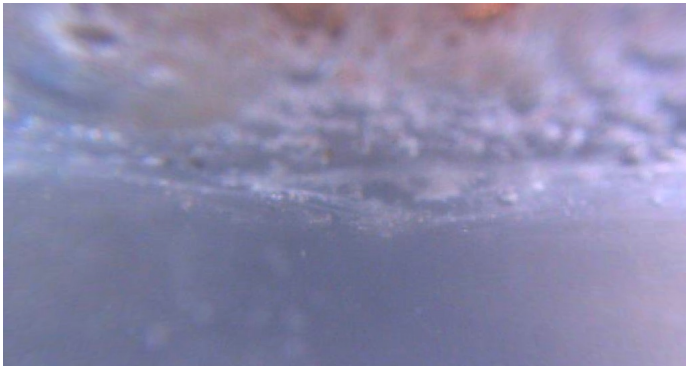
Code: **MCU**
Description: **Camera Underwater**

Distance (ft): **62.0**
Structural Grade: **0**
O&M Grade: **4**
Clock Start/From:
Clock To:
1st Value:
2nd Value:
Value Percent:
Continuous Index: **S01**
Within 8" of Joint: **NO**
Remarks:
