## Profile/Photo Observation Report

| Street: | <b>Lakewood Dr.</b> | Flow Control: | <b>Not Controlled</b> |
| City: | <b>Hobart, IN</b> | Year Renewed: | |

| US MH: | <b>M-704-068</b> | DS MH: | <b>M-704-072</b> |

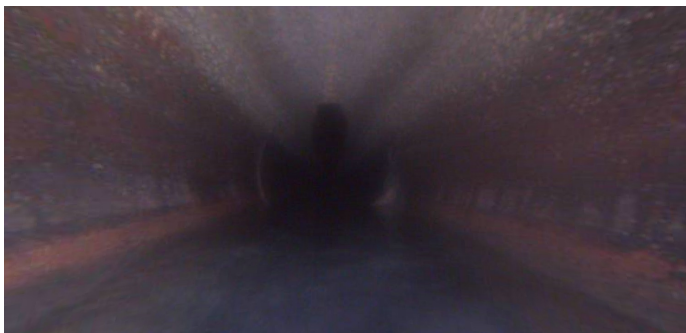
Code: **AMH**  
Description: **Manhole**

Distance (ft): **.0**  
Structural Grade: **0**  
O&M Grade: **0**  
Clock Start/From:  
Clock To:  
1st Value:  
2nd Value:  
Value Percent:  
Continuous Index:  
Within 8" of Joint: **NO**  
Remarks: **M-704-072**

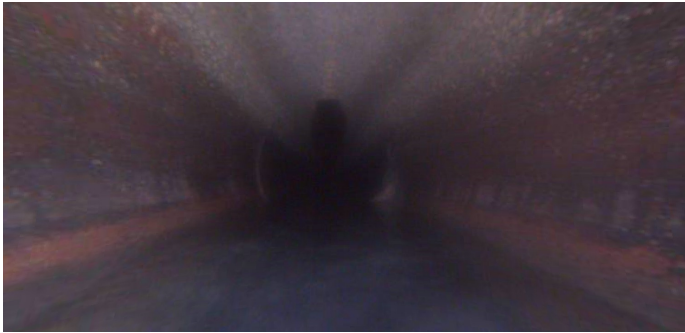
| Code: | <b>MWL</b> |
| Description: | <b>Water Level</b> |

| Value Percent: | <b>20.000</b> |

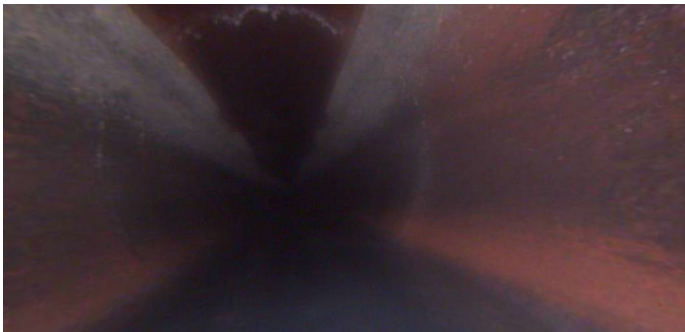
| Code: | <b>MSA</b> |
| Description: | <b>Abandoned Survey</b> |

| Distance (ft): | <b>7.9</b> |
| Remarks: | <b>unknown</b> |
