## Profile/Photo Observation Report

Date:	<b>04/10/2018</b>	Weather:		Coding:	<b>PACP 6.0</b>
Pipe Length (ft):	<b>120.9</b>	Owner:	<b>NA</b>	Pre Clean:	<b>Not Known</b>
P.O.#:		Surveyor:	<b>Byrd Fitzgerald</b>	PSR:	<b>P-704-061-070</b>
Customer:		Clean Date:	<b>01/01/1900</b>	Shape:	<b>C</b>

Street:	<b>Ruta Dr.</b>	Flow Control:	<b>Not Controlled</b>
City:	<b>Hobart, IN</b>	Year Renewed:	
Location:	<b>Other</b>	Tape/Media #:	
Purpose:	<b>Not Known</b>	Dia/Height:	<b>8"</b>
Use:	<b>Sanitary</b>	Material:	<b>VCP</b>
Drain Area:	<b>NA</b>	Lining:	
Category:	<b>NA</b>		
Comment:

Location Details:		Direction of Survey:	<b>Downstream</b>
US MH:	<b>M-704-070</b>	DS MH:	<b>M-704-061</b>
		Total Length Surveyed (ft):	<b>31.8</b>

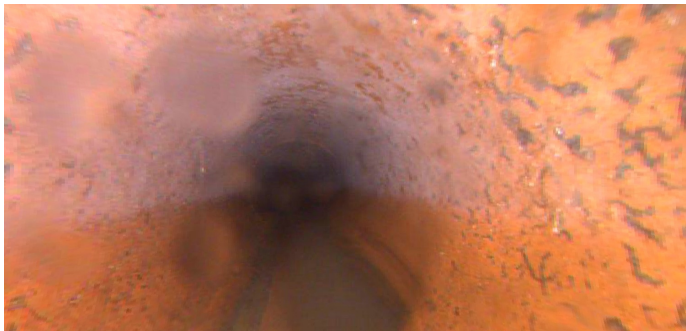
Code: **AMH**  
Description: **Manhole**

Distance (ft): **.0**  
Structural Grade: **0**  
O&M Grade: **0**  
Clock Start/From:  
Clock To:  
1st Value:  
2nd Value:  
Value Percent:  
Continuous Index:  
Within 8" of Joint: **NO**  
Remarks: **M-704-070**

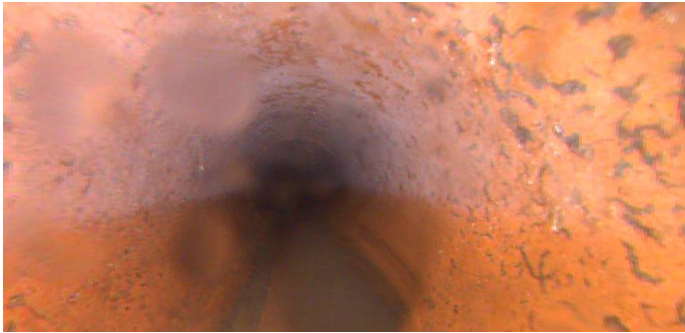
Code:	<b>MWL</b>
Description:	<b>Water Level</b>

Distance (ft):	<b>.0</b>
Structural Grade:	<b>0</b>
O&M Grade:	<b>0</b>
Clock Start/From:	
Clock To:	
1st Value:	
2nd Value:	
Value Percent:	<b>5.000</b>
Continuous Index:	
Within 8" of Joint:	<b>NO</b>
Remarks:

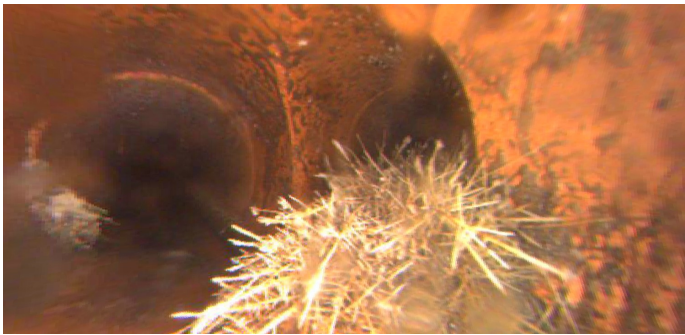
Code:	<b>RMC</b>
Description:	<b>Roots Medium Connection</b>

Distance (ft):	<b>19.0</b>
Structural Grade:	<b>0</b>
O&M Grade:	<b>3</b>
Clock Start/From:	<b>4</b>
Clock To:	<b>5</b>
1st Value:	
2nd Value:	
Value Percent:	<b>10.000</b>
Continuous Index:	
Within 8" of Joint:	<b>NO</b>
Remarks:

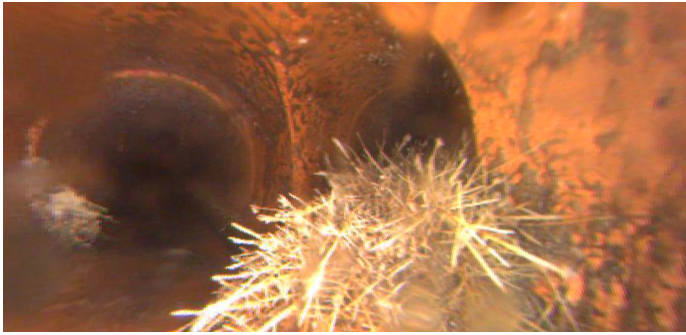
Code: **TFD**  
Description: **Tap Factory Defective**

Distance (ft): **19.0**  
Structural Grade: **0**  
O&M Grade: **2**  
Clock Start/From: **3**  
Clock To:  
1st Value: **4.000**  
2nd Value:  
Value Percent:  
Continuous Index:  
Within 8" of Joint: **YES**  
Remarks: **partially blocked by roots**

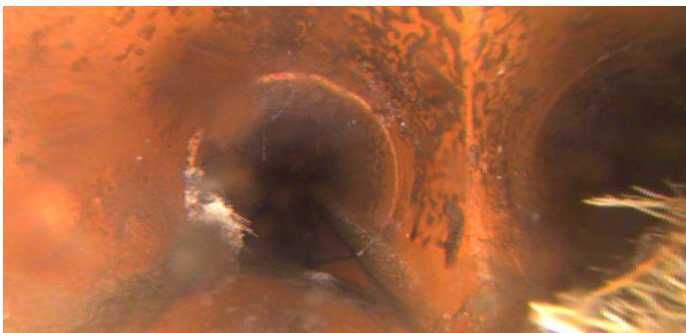
Code: **RFJ**  
Description: **Roots Fine Joint**

Distance (ft): **19.2**  
Structural Grade: **0**  
O&M Grade: **1**  
Clock Start/From: **8**  
Clock To:  
1st Value:  
2nd Value:  
Value Percent:  
Continuous Index:  
Within 8" of Joint: **YES**  
Remarks:

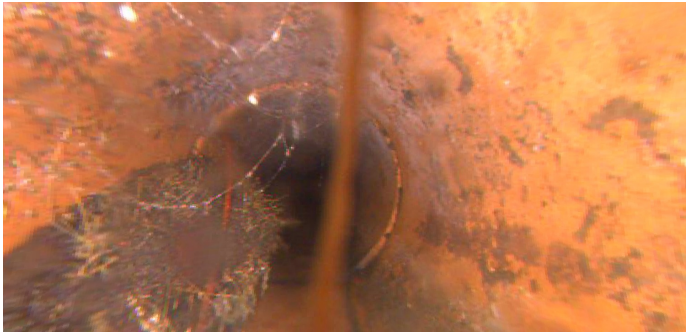
Code: **RMJ**  
Description: **Roots Medium Joint**

Distance (ft): **29.1**  
Structural Grade: **0**  
O&M Grade: **3**  
Clock Start/From: **7**  
Clock To: **10**  
1st Value:  
2nd Value:  
Value Percent: **20.000**  
Continuous Index:  
Within 8" of Joint: **YES**  
Remarks: **into barrel**

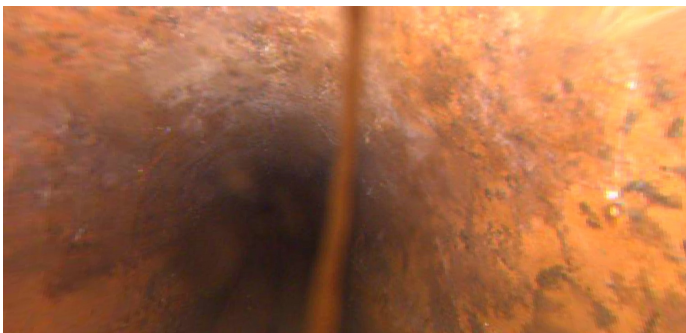
Code: **MSA**  
Description: **Abandoned Survey**

Distance (ft): **31.8**  
Structural Grade: **0**  
O&M Grade: **0**  
Clock Start/From:  
Clock To:  
1st Value:  
2nd Value:  
Value Percent:  
Continuous Index:  
Within 8" of Joint: **NO**  
Remarks: **rmj**
