Profile/Photo Observation Report

Date:	04/10/2018	Weather:		Coding:	PACP 6.0
Pipe Length (ft):	120.9	Owner:	NA	Pre Clean:	Not Known
P.O.#:		Surveyor:	Mark Ruby	PSR:	P-704-061-070
Customer:		Clean Date:	01/01/1900	Shape:	C

Street:	OFF PRIVATE DR	Flow Control:	Not Controlled
City:	Hobart, IN	Year Renewed:	
Location:	Other	Tape/Media #:	
Purpose:	Not Known	Dia/Height:	8"
Use:	Sanitary	Material:	VCP
Drain Area:	NA	Lining:	
Category:	NA		
Comment:

Location Details:		Direction of Survey:	Upstream
US MH:	M-704-070	DS MH:	M-704-061
		Total Length Surveyed (ft):	118.8

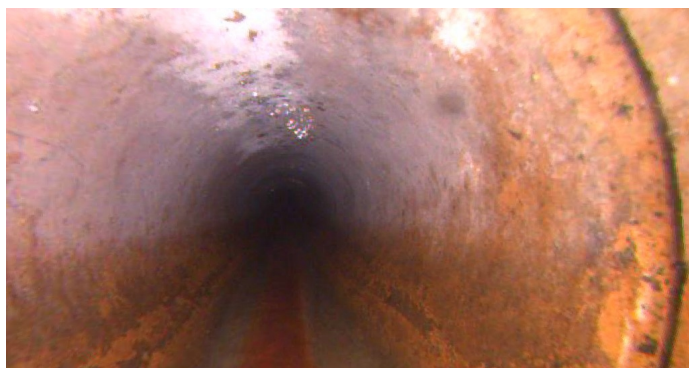
Code: **AMH**
Description: **Manhole**

Distance (ft): **.0**
Structural Grade: **0**
O&M Grade: **0**
Clock Start/From:
Clock To:
1st Value:
2nd Value:
Value Percent:
Continuous Index:
Within 8" of Joint: **NO**
Remarks: **M-704-061**

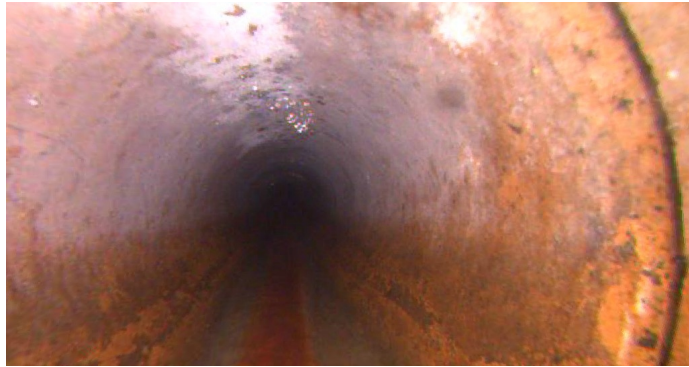
Code:	MWL
Description:	Water Level
Distance (ft):	.0
Structural Grade:	0
O&M Grade:	0
Clock Start/From:	
Clock To:	
1st Value:	
2nd Value:	
Value Percent:	10.000
Continuous Index:	
Within 8" of Joint:	NO
Remarks:

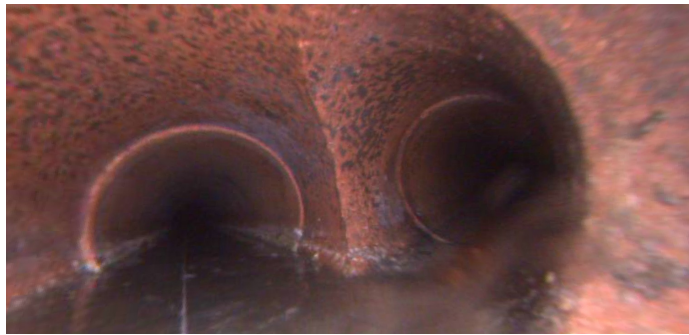
Code:	TF
Description:	Tap Factory
Distance (ft):	57.3
Structural Grade:	0
O&M Grade:	0
Clock Start/From:	9
Clock To:	
1st Value:	4.000
2nd Value:	
Value Percent:	
Continuous Index:	
Within 8" of Joint:	
Remarks:

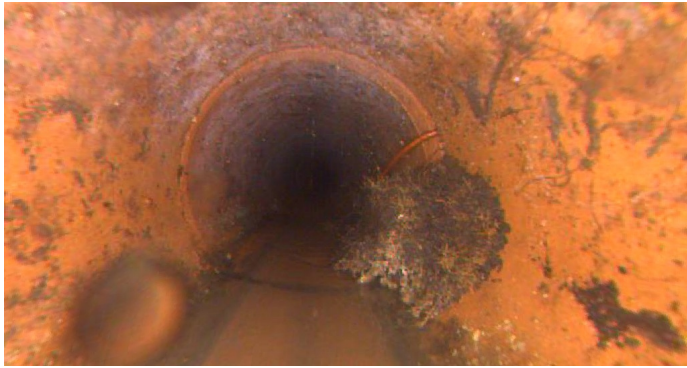
Code: **RFJ**
Description: **Roots Fine Joint**

Distance (ft): **87.3**
Structural Grade: **0**
O&M Grade: **1**
Clock Start/From: **5**
Clock To:
1st Value:
2nd Value:
Value Percent:
Continuous Index:
Within 8" of Joint: **YES**
Remarks:

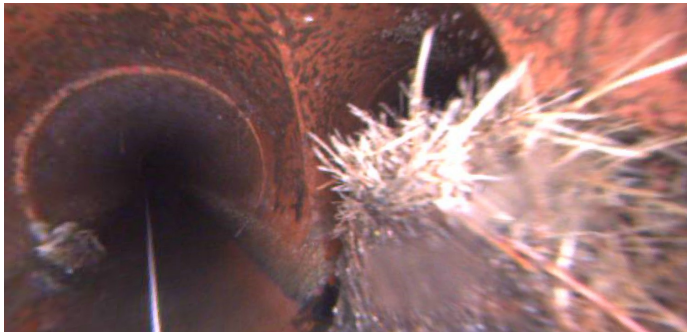
Code: **TFD**
Description: **Tap Factory Defective**

Distance (ft): **99.1**
Structural Grade: **0**
O&M Grade: **2**
Clock Start/From: **9**
Clock To:
1st Value: **4.000**
2nd Value:
Value Percent:
Continuous Index:
Within 8" of Joint:
Remarks: **ROOTS**

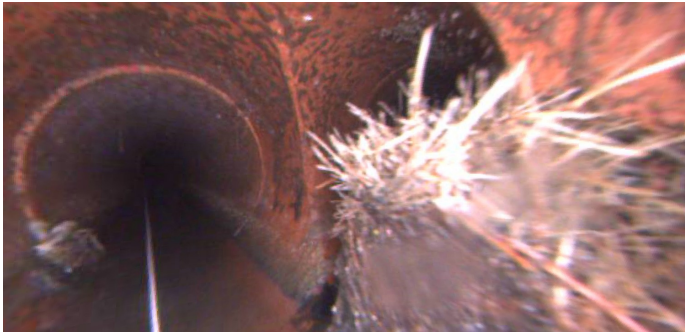
Code: **RML**
Description: **Roots Medium Lateral**

Distance (ft): **99.1**
Structural Grade: **0**
O&M Grade: **3**
Clock Start/From: **8**
Clock To: **10**
1st Value:
2nd Value:
Value Percent: **10.000**
Continuous Index:
Within 8" of Joint: **NO**
Remarks:

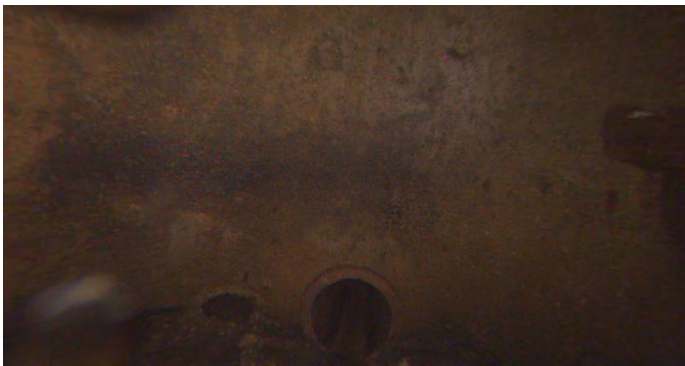
Code: **AMH**
Description: **Manhole**

Distance (ft): **118.8**
Structural Grade: **0**
O&M Grade: **0**
Clock Start/From:
Clock To:
1st Value:
2nd Value:
Value Percent:
Continuous Index:
Within 8" of Joint: **NO**
Remarks: **M-704-070**
