## Profile/Photo Observation Report

Date:	<b>04/10/2018</b>	Weather:		Coding:	<b>PACP 6.0</b>
Pipe Length (ft):	<b>120.9</b>	Owner:	<b>NA</b>	Pre Clean:	<b>Not Known</b>
P.O.#:		Surveyor:	<b>Mark Ruby</b>	PSR:	<b>P-704-061-070</b>
Customer:		Clean Date:	<b>01/01/1900</b>	Shape:	<b>C</b>

Street:	<b>Ruta Dr.</b>	Flow Control:	<b>Not Controlled</b>
City:	<b>Hobart, IN</b>	Year Renewed:	
Location:	<b>Other</b>	Tape/Media #:	
Purpose:	<b>Not Known</b>	Dia/Height:	<b>8"</b>
Use:	<b>Sanitary</b>	Material:	<b>VCP</b>
Drain Area:	<b>NA</b>	Lining:	
Category:	<b>NA</b>		
Comment:

Location Details:		Direction of Survey:	<b>Upstream</b>
US MH:	<b>M-704-070</b>	DS MH:	<b>M-704-061</b>
		Total Length Surveyed (ft):	<b>118.8</b>

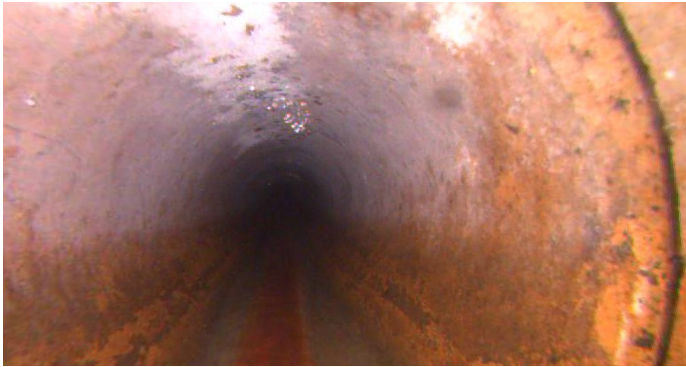
Code: **MWL**  
Description: **Water Level**

Distance (ft): **.0**  
Structural Grade: **0**  
O&M Grade: **0**  
Clock Start/From:  
Clock To:  
1st Value:  
2nd Value:  
Value Percent: **10.000**  
Continuous Index:  
Within 8" of Joint: **NO**  
Remarks:

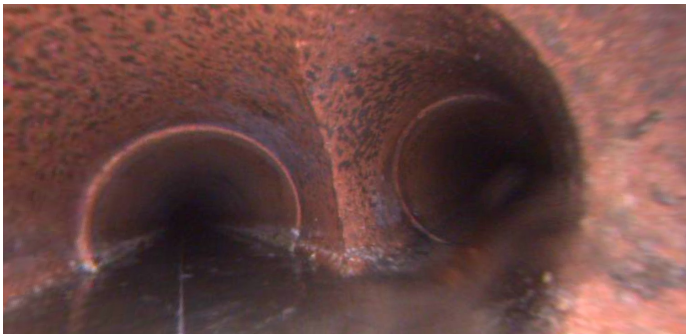
Code: **TF**  
Description: **Tap Factory**

Distance (ft): **57.3**  
Structural Grade: **0**  
O&M Grade: **0**  
Clock Start/From: **9**  
Clock To:  
1st Value: **4.000**  
2nd Value:  
Value Percent:  
Continuous Index:  
Within 8" of Joint:  
Remarks:

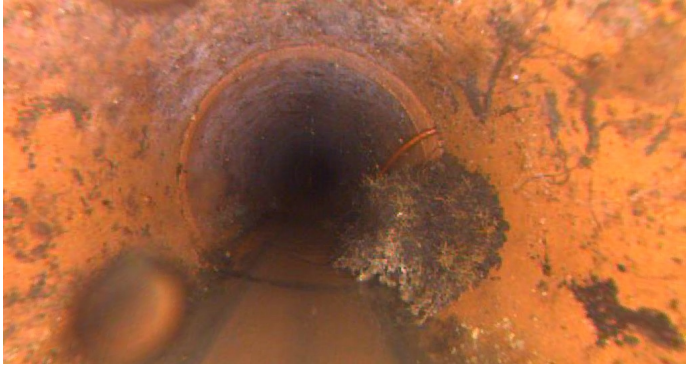
Code: **RFJ**  
Description: **Roots Fine Joint**

Distance (ft): **87.3**  
Structural Grade: **0**  
O&M Grade: **1**  
Clock Start/From: **5**  
Clock To:  
1st Value:  
2nd Value:  
Value Percent:  
Continuous Index:  
Within 8" of Joint: **YES**  
Remarks:

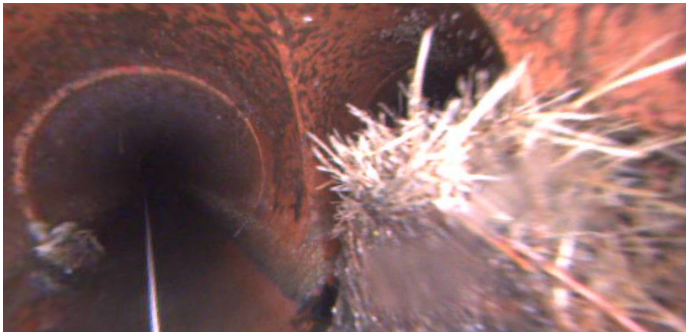
Code: **TFD**  
Description: **Tap Factory Defective**

Distance (ft): **99.1**  
Structural Grade: **0**  
O&M Grade: **2**  
Clock Start/From: **9**  
Clock To:  
1st Value: **4.000**  
2nd Value:  
Value Percent:  
Continuous Index:  
Within 8" of Joint:  
Remarks: **ROOTS**

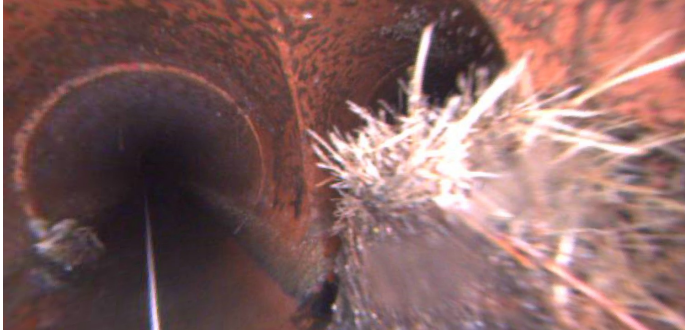
Code: **RML**  
Description: **Roots Medium Lateral**

Distance (ft): **99.1**  
Structural Grade: **0**  
O&M Grade: **3**  
Clock Start/From: **8**  
Clock To: **10**  
1st Value:  
2nd Value:  
Value Percent: **10.000**  
Continuous Index:  
Within 8" of Joint: **NO**  
Remarks:

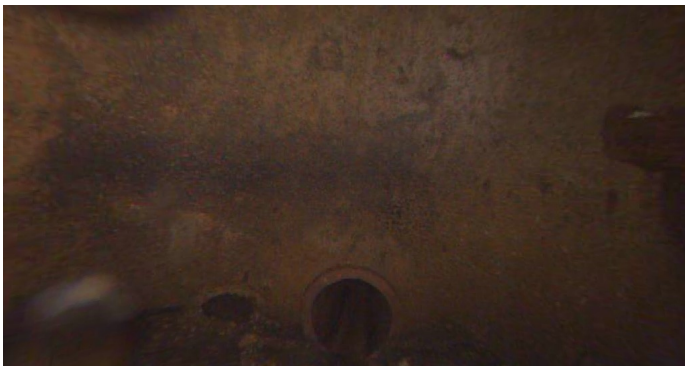
Code: **AMH**  
Description: **Manhole**

Distance (ft): **118.8**  
Structural Grade: **0**  
O&M Grade: **0**  
Clock Start/From:  
Clock To:  
1st Value:  
2nd Value:  
Value Percent:  
Continuous Index:  
Within 8" of Joint: **NO**  
Remarks: **M-704-070**
