Date:	10/19/2021	Weather:			Coding:	PACP 6.0
Pipe Length (ft):	Owner:	Hobart, IN		Pre Clean:	Not Known
P.O.#:	900_1	Surveyor:	M. Pielacha		PSR:	P-705-LMP-015
Customer:	Hobart, IN	Clean Date:			Shape:	С
Street:	5th Street		Flow Control:			
City:	Hobart, IN		Year Renewed:			
Location:	Light Highway		Tape/Media #:		900	
Purpose:	Routine Assessment	:	Dia/Height:		8"	
Use:	Sanitary		Material:		VCP	
Drain Area:			Lining:			
Category:	NA					
Comment:						
Location Detai	ls:		Direction of Sur	vey:	Upstream	
US MH:	M-705-15	DS MH:	M-705-15	Total Leng	gth Surveyed (ft):	19.5
)&M Index:	4.00	O&M Quick:	410	00_0	&M Rating:	4.00
tructural Index:	3.00	Structural Qu	244		ructural Rating:	3.00
Overall Index:	3.50	Overall Quick			verall Rating:	7.00

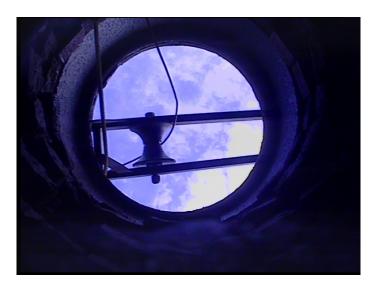
Code: Description:	AMH Manhole
Distance (ft):	.0
Structural Grade:	0
O&M Grade:	0
Clock Start/From:	
Clock To:	
1st Value:	
2nd Value:	
Value Percent:	
Continuous Index:	
Within 8" of Joint:	NO
Remarks:	M-705-15

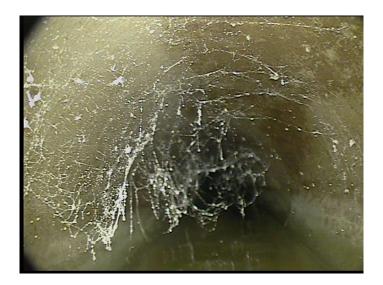
Code:	MWL
Description:	Water Level
Distance (ft):	0
Distance (ft):	.0
Structural Grade:	0
O&M Grade:	0
Clock Start/From:	
Clock To:	
1st Value:	
2nd Value:	
Value Percent:	5.000
Continuous Index:	
Within 8" of Joint:	NO
Remarks:

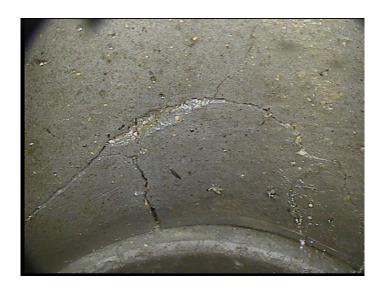
Code: Description:	CM Crack Multiple
Distance (ft):	10.3
Structural Grade:	3
O&M Grade:	0
Clock Start/From:	10
Clock To:	1
1st Value:	
2nd Value:	
Value Percent:	
Continuous Index:	
Within 8" of Joint:	YES
Remarks:

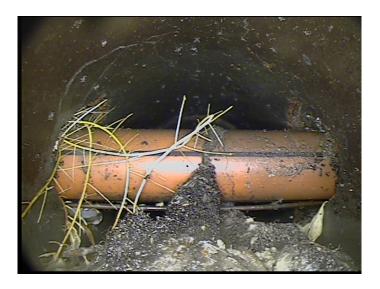
Code: Description:	OBP Obstacle External Pipe or Cable
Distance (ft):	19.5
Structural Grade:	0
O&M Grade:	4
Clock Start/From:	3
Clock To:	
1st Value:	
2nd Value:	
Value Percent:	30.000
Continuous Index:	
Within 8" of Joint:	NO
Remarks:

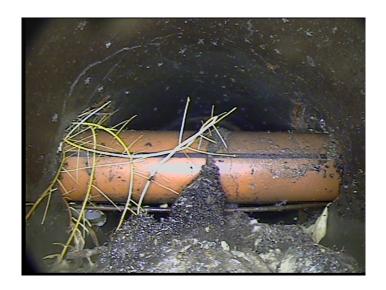
Code: Description:	MSA Abandoned Survey
Distance (ft):	19.5
Structural Grade:	0
O&M Grade:	0
Clock Start/From:	
Clock To:	
1st Value:	
2nd Value:	
Value Percent:	
Continuous Index:	
Within 8" of Joint:	NO
Remarks:	Unable to pass external pipe
