Profile/Photo Observation Report

| Pipe Length (ft): | 372.0 | Owner: | City of Hobart | Pre Clean: | No Pre-Cleaning |

| Street: | East 5th Street | Flow Control: | Not Controlled |

| US MH: | M-705-016 | DS MH: | M-705-015 | Total Length Surveyed (ft): | 44.2 |

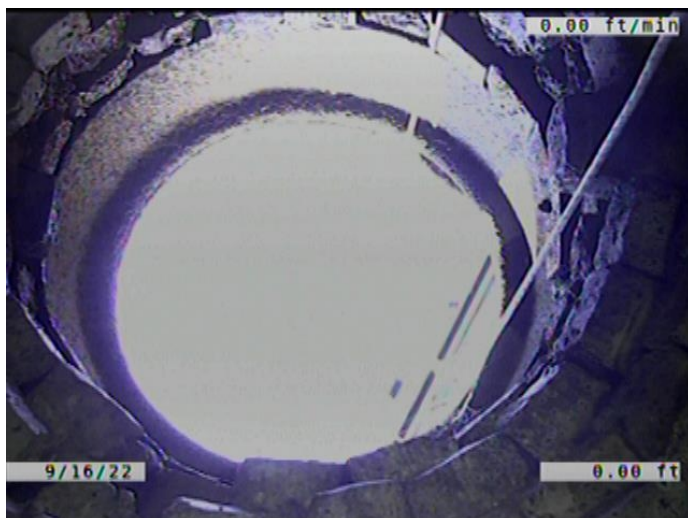
Code: **AMH**
 Description: **Manhole**

Distance (ft): **.0**
 Structural Grade: **0**
 O&M Grade: **0**
 Clock Start/From:
 Clock To:
 1st Value:
 2nd Value:
 Value Percent:
 Continuous Index:
 Within 8" of Joint: **NO**
 Remarks: **M-705-016**

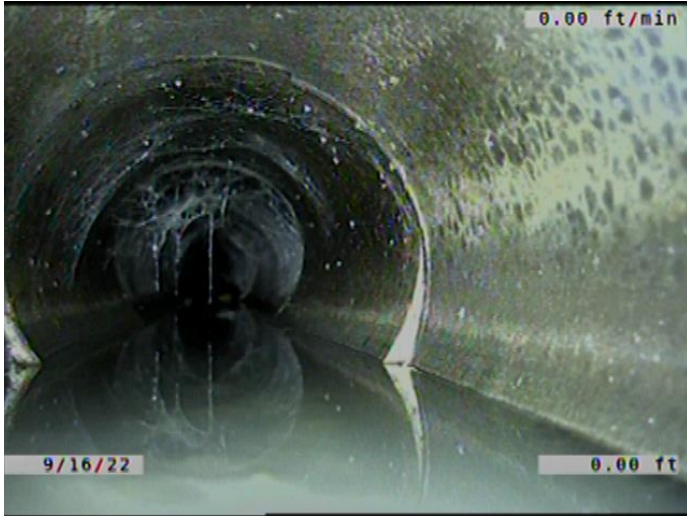
Code: **MWL**
Description: **Miscellaneous Water Level**

Distance (ft): **.0**
Structural Grade: **0**
O&M Grade: **0**
Clock Start/From:
Clock To:
1st Value:
2nd Value:
Value Percent: **10.000**
Continuous Index:
Within 8" of Joint: **NO**
Remarks:

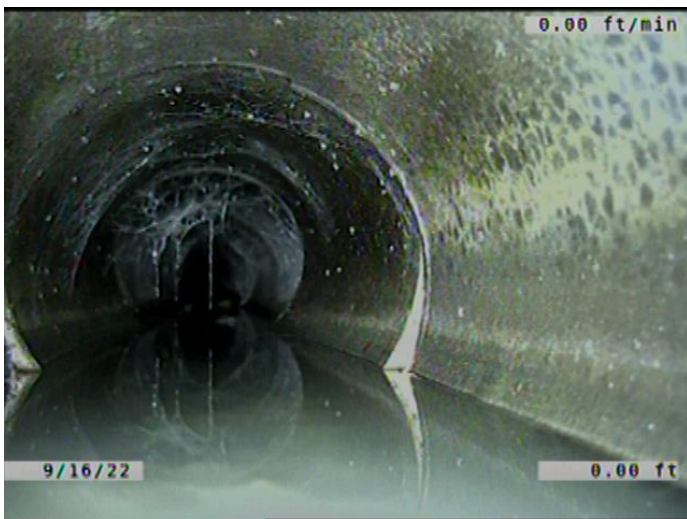
Code: **DSF**
Description: **Deposits Settled Fine**

Distance (ft): **.0**
Structural Grade: **0**
O&M Grade: **2**
Clock Start/From: **5**
Clock To: **7**
1st Value:
2nd Value:
Value Percent: **5.000**
Continuous Index: **S01**
Within 8" of Joint: **YES**
Remarks:

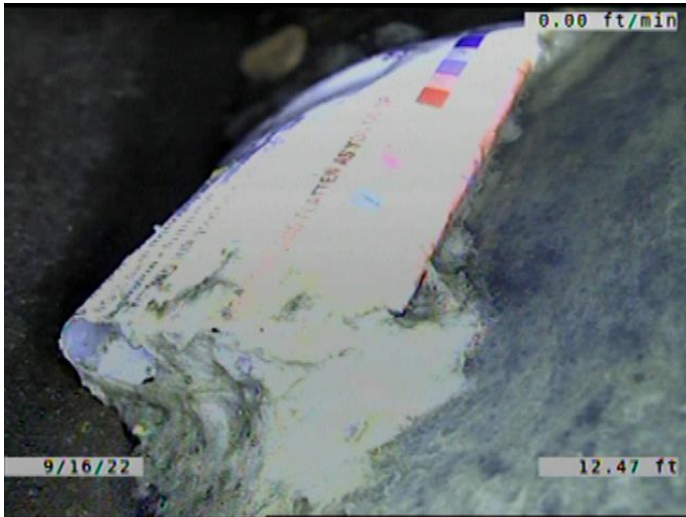
Code: **OBZ**
 Description: **Obstruction Other**

Distance (ft): **12.5**
 Structural Grade: **0**
 O&M Grade: **2**
 Clock Start/From: **6**
 Clock To: **7**
 1st Value:
 2nd Value:
 Value Percent: **5.000**
 Continuous Index:
 Within 8" of Joint: **YES**
 Remarks: **TRASH**

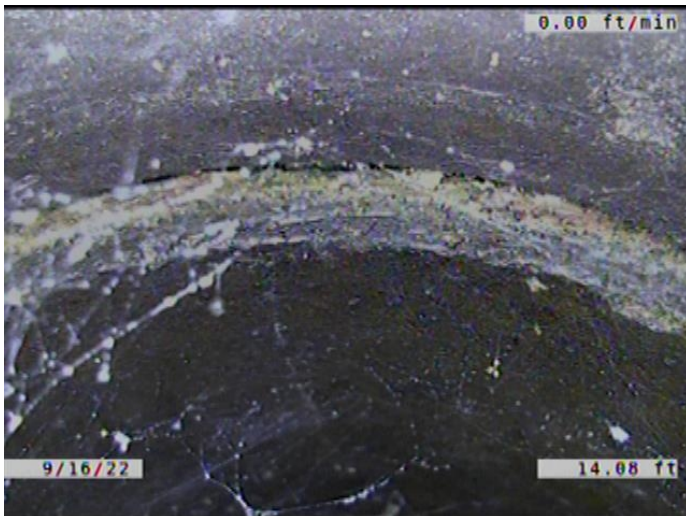
Code: **JOM**
 Description: **Joint Offset Medium**

Distance (ft): **14.1**
 Structural Grade: **3**
 O&M Grade: **0**
 Clock Start/From:
 Clock To:
 1st Value:
 2nd Value:
 Value Percent:
 Continuous Index:
 Within 8" of Joint: **NO**
 Remarks:

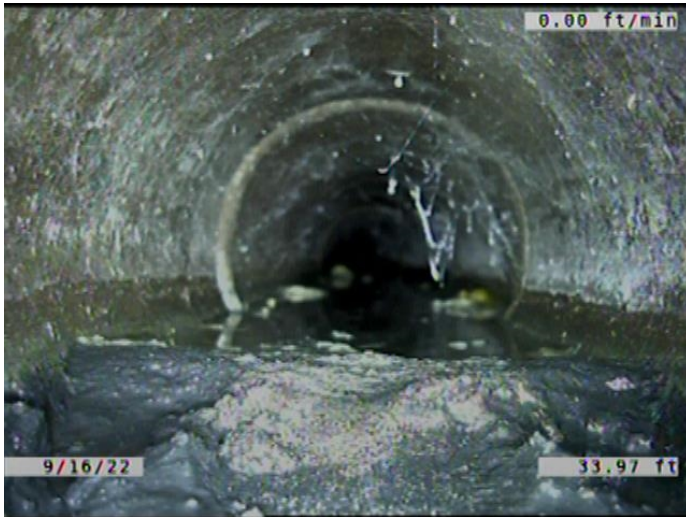
Code: **DSF**
Description: **Deposits Settled Fine**

Distance (ft): **34.0**
Structural Grade: **0**
O&M Grade: **3**
Clock Start/From: **4**
Clock To: **8**
1st Value:
2nd Value:
Value Percent: **15.000**
Continuous Index: **S02**
Within 8" of Joint: **YES**
Remarks:

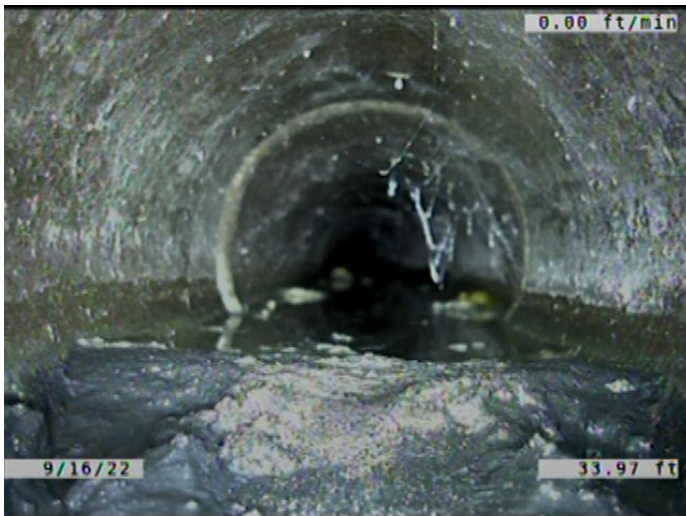
Code: **DSF**
Description: **Deposits Settled Fine**

Distance (ft): **34.0**
Structural Grade: **0**
O&M Grade: **2**
Clock Start/From: **5**
Clock To: **7**
1st Value:
2nd Value:
Value Percent: **5.000**
Continuous Index: **F01**
Within 8" of Joint: **YES**
Remarks:

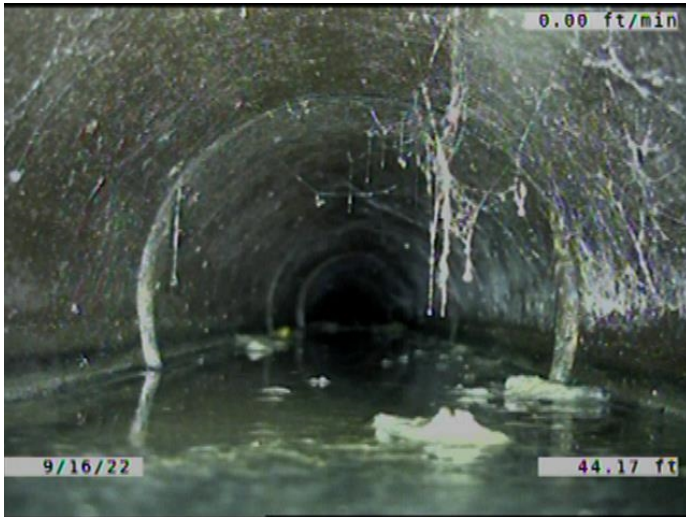
Code: **DSF**
 Description: **Deposits Settled Fine**

Distance (ft): **44.2**
 Structural Grade: **0**
 O&M Grade: **3**
 Clock Start/From: **4**
 Clock To: **8**
 1st Value:
 2nd Value:
 Value Percent: **15.000**
 Continuous Index: **F02**
 Within 8" of Joint: **YES**
 Remarks:

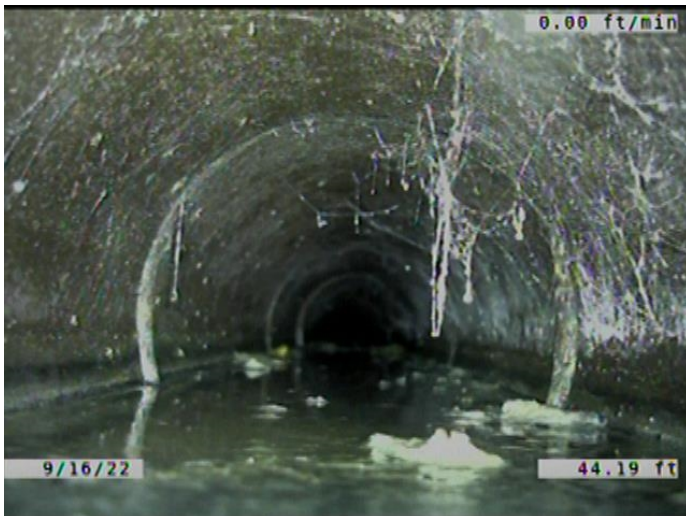
Code: **MSA**
 Description: **Miscellaneous Survey Abandoned**

Distance (ft): **44.2**
 Structural Grade: **0**
 O&M Grade: **0**
 Clock Start/From:
 Clock To:
 1st Value:
 2nd Value:
 Value Percent:
 Continuous Index:
 Within 8" of Joint: **NO**
 Remarks: **CAMERA CANT MAKE IT PAST DEBRIS.**
