Profile/Photo Observation Report

Date:	05/01/2018	Weather:		Coding:	PACP 6.0
Pipe Length (ft):		Owner:	City of Hobart	Pre Clean:	No Pre-Cleaning
P.O.#:	153	Surveyor:	M. Pielacha	PSR:	P-705-017-016
Customer:	City of Hobart	Clean Date:		Shape:	C

Street:	Main Street	Flow Control:	Not Controlled
City:	Hobart, IN	Year Renewed:	
Location:	Light Highway	Tape/Media #:	DEP 153
Purpose:	Routine Assessment	Dia/Height:	18"
Use:	Sanitary	Material:	VCP
Drain Area:		Lining:	
Category:	NA		
Comment:	5-21-2018		
Location Details:		Direction of Survey:	Downstream
US MH:	M-705-016	DS MH:	M-705-017
		Total Length Surveyed (ft):	1.6

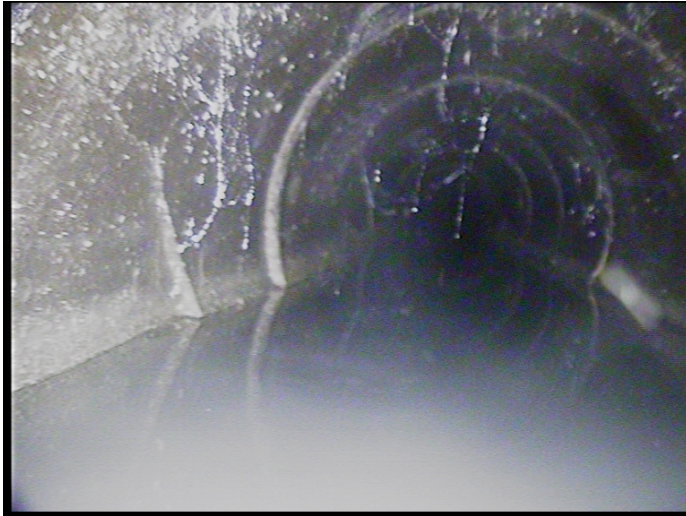
Code:	AMH
Description:	Manhole
Distance (ft):	.0
Structural Grade:	0
O&M Grade:	0
Clock Start/From:	
Clock To:	
1st Value:	
2nd Value:	
Value Percent:	
Continuous Index:	
Within 8" of Joint:	NO
Remarks:	M-705-016

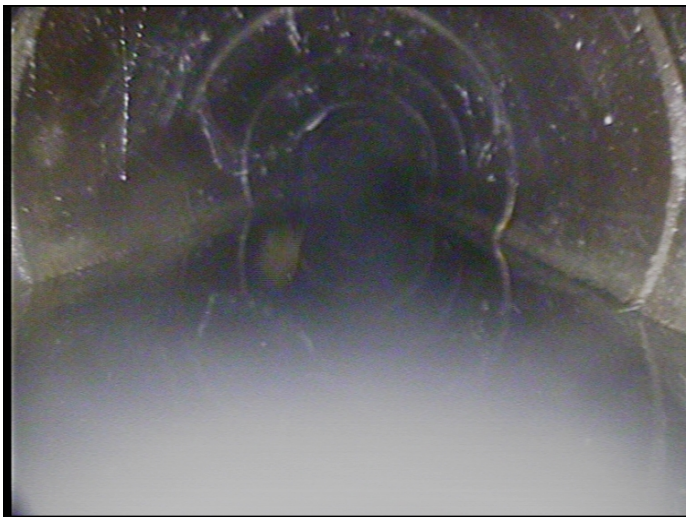
Code: **MWL**
Description: **Water Level**

Distance (ft): **.0**
Structural Grade: **0**
O&M Grade: **0**
Clock Start/From:
Clock To:
1st Value:
2nd Value:
Value Percent: **15.000**
Continuous Index:
Within 8" of Joint: **NO**
Remarks:

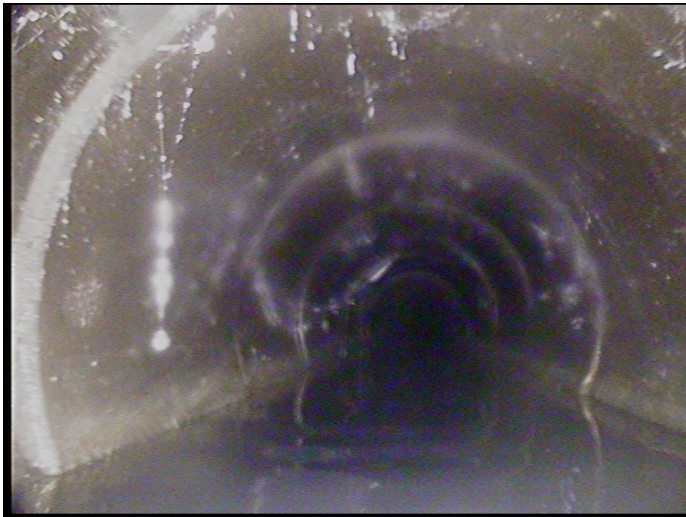
Code: **DSF**
Description: **Deposits Settled Fine**

Distance (ft): **.7**
Structural Grade: **0**
O&M Grade: **3**
Clock Start/From: **4**
Clock To: **8**
1st Value:
2nd Value:
Value Percent: **20.000**
Continuous Index:
Within 8" of Joint: **NO**
Remarks:
