Profile/Photo Observation Report

Profile/Pr	noto Observation R	Weather: Owner: City of Hobart Surveyor: Clean Date: Coding: PACP 6.0 Pre Clean: No Pre-Cleaning PSR: P-705-017-016 Shape: C Flow Control: Not Controlled				
Date: Pipe Length (f	05/02/2018 t):		City of Hobar	t	•	
P.O.#:	168	•	M. Pielacha			P-705-017-016
Customer:	City of Hobart	Clean Date:			Shape:	С
Street:	Main Street		Flow Control:		Not Controlled	
City:	Hobart, IN		Year Renewed:			
Location:	Light Highway		Tape/Media #:		DEP 168	
Purpose:	Routine Assessment		Dia/Height:		18"	
Use:	Sanitary		Material:		VCP	
Drain Area:			Lining:			
Category:	NA

Comment:	5-21-2018					
Location Deta	ils:		Direction of Su	rvey:	Downstream	
US MH:	M-705-016	DS MH:	M-705-017	Total	Length Surveyed (ft):	.1
O&M Index:	0.00	O&M Quick:	00	000	O&M Rating:	0.00
Structural Index	0.00	 _Structural Qu	uick: 00	000	Structural Rating:	0.00
Overall Index:	0.00	 _Overall Quicl	c: 00	000	Overall Rating:	0.00

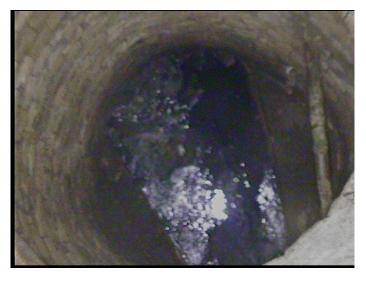
Description: Manhole Distance (ft): .0 Structural Grade: 0 O&M Grade: 0 Clock Start/From: Clock To: 1st Value: 2nd Value: Value Percent: Continuous Index: Within 8" of Joint: NO Remarks: M-705-017

AMH

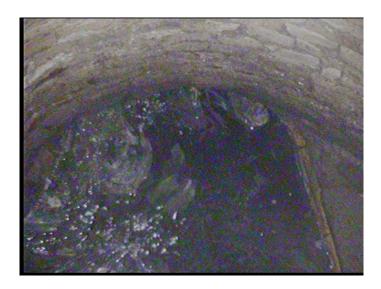
Code: MWL

Description: **Water Level**

Distance (ft): .0 Structural Grade: 0 O&M Grade: 0

15.000
