Profile/Photo Observation Report

Date:	10/21/2021	Weather:		Coding:	PACP 6.0
Pipe Length (ft):		Owner:	Hobart, IN	Pre Clean:	Not Known
P.O.#:	927_1	Surveyor:	M. Pielacha	PSR:	P-705-018-017
Customer:	Hobart, IN	Clean Date:		Shape:	C

Street:	East 6th Street	Flow Control:	
City:	Hobart, IN	Year Renewed:	
Location:	Light Highway	Tape/Media #:	927
Purpose:	Routine Assessment	Dia/Height:	10"
Use:	Sanitary	Material:	VCP
Drain Area:		Lining:	
Category:	NA		
Comment:

Location Details:		Direction of Survey:	Downstream
US MH:	M-705-17	DS MH:	M-705-18
		Total Length Surveyed (ft):	37.5

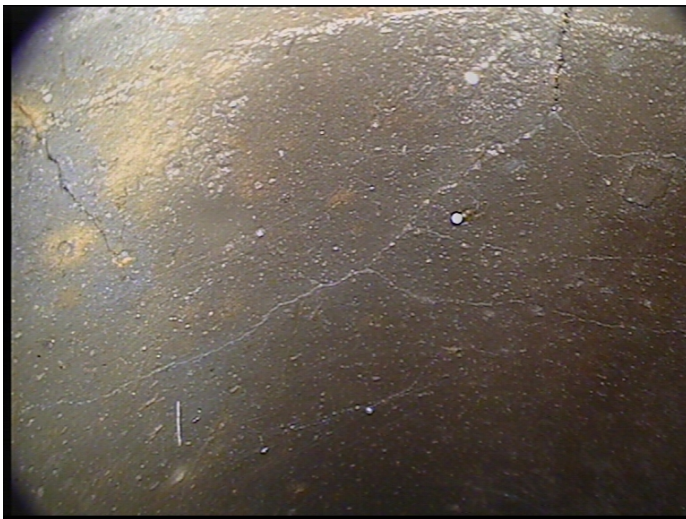
Code: **CM**
Description: **Crack Multiple**

Distance (ft): **12.6**
Structural Grade: **3**
O&M Grade: **0**
Clock Start/From: **8**
Clock To: **12**
1st Value:
2nd Value:
Value Percent:
Continuous Index:
Within 8" of Joint: **YES**
Remarks:

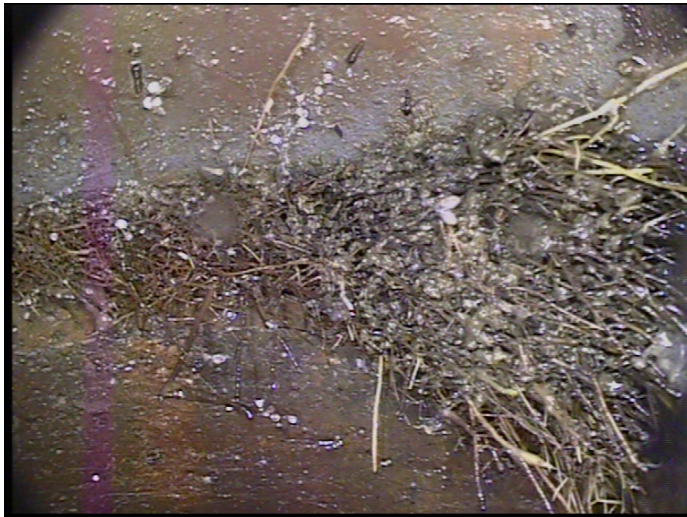
Code: **RMJ**
Description: **Roots Medium Joint**

Distance (ft): **21.1**
Structural Grade: **0**
O&M Grade: **3**
Clock Start/From: **1**
Clock To: **4**
1st Value:
2nd Value:
Value Percent: **5.000**
Continuous Index:
Within 8" of Joint: **YES**
Remarks:

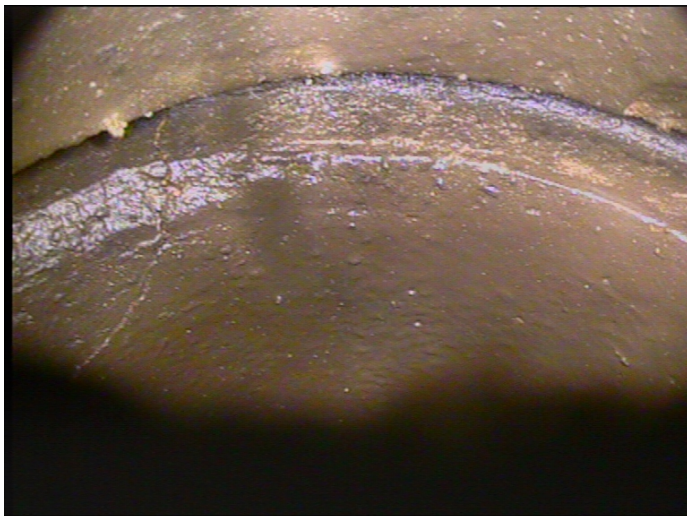
Code: **DSF**
Description: **Deposits Settled Fine**

Distance (ft): **30.0**
Structural Grade: **0**
O&M Grade: **4**
Clock Start/From: **4**
Clock To: **8**
1st Value:
2nd Value:
Value Percent: **25.000**
Continuous Index: **S01**
Within 8" of Joint: **YES**
Remarks:

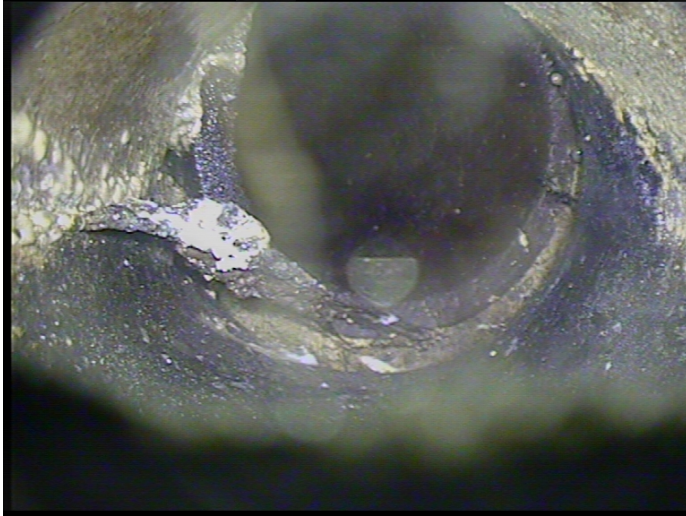
Code: **TF**
Description: **Tap Factory**

Distance (ft): **33.4**
Structural Grade: **0**
O&M Grade: **0**
Clock Start/From: **10**
Clock To:
1st Value: **4.000**
2nd Value:
Value Percent:
Continuous Index:
Within 8" of Joint: **NO**
Remarks:

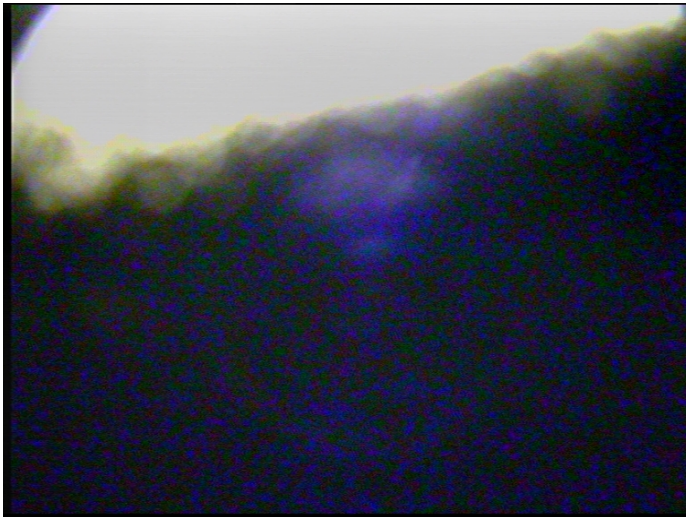
Code: **DSF**
Description: **Deposits Settled Fine**

Distance (ft): **37.5**
Structural Grade: **0**
O&M Grade: **5**
Clock Start/From: **4**
Clock To: **8**
1st Value:
2nd Value:
Value Percent: **35.000**
Continuous Index: **F01**
Within 8" of Joint: **NO**
Remarks:

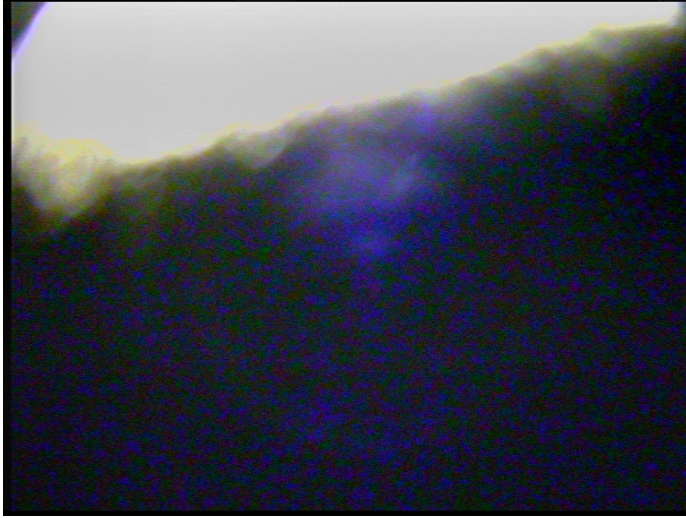
Code:	MSA
Description:	Abandoned Survey
Distance (ft):	37.5
Structural Grade:	0
O&M Grade:	0
Clock Start/From:	
Clock To:	
1st Value:	
2nd Value:	
Value Percent:	
Continuous Index:	
Within 8" of Joint:	NO
Remarks:	deep sediment
