Profile/Photo Observation Report

| Profile/Photo Observation Report | | | | | | | |
|---|---|---|---|---|---|--|--|
| P.O.#: | 249 | Surveyor: | B. Helbling | PSR: | P-706-048-017 | | |
| Street: | Main Street | ı | Flow Control: | Not Controlled | | | |
| US MH: | M-705-017 | DS MH: M | -706-048 | Total Length Surveyed (ft): | 5.9 | | |

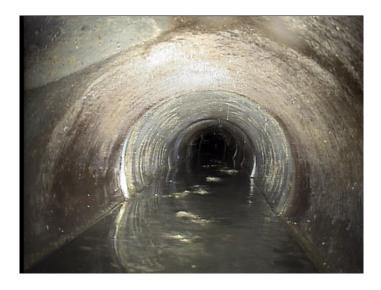
Code: MWL

Description: Water Level

Distance (ft): .0
Structural Grade: 0

Value Percent: 20.000

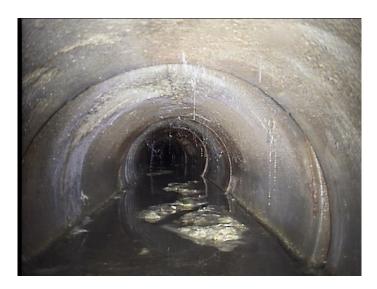
Code: **DSF**

Description: Deposits Settled Fine

Distance (ft): 1.9
Structural Grade: 0
O&M Grade: 3
Clock Start/From: 4
Clock To: 8

Value Percent: 15.000
Continuous Index: S01
Within 8" of Joint: NO

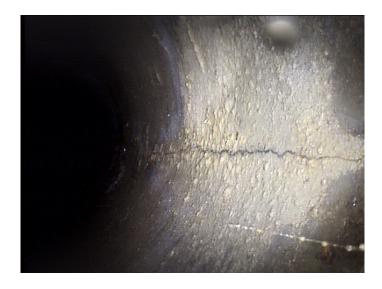
Code: CL

Description: Crack Longitudinal

Distance (ft): 4.1
Structural Grade: 2
O&M Grade: 0
Clock Start/From: 12

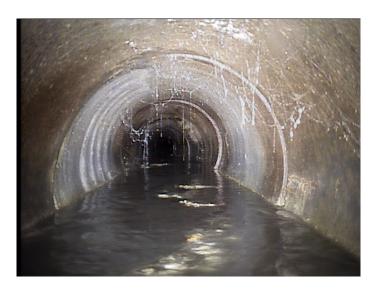
Code: **DSF**

Description: Deposits Settled Fine

Distance (ft): 5.9
Structural Grade: 0
O&M Grade: 3
Clock Start/From: 4
Clock To: 8
1st Value:

2nd Value:
Value Percent: 15.000
Continuous Index: F01

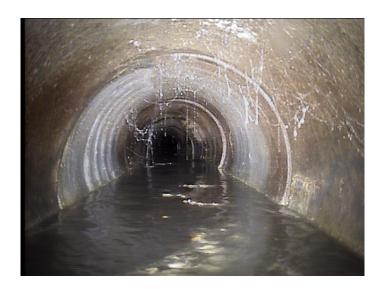
Code: MSA

Description: Abandoned Survey

Distance (ft): 5.9
Structural Grade: 0

Remarks: **Heavy sediment**
