## Profile/Photo Observation Report

Date:	<b>04/19/2018</b>	Weather:		Coding:	<b>PACP 6.0</b>
Pipe Length (ft):	<b>324.5</b>	Owner:	<b>NA</b>	Pre Clean:	<b>Not Known</b>
P.O.#:		Surveyor:	<b>Jen Costello</b>	PSR:	<b>P-705-019-018</b>
Customer:		Clean Date:	<b>01/01/1900</b>	Shape:	<b>C</b>

Street:	<b>Capitol</b>	Flow Control:	<b>Not Controlled</b>
City:	<b>Hobart, IN</b>	Year Renewed:	
Location:	<b>Light Highway</b>	Tape/Media #:	
Purpose:	<b>Maintenance Related</b>	Dia/Height:	<b>12"</b>
Use:	<b>Sanitary</b>	Material:	<b>VCP</b>
Drain Area:	<b>NA</b>	Lining:	<b>Cured in Place</b>
Category:	<b>NA</b>		
Comment:	<b>heavy blk silt at 13'.</b>

Location Details:		Direction of Survey:	<b>Downstream</b>
US MH:	<b>M-705-018</b>	DS MH:	<b>M-705-019</b>
		Total Length Surveyed (ft):	<b>13.9</b>

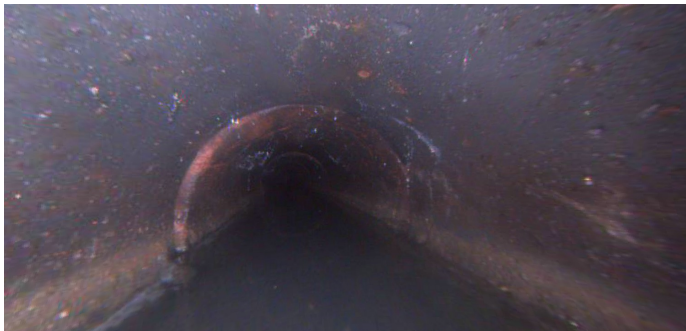
Code: **AMH**  
Description: **Manhole**

Distance (ft): **.0**  
Structural Grade: **0**  
O&M Grade: **0**  
Clock Start/From:  
Clock To:  
1st Value:  
2nd Value:  
Value Percent:  
Continuous Index:  
Within 8" of Joint: **NO**  
Remarks: **M-705-018**

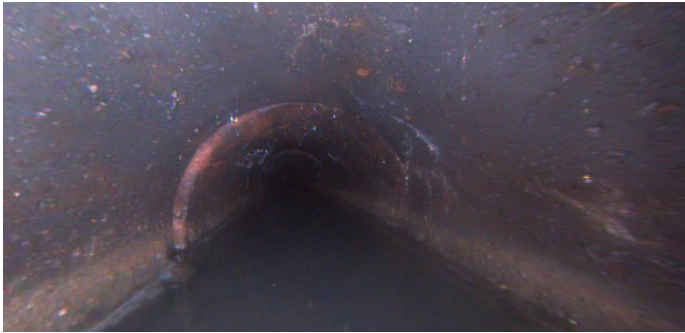
Code:	<b>MWL</b>
Description:	<b>Water Level</b>

Distance (ft):	<b>.0</b>
Structural Grade:	<b>0</b>
O&M Grade:	<b>0</b>
Clock Start/From:	
Clock To:	
1st Value:	
2nd Value:	
Value Percent:	<b>30.000</b>
Continuous Index:	
Within 8" of Joint:	<b>NO</b>
Remarks:

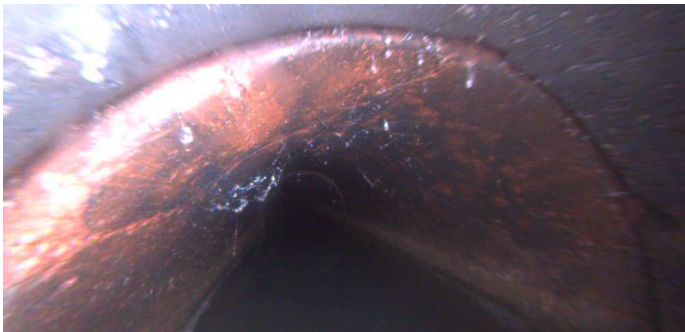
Code:	<b>FM</b>
Description:	<b>Fracture Multiple</b>

Distance (ft):	<b>1.0</b>
Structural Grade:	<b>4</b>
O&M Grade:	<b>0</b>
Clock Start/From:	<b>9</b>
Clock To:	<b>1</b>
1st Value:	
2nd Value:	
Value Percent:	
Continuous Index:	
Within 8" of Joint:	<b>YES</b>
Remarks:

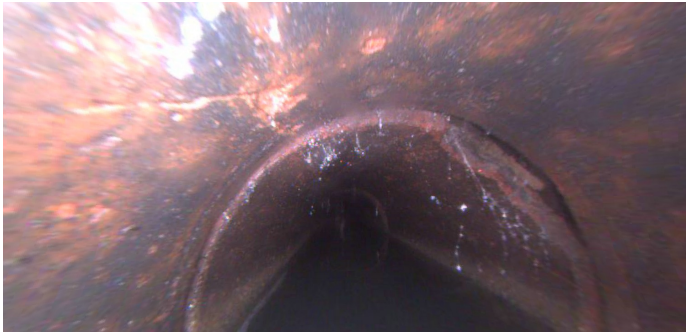
Code: **FM**  
Description: **Fracture Multiple**

Distance (ft): **5.2**  
Structural Grade: **4**  
O&M Grade: **0**  
Clock Start/From: **10**  
Clock To: **12**  
1st Value:  
2nd Value:  
Value Percent:  
Continuous Index:  
Within 8" of Joint: **YES**  
Remarks:

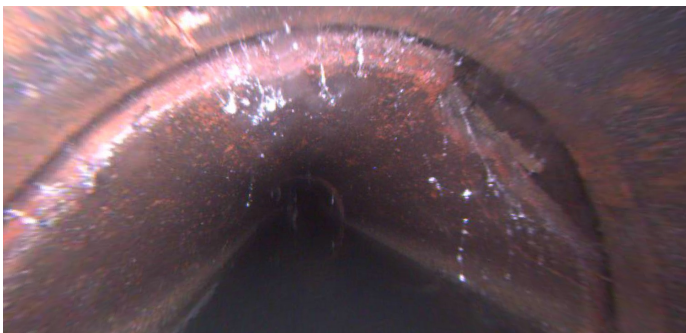
Code: **HSV**  
Description: **Hole Soil Visible**

Distance (ft): **5.5**  
Structural Grade: **5**  
O&M Grade: **0**  
Clock Start/From: **1**  
Clock To: **3**  
1st Value:  
2nd Value:  
Value Percent:  
Continuous Index:  
Within 8" of Joint: **YES**  
Remarks:

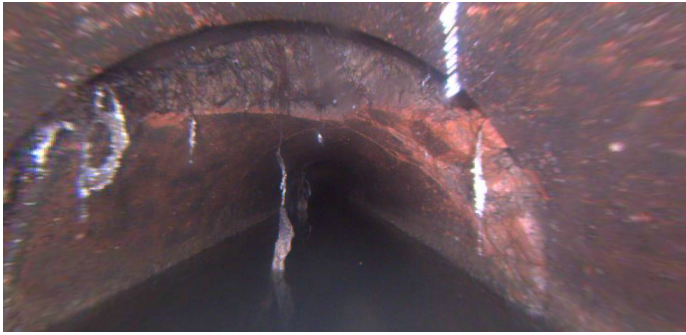
Code: **HSV**  
Description: **Hole Soil Visible**

Distance (ft): **7.4**  
Structural Grade: **5**  
O&M Grade: **0**  
Clock Start/From: **10**  
Clock To: **2**  
1st Value:  
2nd Value:  
Value Percent:  
Continuous Index:  
Within 8" of Joint: **YES**  
Remarks:

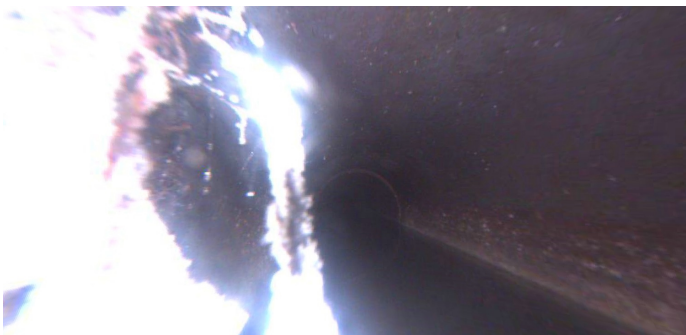
Code: **RMJ**  
Description: **Roots Medium Joint**

Distance (ft): **9.7**  
Structural Grade: **0**  
O&M Grade: **3**  
Clock Start/From: **8**  
Clock To: **12**  
1st Value:  
2nd Value:  
Value Percent: **10.000**  
Continuous Index:  
Within 8" of Joint: **YES**  
Remarks:

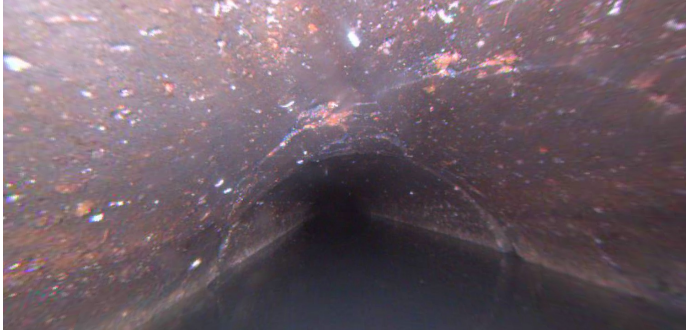
Code: **FM**  
Description: **Fracture Multiple**

Distance (ft): **13.2**  
Structural Grade: **4**  
O&M Grade: **0**  
Clock Start/From: **8**  
Clock To: **4**  
1st Value:  
2nd Value:  
Value Percent:  
Continuous Index:  
Within 8" of Joint: **YES**  
Remarks:

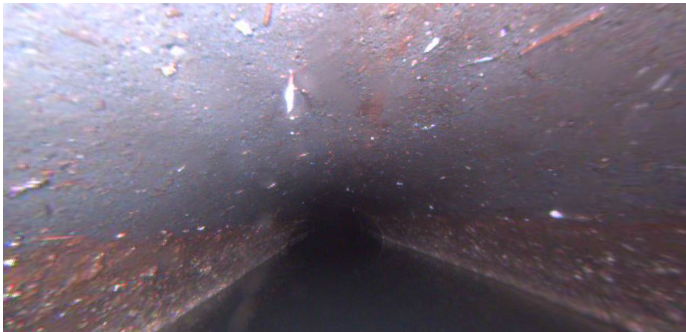
Code: **MSA**  
Description: **Abandoned Survey**

Distance (ft): **13.9**  
Structural Grade: **0**  
O&M Grade: **0**  
Clock Start/From:  
Clock To:  
1st Value:  
2nd Value:  
Value Percent:  
Continuous Index:  
Within 8" of Joint: **NO**  
Remarks: **debris under weater**
