## Profile/Photo Observation Report

Street:	<b>E 6TH ST &amp; STATE ST</b>	Flow Control:	<b>Not Controlled</b>
City:	<b>Hobart, IN</b>	Year Renewed:	
Location:	<b>Light Highway</b>	Tape/Media #:	
Purpose:	<b>Maintenance Related</b>	Dia/Height:	<b>8"</b>
Use:	<b>Sanitary</b>	Material:	<b>VCP</b>
Drain Area:	<b>NA</b>	Lining:	<b>Cured in Place</b>
Category:	<b>NA</b>		
Comment:	<b>heavy blk silt at 25'.</b>		
Location Details:		Direction of Survey:	<b>Upstream</b>
US MH:	<b>M-705-018</b>	DS MH:	<b>M-706-029</b>
		Total Length Surveyed (ft):	<b>26.6</b>

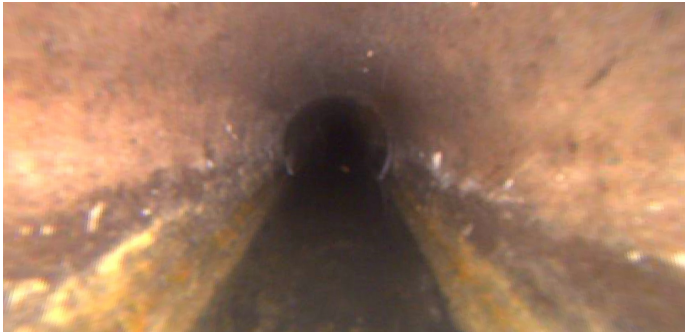
Code:	<b>MWL</b>
Description:	<b>Water Level</b>

Distance (ft):	<b>.0</b>
Structural Grade:	<b>0</b>
O&M Grade:	<b>0</b>
Clock Start/From:	
Clock To:	
1st Value:	
2nd Value:	
Value Percent:	<b>5.000</b>
Continuous Index:	
Within 8" of Joint:	<b>NO</b>
Remarks:

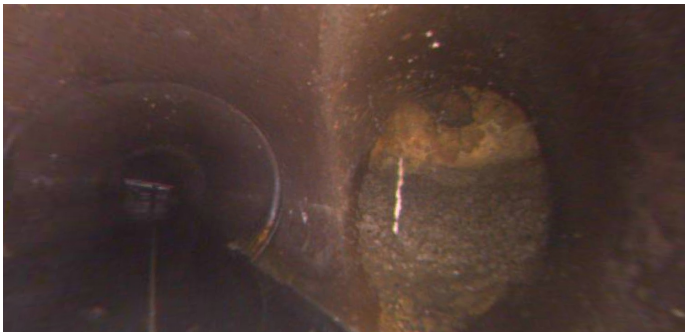
Code:	<b>TFC</b>
Description:	<b>Tap Factory Capped</b>

Distance (ft):	<b>6.4</b>
Structural Grade:	<b>0</b>
O&M Grade:	<b>0</b>
Clock Start/From:	<b>9</b>
Clock To:	
1st Value:	<b>4.000</b>
2nd Value:	
Value Percent:	
Continuous Index:	
Within 8" of Joint:	
Remarks:

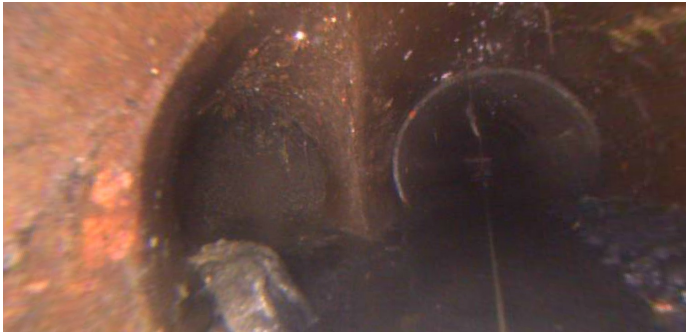
Code: **TFC**  
Description: **Tap Factory Capped**

Distance (ft): **8.6**  
Structural Grade: **0**  
O&M Grade: **0**  
Clock Start/From: **3**  
Clock To:  
1st Value: **4.000**  
2nd Value:  
Value Percent:  
Continuous Index:  
Within 8" of Joint:  
Remarks:

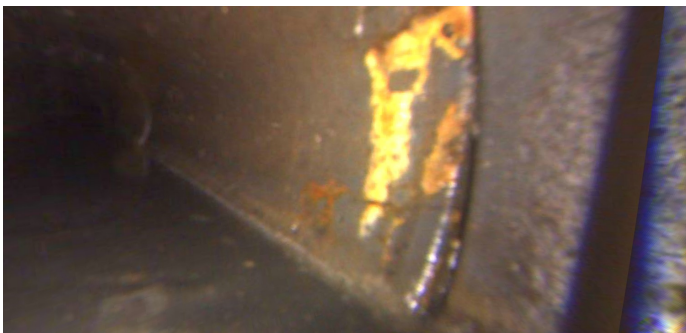
Code: **FM**  
Description: **Fracture Multiple**

Distance (ft): **17.4**  
Structural Grade: **4**  
O&M Grade: **0**  
Clock Start/From: **2**  
Clock To: **4**  
1st Value:  
2nd Value:  
Value Percent:  
Continuous Index:  
Within 8" of Joint: **YES**  
Remarks:

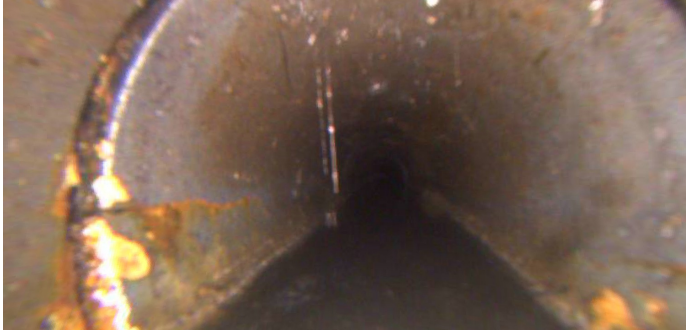
Code: **FM**  
Description: **Fracture Multiple**

Distance (ft): **19.4**  
Structural Grade: **4**  
O&M Grade: **0**  
Clock Start/From: **8**  
Clock To: **4**  
1st Value:  
2nd Value:  
Value Percent:  
Continuous Index:  
Within 8" of Joint: **YES**  
Remarks:

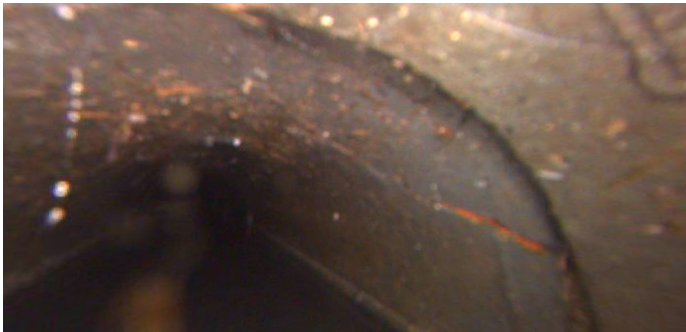
Code: **FC**  
Description: **Fracture Circumferential**

Distance (ft): **25.6**  
Structural Grade: **2**  
O&M Grade: **0**  
Clock Start/From: **12**  
Clock To: **2**  
1st Value:  
2nd Value:  
Value Percent:  
Continuous Index:  
Within 8" of Joint: **YES**  
Remarks:
