Profile/Photo Observation Report

Date:	04/18/2018	Weather:		Coding:	PACP 6.0
Pipe Length (ft):	299.7	Owner:	NA	Pre Clean:	Not Known
P.O.#:		Surveyor:	Byrd Fitzgerald	PSR:	P-706-029-018
Customer:		Clean Date:	01/01/1900	Shape:	C

Location Details:		Direction of Survey:	Upstream
US MH:	M-705-018	DS MH:	M-706-029
		Total Length Surveyed (ft):	26.6

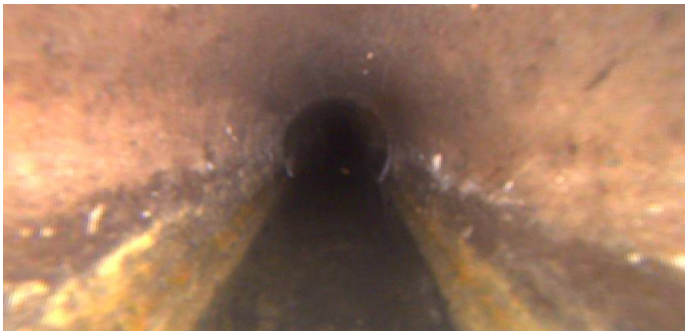
Code: **AMH**
Description: **Manhole**

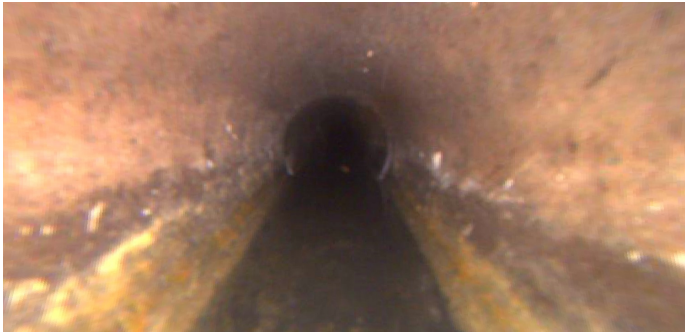
Code:	MWL
Description:	Water Level

Distance (ft):	.0
Structural Grade:	0
O&M Grade:	0
Clock Start/From:	
Clock To:	
1st Value:	
2nd Value:	
Value Percent:	5.000
Continuous Index:	
Within 8" of Joint:	NO
Remarks:

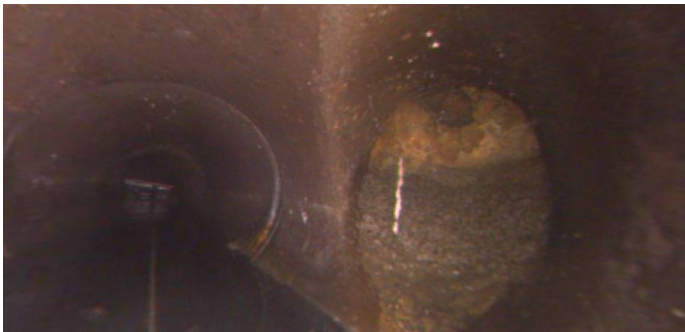
Code:	TFC
Description:	Tap Factory Capped

Distance (ft):	6.4
Structural Grade:	0
O&M Grade:	0
Clock Start/From:	9
Clock To:	
1st Value:	4.000
2nd Value:	
Value Percent:	
Continuous Index:	
Within 8" of Joint:	
Remarks:

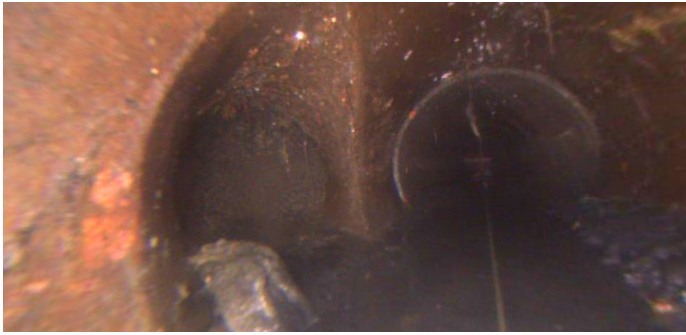
Code: **TFC**
Description: **Tap Factory Capped**

Distance (ft): **8.6**
Structural Grade: **0**
O&M Grade: **0**
Clock Start/From: **3**
Clock To:
1st Value: **4.000**
2nd Value:
Value Percent:
Continuous Index:
Within 8" of Joint:
Remarks:

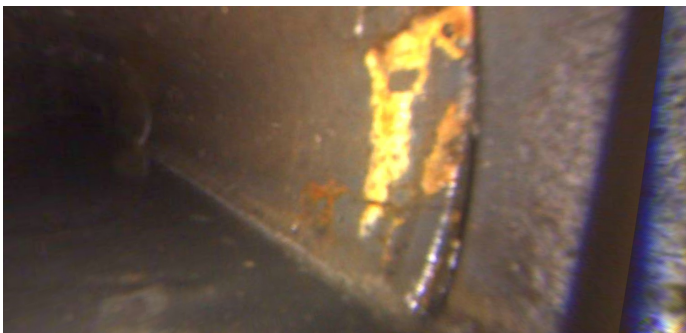
Code: **FM**
Description: **Fracture Multiple**

Distance (ft): **17.4**
Structural Grade: **4**
O&M Grade: **0**
Clock Start/From: **2**
Clock To: **4**
1st Value:
2nd Value:
Value Percent:
Continuous Index:
Within 8" of Joint: **YES**
Remarks:

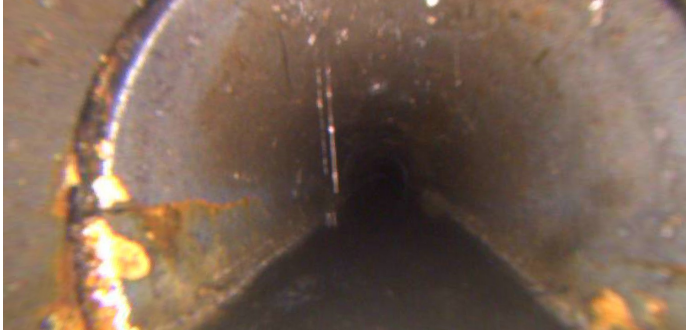
Code: **FM**
Description: **Fracture Multiple**

Distance (ft): **19.4**
Structural Grade: **4**
O&M Grade: **0**
Clock Start/From: **8**
Clock To: **4**
1st Value:
2nd Value:
Value Percent:
Continuous Index:
Within 8" of Joint: **YES**
Remarks:

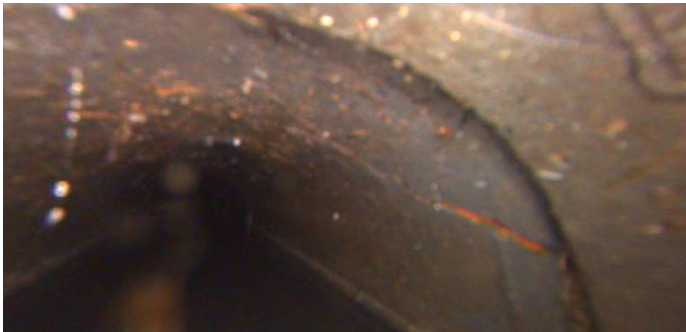
Code: **FC**
Description: **Fracture Circumferential**

Distance (ft): **25.6**
Structural Grade: **2**
O&M Grade: **0**
Clock Start/From: **12**
Clock To: **2**
1st Value:
2nd Value:
Value Percent:
Continuous Index:
Within 8" of Joint: **YES**
Remarks:
