Profile/Photo Observation Report

Date:	04/19/2018	Weather:		Coding:	PACP 6.0
Pipe Length (ft):	299.7	Owner:	NA	Pre Clean:	Not Known
P.O.#:		Surveyor:	Byrd Fitzgerald	PSR:	P-706-029-018
Customer:		Clean Date:	01/01/1900	Shape:	C

Street:	Capitol	Flow Control:	Not Controlled
City:	Hobart, IN	Year Renewed:	
Location:	Light Highway	Tape/Media #:	
Purpose:	Maintenance Related	Dia/Height:	8"
Use:	Sanitary	Material:	PVC
Drain Area:	NA	Lining:	Cured in Place
Category:	NA		
Comment:	Reverse setup. Roots at 99'.		
Location Details:		Direction of Survey:	Downstream
US MH:	M-705-018	DS MH:	M-706-029
		Total Length Surveyed (ft):	100.5

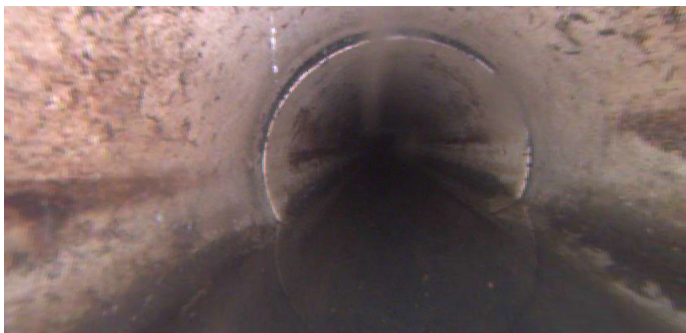
Code: **AMH**
Description: **Manhole**

Distance (ft): **.0**
Structural Grade: **0**
O&M Grade: **0**
Clock Start/From:
Clock To:
1st Value:
2nd Value:
Value Percent:
Continuous Index:
Within 8" of Joint: **NO**
Remarks: **M-705-018**

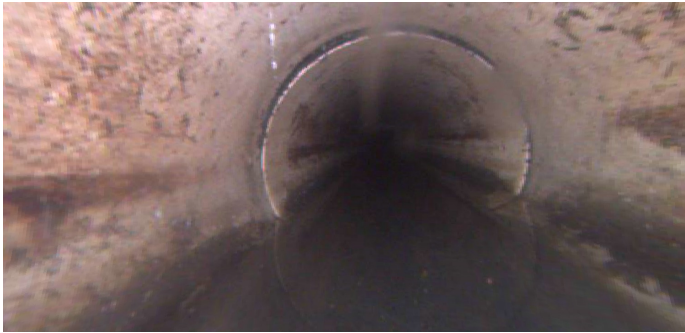
Code:	MWL
Description:	Water Level

Distance (ft):	.0
Structural Grade:	0
O&M Grade:	0
Clock Start/From:	
Clock To:	
1st Value:	
2nd Value:	
Value Percent:	5.000
Continuous Index:	
Within 8" of Joint:	NO
Remarks:

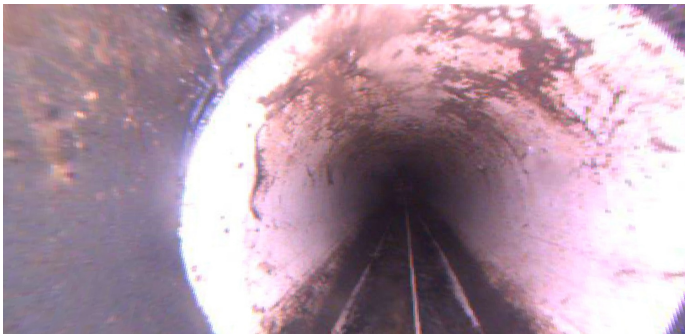
Code:	MMC
Description:	Material Change

Distance (ft):	10.0
Structural Grade:	0
O&M Grade:	0
Clock Start/From:	
Clock To:	
1st Value:	
2nd Value:	
Value Percent:	
Continuous Index:	
Within 8" of Joint:	NO
Remarks:	vcp

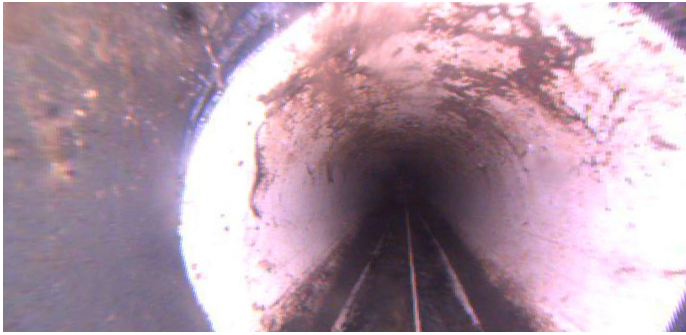
Code: **MGO**
Description: **General Observation**

Distance (ft): **10.0**
Structural Grade: **0**
O&M Grade: **0**
Clock Start/From:
Clock To:
1st Value:
2nd Value:
Value Percent:
Continuous Index:
Within 8" of Joint: **NO**
Remarks: **rear camera/cob webs**

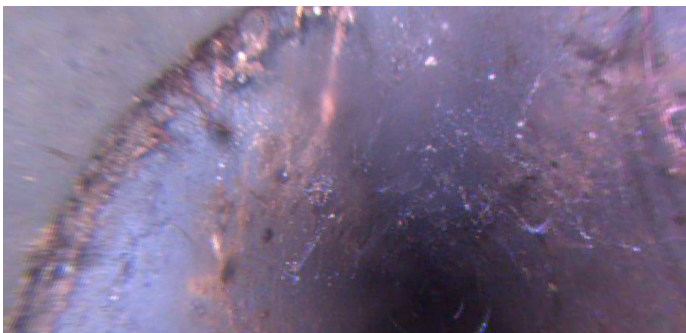
Code: **RFJ**
Description: **Roots Fine Joint**

Distance (ft): **17.8**
Structural Grade: **0**
O&M Grade: **1**
Clock Start/From: **7**
Clock To: **5**
1st Value:
2nd Value:
Value Percent:
Continuous Index: **S01**
Within 8" of Joint: **YES**
Remarks: **wandering**

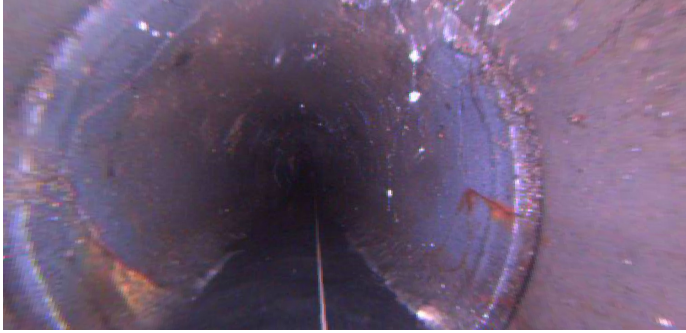
Code: **CM**
Description: **Crack Multiple**

Distance (ft): **26.1**
Structural Grade: **3**
O&M Grade: **0**
Clock Start/From: **7**
Clock To: **5**
1st Value:
2nd Value:
Value Percent:
Continuous Index: **S02**
Within 8" of Joint: **YES**
Remarks: **wandering**

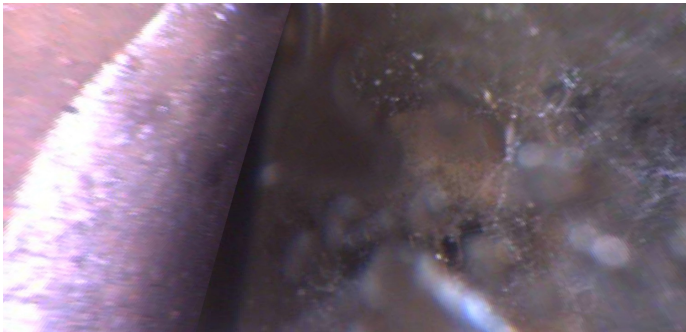
Code: **TFC**
Description: **Tap Factory Capped**

Distance (ft): **30.7**
Structural Grade: **0**
O&M Grade: **0**
Clock Start/From: **10**
Clock To:
1st Value: **4.000**
2nd Value:
Value Percent:
Continuous Index:
Within 8" of Joint: **YES**
Remarks:

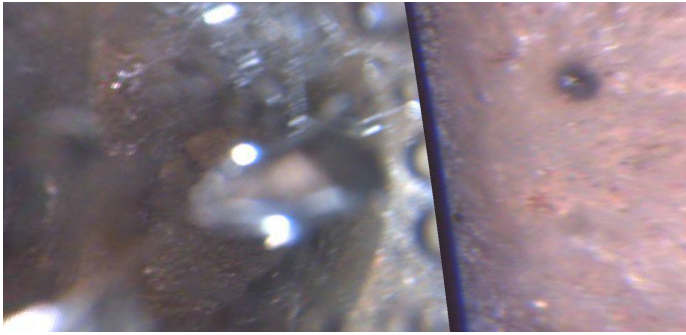
Code: **TFC**
Description: **Tap Factory Capped**

Distance (ft): **32.5**
Structural Grade: **0**
O&M Grade: **0**
Clock Start/From: **2**
Clock To:
1st Value: **4.000**
2nd Value:
Value Percent:
Continuous Index:
Within 8" of Joint: **YES**
Remarks:

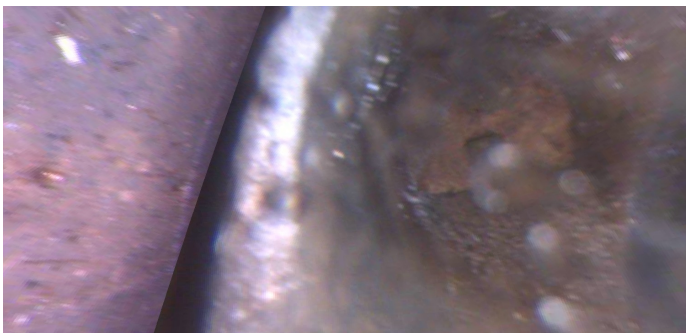
Code: **TFC**
Description: **Tap Factory Capped**

Distance (ft): **56.8**
Structural Grade: **0**
O&M Grade: **0**
Clock Start/From: **10**
Clock To:
1st Value: **4.000**
2nd Value:
Value Percent:
Continuous Index:
Within 8" of Joint: **YES**
Remarks:

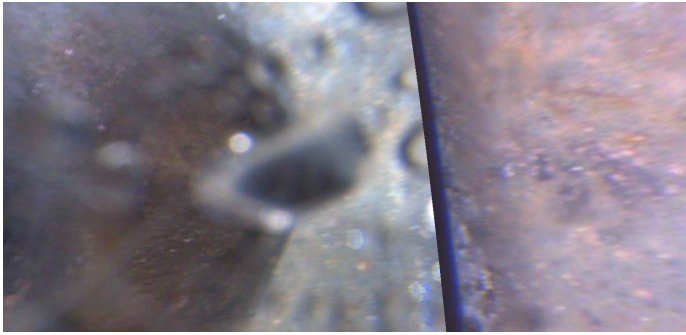
Code: **TFC**
Description: **Tap Factory Capped**

Distance (ft): **58.6**
Structural Grade: **0**
O&M Grade: **0**
Clock Start/From: **2**
Clock To:
1st Value: **4.000**
2nd Value:
Value Percent:
Continuous Index:
Within 8" of Joint: **YES**
Remarks:

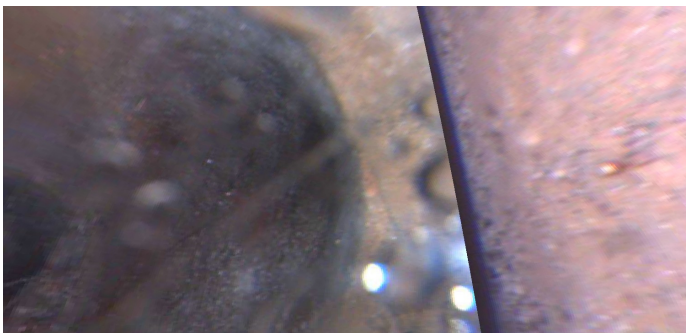
Code: **TFC**
Description: **Tap Factory Capped**

Distance (ft): **91.0**
Structural Grade: **0**
O&M Grade: **0**
Clock Start/From: **2**
Clock To:
1st Value: **4.000**
2nd Value:
Value Percent:
Continuous Index:
Within 8" of Joint: **YES**
Remarks: **or blocked?**

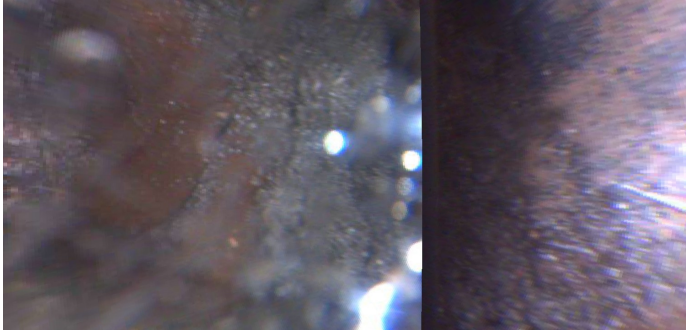
Code: **RFL**
Description: **Roots Fine Lateral**

Distance (ft): **91.5**
Structural Grade: **0**
O&M Grade: **1**
Clock Start/From: **9**
Clock To:
1st Value:
2nd Value:
Value Percent:
Continuous Index:
Within 8" of Joint: **NO**
Remarks:

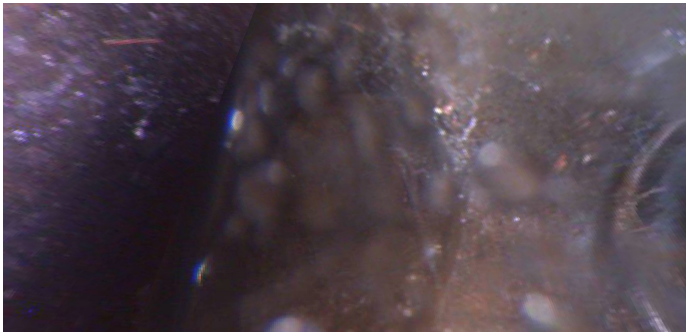
Code: **TFC**
Description: **Tap Factory Capped**

Distance (ft): **93.6**
Structural Grade: **0**
O&M Grade: **0**
Clock Start/From: **10**
Clock To:
1st Value: **4.000**
2nd Value:
Value Percent:
Continuous Index:
Within 8" of Joint: **YES**
Remarks:

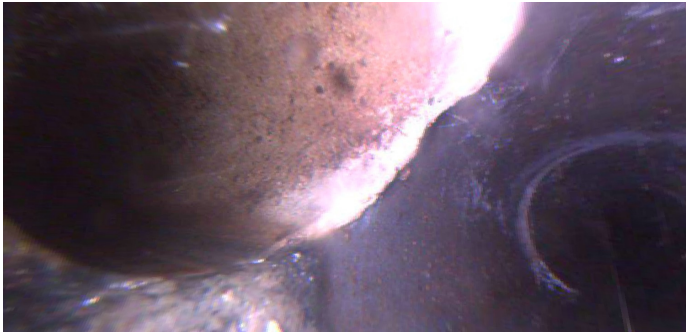
Code: **TB**
Description: **Tap Break-in**

Distance (ft): **96.0**
Structural Grade: **0**
O&M Grade: **0**
Clock Start/From: **2**
Clock To:
1st Value: **6.000**
2nd Value:
Value Percent:
Continuous Index:
Within 8" of Joint:
Remarks:

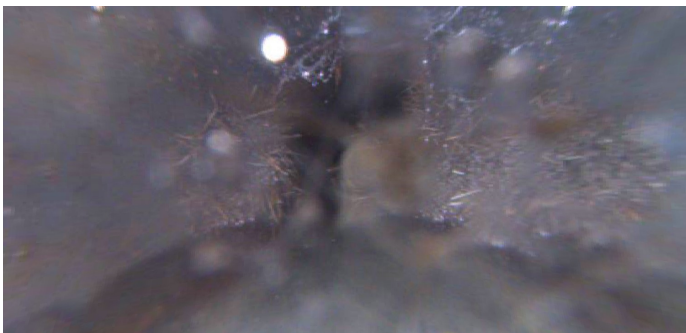
Code: **RBJ**
Description: **Roots Ball Joint**

Distance (ft): **99.5**
Structural Grade: **0**
O&M Grade: **4**
Clock Start/From: **7**
Clock To: **5**
1st Value:
2nd Value:
Value Percent: **55.000**
Continuous Index:
Within 8" of Joint: **YES**
Remarks:

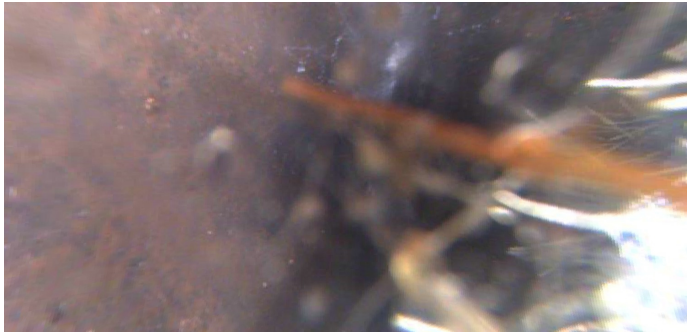
Code:	MSA
Description:	Abandoned Survey
Distance (ft):	100.5
Structural Grade:	0
O&M Grade:	0
Clock Start/From:	
Clock To:	
1st Value:	
2nd Value:	
Value Percent:	
Continuous Index:	
Within 8" of Joint:	NO
Remarks:	rbj

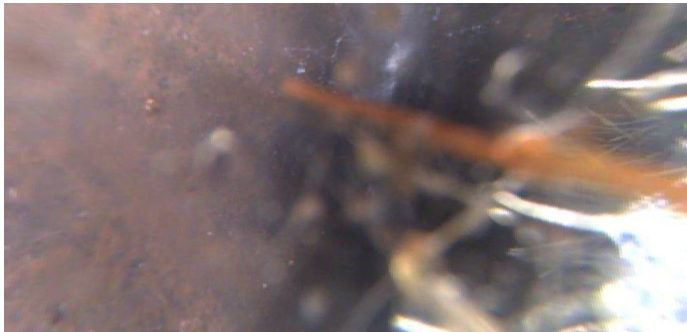
Code:	CM
Description:	Crack Multiple
Distance (ft):	100.5
Structural Grade:	3
O&M Grade:	0
Clock Start/From:	7
Clock To:	5
1st Value:	
2nd Value:	
Value Percent:	
Continuous Index:	F02
Within 8" of Joint:	YES
Remarks:	wandering

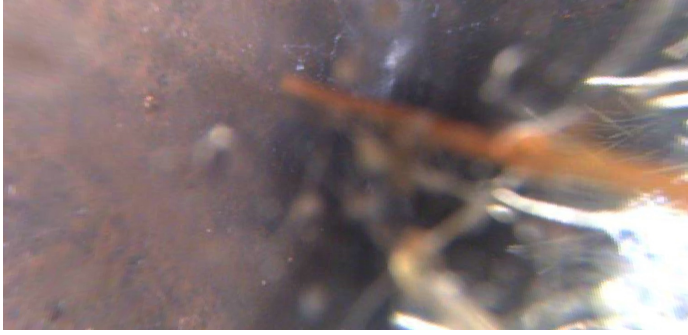
Code:	RFJ
Description:	Roots Fine Joint
Distance (ft):	100.5
Structural Grade:	0
O&M Grade:	1
Clock Start/From:	7
Clock To:	5
1st Value:	
2nd Value:	
Value Percent:	
Continuous Index:	F01
Within 8" of Joint:	YES
Remarks:	wandering
