## Profile/Photo Observation Report

Street:	<b>E 6TH ST &amp; LAKE ST</b>	Flow Control:	<b>Not Controlled</b>
City:	<b>Hobart, IN</b>	Year Renewed:	
Location:	<b>Light Highway</b>	Tape/Media #:	
Purpose:	<b>Maintenance Related</b>	Dia/Height:	<b>8"</b>
Use:	<b>Sanitary</b>	Material:	<b>VCP</b>
Drain Area:	<b>NA</b>	Lining:	<b>Cured in Place</b>
Category:	<b>NA</b>		
Comment:	<b>sludge and debris at 73'.</b>

Location Details:		Direction of Survey:	<b>Upstream</b>
US MH:	<b>M-705-019</b>	DS MH:	<b>M-705-020</b>
		Total Length Surveyed (ft):	<b>74.4</b>

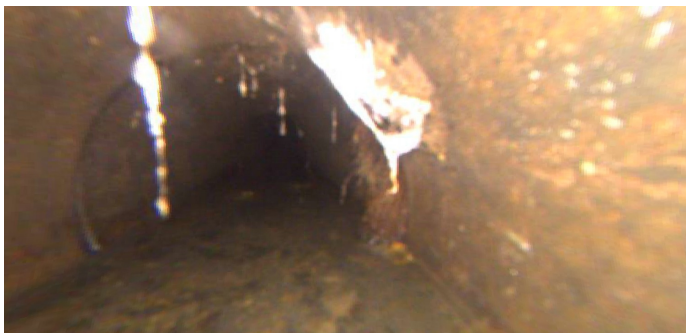
Code: **AMH**  
Description: **Manhole**

Distance (ft): **.0**  
Structural Grade: **0**  
O&M Grade: **0**  
Clock Start/From:  
Clock To:  
1st Value:  
2nd Value:  
Value Percent:  
Continuous Index:  
Within 8" of Joint: **NO**  
Remarks: **M-705-020**

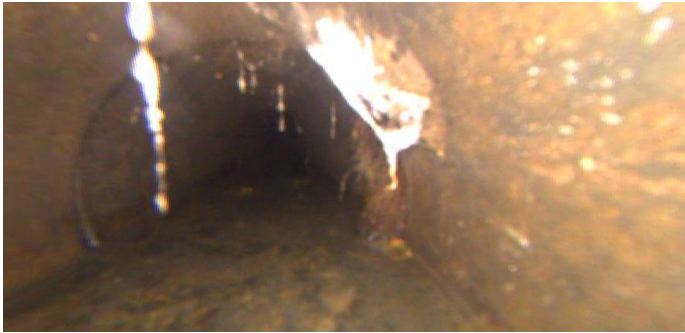
Code:	<b>MWL</b>
Description:	<b>Water Level</b>

Distance (ft):	<b>.0</b>
Structural Grade:	<b>0</b>
O&M Grade:	<b>0</b>
Clock Start/From:	
Clock To:	
1st Value:	
2nd Value:	
Value Percent:	<b>5.000</b>
Continuous Index:	
Within 8" of Joint:	<b>NO</b>
Remarks:

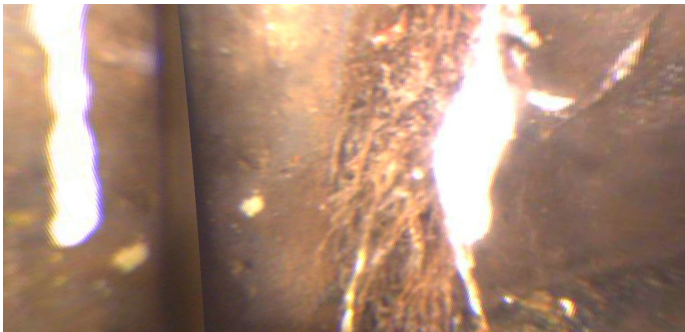
Code:	<b>RFJ</b>
Description:	<b>Roots Fine Joint</b>

Distance (ft):	<b>1.8</b>
Structural Grade:	<b>0</b>
O&M Grade:	<b>1</b>
Clock Start/From:	<b>1</b>
Clock To:	<b>5</b>
1st Value:	
2nd Value:	
Value Percent:	
Continuous Index:	<b>S01</b>
Within 8" of Joint:	<b>YES</b>
Remarks:	<b>wandering</b>

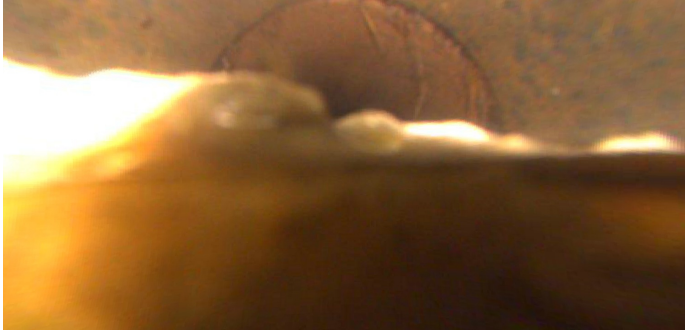
Code: **MWL**  
Description: **Water Level**

Distance (ft): **28.3**  
Structural Grade: **0**  
O&M Grade: **0**  
Clock Start/From:  
Clock To:  
1st Value:  
2nd Value:  
Value Percent: **50.000**  
Continuous Index:  
Within 8" of Joint: **NO**  
Remarks:

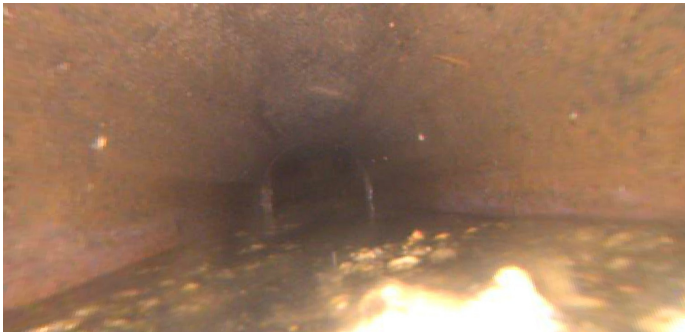
Code: **MGO**  
Description: **General Observation**

Distance (ft): **39.3**  
Structural Grade: **0**  
O&M Grade: **0**  
Clock Start/From:  
Clock To:  
1st Value:  
2nd Value:  
Value Percent:  
Continuous Index:  
Within 8" of Joint: **NO**  
Remarks: **rear camera/mcu**

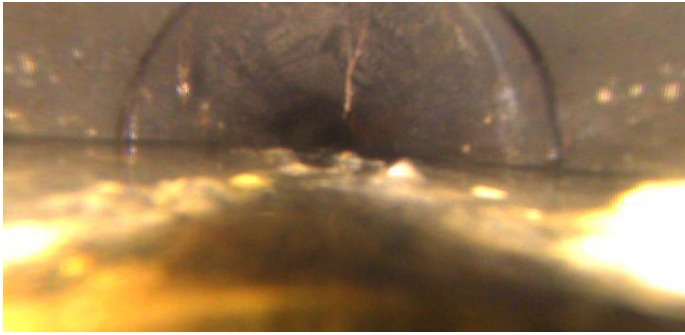
Code: **MSA**  
Description: **Abandoned Survey**

Distance (ft): **74.4**  
Structural Grade: **0**  
O&M Grade: **0**  
Clock Start/From:  
Clock To:  
1st Value:  
2nd Value:  
Value Percent:  
Continuous Index:  
Within 8" of Joint: **NO**  
Remarks: **camera stopped/stuck in debris?**

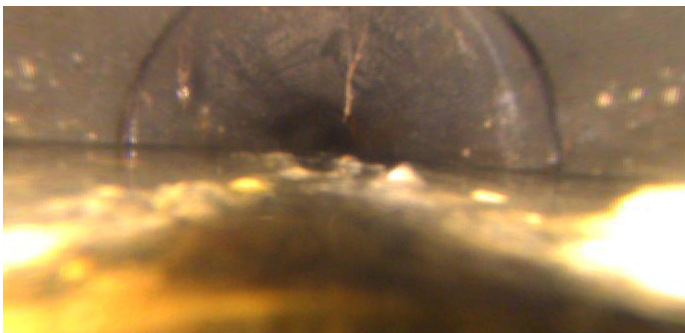
Code: **RFJ**  
Description: **Roots Fine Joint**

Distance (ft): **74.4**  
Structural Grade: **0**  
O&M Grade: **1**  
Clock Start/From: **1**  
Clock To: **5**  
1st Value:  
2nd Value:  
Value Percent:  
Continuous Index: **F01**  
Within 8" of Joint: **YES**  
Remarks: **wandering**
