Profile/Photo Observation Report

Date:	04/19/2018	Weather:		Coding:	PACP 6.0
Pipe Length (ft):	166.1	Owner:	NA	Pre Clean:	Not Known
P.O.#:		Surveyor:	Byrd Fitzgerald	PSR:	P-705-020-019
Customer:		Clean Date:	01/01/1900	Shape:	C

Street:	Capitol	Flow Control:	Not Controlled
City:	Hobart, IN	Year Renewed:	
Location:	Light Highway	Tape/Media #:	
Purpose:	Maintenance Related	Dia/Height:	8"
Use:	Sanitary	Material:	VCP
Drain Area:	NA	Lining:	Cured in Place
Category:	NA		
Comment:	sludge and debris at 73'.		
Location Details:		Direction of Survey:	Upstream
US MH:	M-705-019	DS MH:	M-705-020
		Total Length Surveyed (ft):	74.4

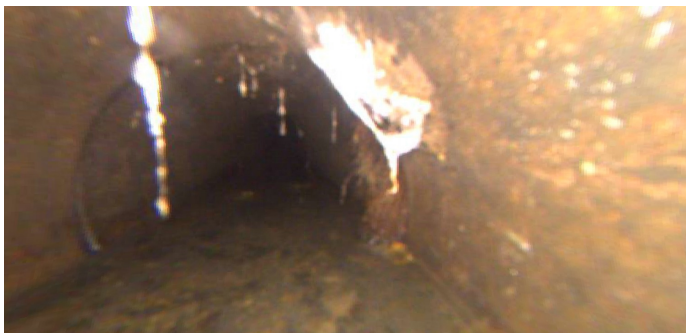
Code: **AMH**
Description: **Manhole**

Distance (ft): **.0**
Structural Grade: **0**
O&M Grade: **0**
Clock Start/From:
Clock To:
1st Value:
2nd Value:
Value Percent:
Continuous Index:
Within 8" of Joint: **NO**
Remarks: **M-705-020**

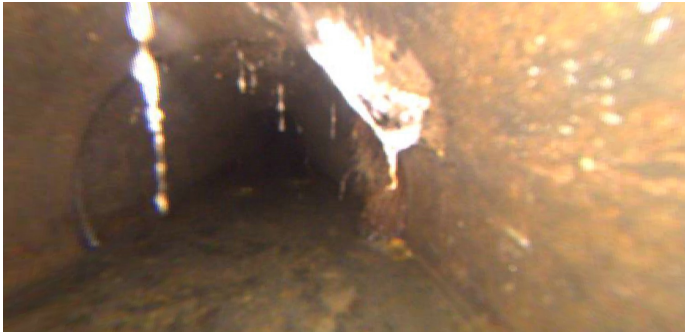
Code:	MWL
Description:	Water Level

Distance (ft):	.0
Structural Grade:	0
O&M Grade:	0
Clock Start/From:	
Clock To:	
1st Value:	
2nd Value:	
Value Percent:	5.000
Continuous Index:	
Within 8" of Joint:	NO
Remarks:

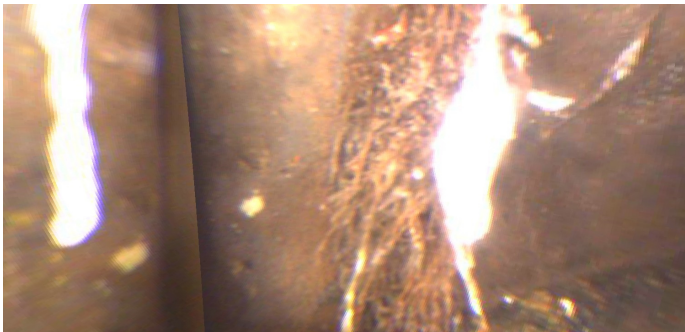
Code:	RFJ
Description:	Roots Fine Joint

Distance (ft):	1.8
Structural Grade:	0
O&M Grade:	1
Clock Start/From:	1
Clock To:	5
1st Value:	
2nd Value:	
Value Percent:	
Continuous Index:	S01
Within 8" of Joint:	YES
Remarks:	wandering

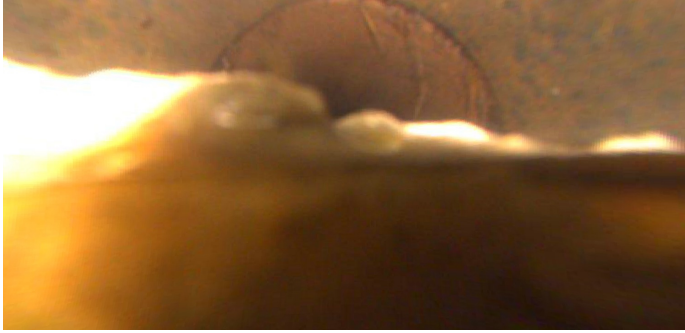
Code: **MWL**
Description: **Water Level**

Distance (ft): **28.3**
Structural Grade: **0**
O&M Grade: **0**
Clock Start/From:
Clock To:
1st Value:
2nd Value:
Value Percent: **50.000**
Continuous Index:
Within 8" of Joint: **NO**
Remarks:

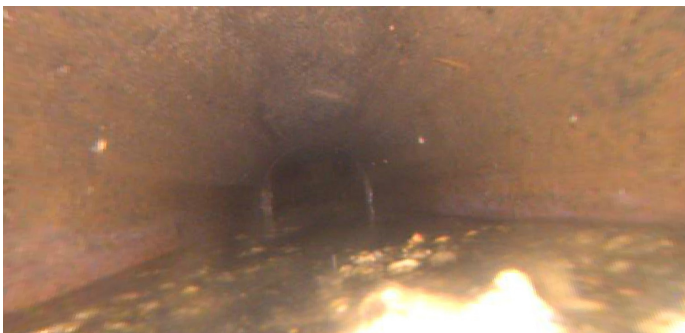
Code: **MGO**
Description: **General Observation**

Distance (ft): **39.3**
Structural Grade: **0**
O&M Grade: **0**
Clock Start/From:
Clock To:
1st Value:
2nd Value:
Value Percent:
Continuous Index:
Within 8" of Joint: **NO**
Remarks: **rear camera/mcu**

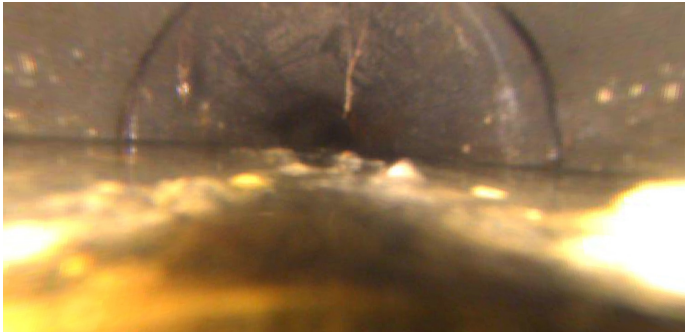
Code: **MSA**
Description: **Abandoned Survey**

Distance (ft): **74.4**
Structural Grade: **0**
O&M Grade: **0**
Clock Start/From:
Clock To:
1st Value:
2nd Value:
Value Percent:
Continuous Index:
Within 8" of Joint: **NO**
Remarks: **camera stopped/stuck in debris?**

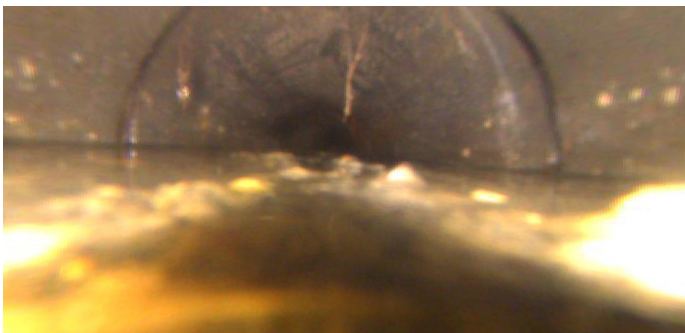
Code: **RFJ**
Description: **Roots Fine Joint**

Distance (ft): **74.4**
Structural Grade: **0**
O&M Grade: **1**
Clock Start/From: **1**
Clock To: **5**
1st Value:
2nd Value:
Value Percent:
Continuous Index: **F01**
Within 8" of Joint: **YES**
Remarks: **wandering**
