Profile/Photo Observation Report

Date:	04/21/2018	Weather:		Coding:	PACP 6.0
Pipe Length (ft):	267.7	Owner:	NA	Pre Clean:	Not Known
P.O.#:		Surveyor:	Mark Ruby	PSR:	P-705-022-019
Customer:		Clean Date:	01/01/1900	Shape:	C

Street:	E 6TH ST & LAKE ST	Flow Control:	Not Controlled
City:	Hobart, IN	Year Renewed:	
Location:	Light Highway	Tape/Media #:	
Purpose:	Maintenance Related	Dia/Height:	8"
Use:	Sanitary	Material:	VCP
Drain Area:	NA	Lining:	Cured in Place
Category:	NA		
Comment:	Roots at 109'.-flow reversed.		
Location Details:		Direction of Survey:	Upstream
US MH:	M-705-019	DS MH:	M-705-022
		Total Length Surveyed (ft):	111.0

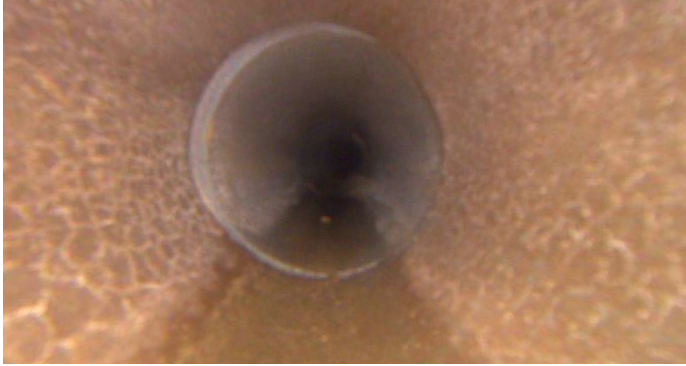
Code: **AMH**
Description: **Manhole**

Distance (ft): **.0**
Structural Grade: **0**
O&M Grade: **0**
Clock Start/From:
Clock To:
1st Value:
2nd Value:
Value Percent:
Continuous Index:
Within 8" of Joint: **NO**
Remarks: **M-705-022**

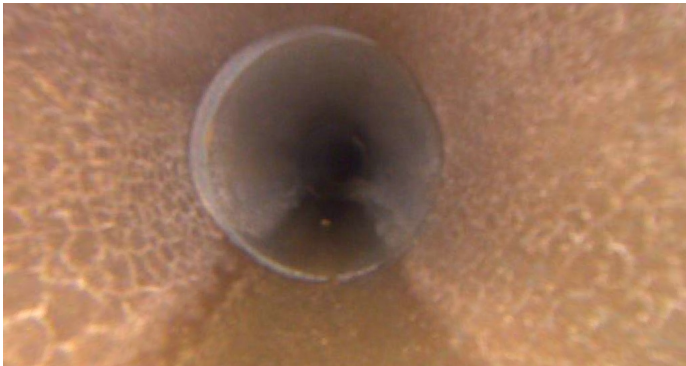
Code: **MWL**
Description: **Water Level**

Distance (ft): **.0**
Structural Grade: **0**
O&M Grade: **0**
Clock Start/From:
Clock To:
1st Value:
2nd Value:
Value Percent: **10.000**
Continuous Index:
Within 8" of Joint: **NO**
Remarks:

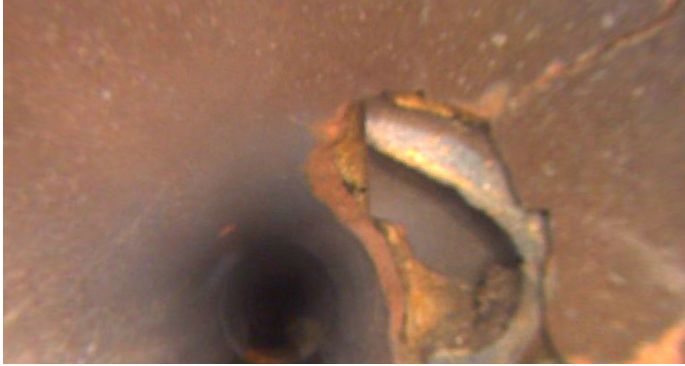
Code: **CM**
Description: **Crack Multiple**

Distance (ft): **3.8**
Structural Grade: **3**
O&M Grade: **0**
Clock Start/From: **1**
Clock To: **5**
1st Value:
2nd Value:
Value Percent:
Continuous Index:
Within 8" of Joint:
Remarks:

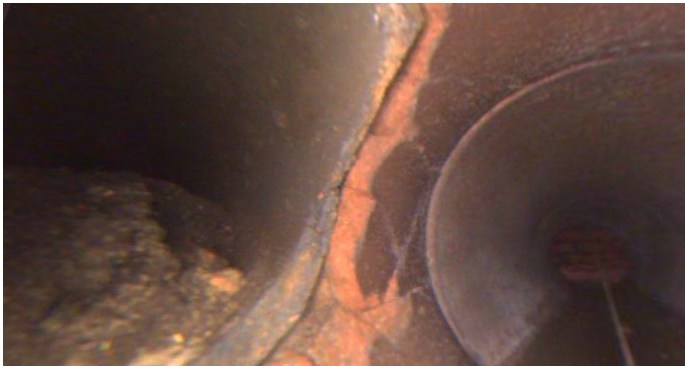
Code: **TB**
Description: **Tap Break-in**

Distance (ft): **4.6**
Structural Grade: **0**
O&M Grade: **0**
Clock Start/From: **3**
Clock To:
1st Value: **4.000**
2nd Value:
Value Percent:
Continuous Index:
Within 8" of Joint:
Remarks:

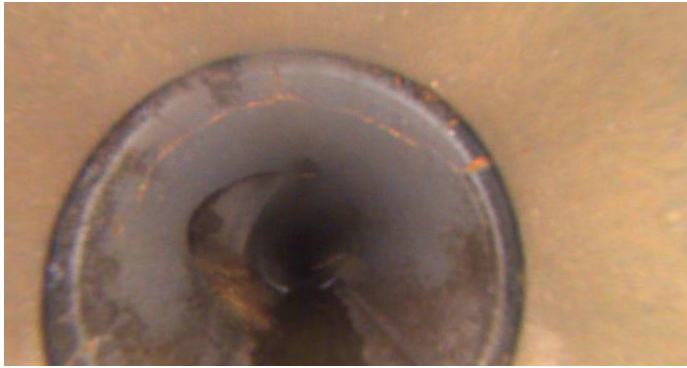
Code: **CM**
Description: **Crack Multiple**

Distance (ft): **17.8**
Structural Grade: **3**
O&M Grade: **0**
Clock Start/From: **9**
Clock To: **3**
1st Value:
2nd Value:
Value Percent:
Continuous Index:
Within 8" of Joint: **YES**
Remarks:

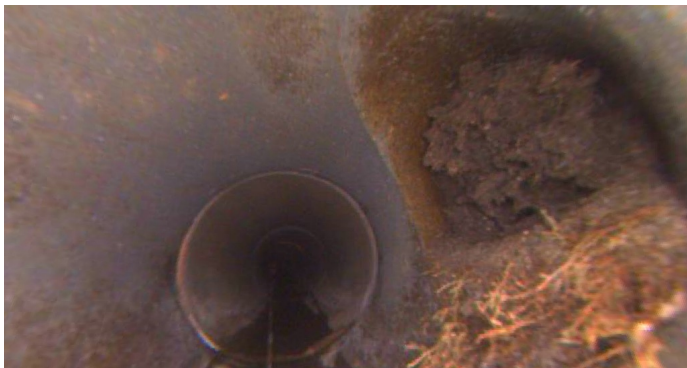
Code: **TFD**
Description: **Tap Factory Defective**

Distance (ft): **19.7**
Structural Grade: **0**
O&M Grade: **2**
Clock Start/From: **9**
Clock To:
1st Value: **4.000**
2nd Value:
Value Percent:
Continuous Index:
Within 8" of Joint:
Remarks: **Debris**

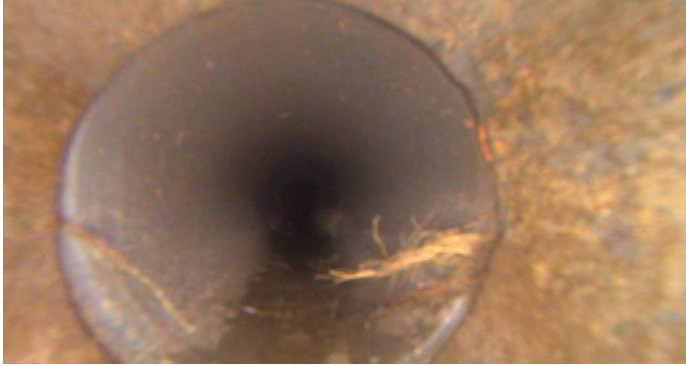
Code: **RFJ**
Description: **Roots Fine Joint**

Distance (ft): **19.9**
Structural Grade: **0**
O&M Grade: **1**
Clock Start/From: **7**
Clock To: **5**
1st Value:
2nd Value:
Value Percent:
Continuous Index: **S01**
Within 8" of Joint: **YES**
Remarks:

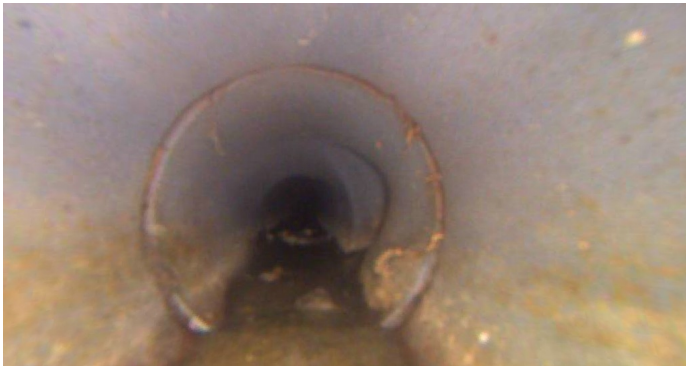
Code: **RFJ**
Description: **Roots Fine Joint**

Distance (ft): **38.5**
Structural Grade: **0**
O&M Grade: **1**
Clock Start/From: **7**
Clock To: **5**
1st Value:
2nd Value:
Value Percent:
Continuous Index: **F01**
Within 8" of Joint: **YES**
Remarks:

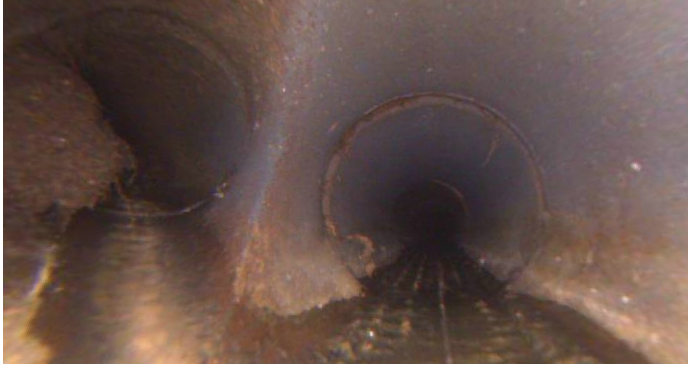
Code: **TF**
Description: **Tap Factory**

Distance (ft): **40.4**
Structural Grade: **0**
O&M Grade: **0**
Clock Start/From: **3**
Clock To:
1st Value: **4.000**
2nd Value:
Value Percent:
Continuous Index:
Within 8" of Joint:
Remarks:

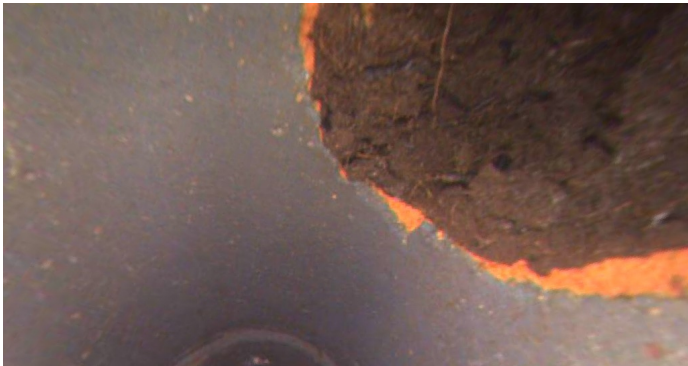
Code: **TBD**
Description: **Tap Break-in Defective**

Distance (ft): **44.6**
Structural Grade: **0**
O&M Grade: **3**
Clock Start/From: **10**
Clock To:
1st Value: **4.000**
2nd Value:
Value Percent:
Continuous Index:
Within 8" of Joint:
Remarks: **Debris**

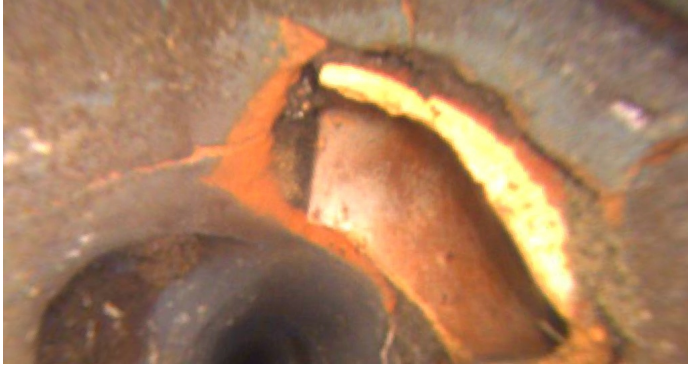
Code: **CM**
Description: **Crack Multiple**

Distance (ft): **45.3**
Structural Grade: **3**
O&M Grade: **0**
Clock Start/From: **2**
Clock To: **4**
1st Value:
2nd Value:
Value Percent:
Continuous Index:
Within 8" of Joint:
Remarks:

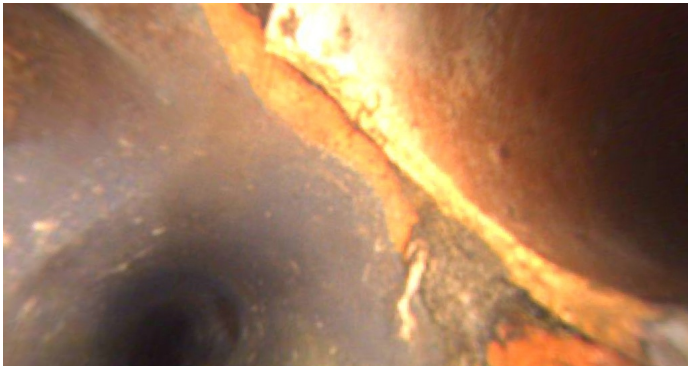
Code: **TB**
Description: **Tap Break-in**

Distance (ft): **45.8**
Structural Grade: **0**
O&M Grade: **0**
Clock Start/From: **2**
Clock To:
1st Value: **4.000**
2nd Value:
Value Percent:
Continuous Index:
Within 8" of Joint:
Remarks:

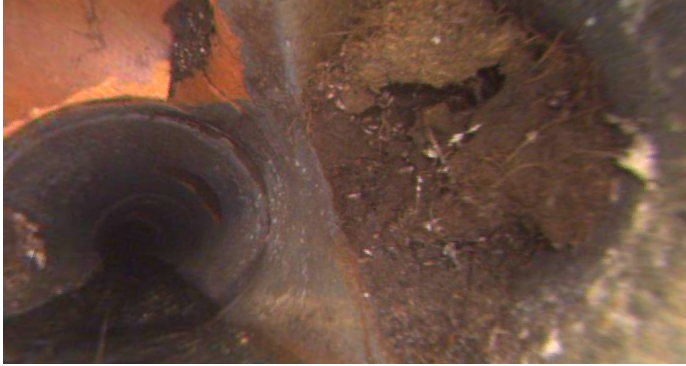
Code: **TFD**
Description: **Tap Factory Defective**

Distance (ft): **46.6**
Structural Grade: **0**
O&M Grade: **2**
Clock Start/From: **9**
Clock To:
1st Value: **4.000**
2nd Value:
Value Percent:
Continuous Index:
Within 8" of Joint:
Remarks: **Roots**

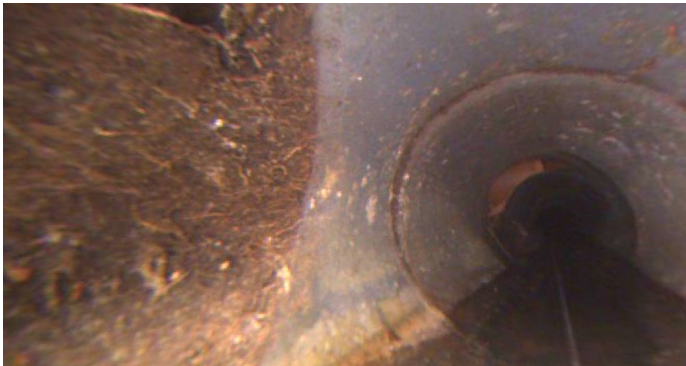
Code: **TFD**
Description: **Tap Factory Defective**

Distance (ft): **48.5**
Structural Grade: **0**
O&M Grade: **2**
Clock Start/From: **4**
Clock To:
1st Value: **4.000**
2nd Value:
Value Percent:
Continuous Index:
Within 8" of Joint:
Remarks: **RML**

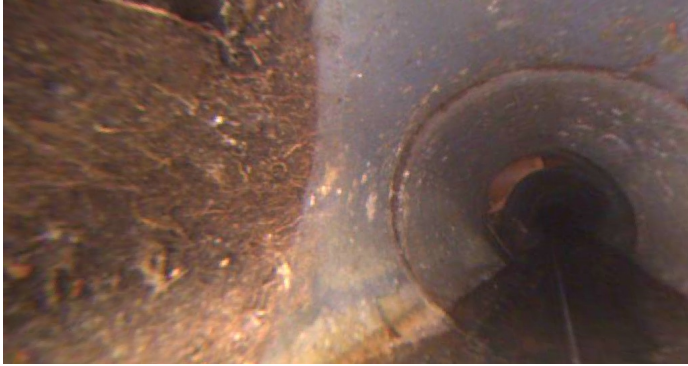
Code: **RML**
Description: **Roots Medium Lateral**

Distance (ft): **48.5**
Structural Grade: **0**
O&M Grade: **3**
Clock Start/From: **4**
Clock To:
1st Value:
2nd Value:
Value Percent: **30.000**
Continuous Index:
Within 8" of Joint: **NO**
Remarks:

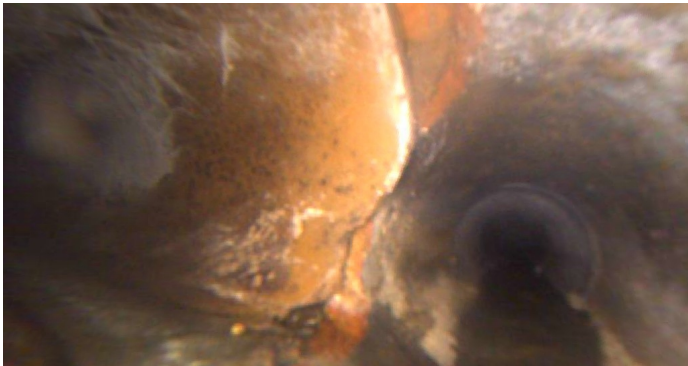
Code: **TB**
Description: **Tap Break-in**

Distance (ft): **56.0**
Structural Grade: **0**
O&M Grade: **0**
Clock Start/From: **9**
Clock To:
1st Value: **4.000**
2nd Value:
Value Percent:
Continuous Index:
Within 8" of Joint:
Remarks:

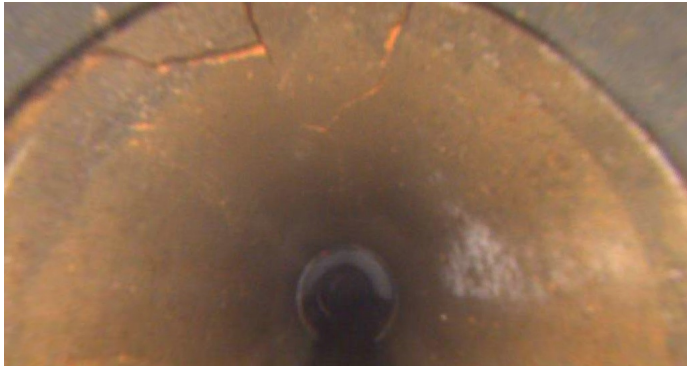
Code: **CM**
Description: **Crack Multiple**

Distance (ft): **61.7**
Structural Grade: **3**
O&M Grade: **0**
Clock Start/From: **7**
Clock To: **1**
1st Value:
2nd Value:
Value Percent:
Continuous Index:
Within 8" of Joint: **YES**
Remarks:

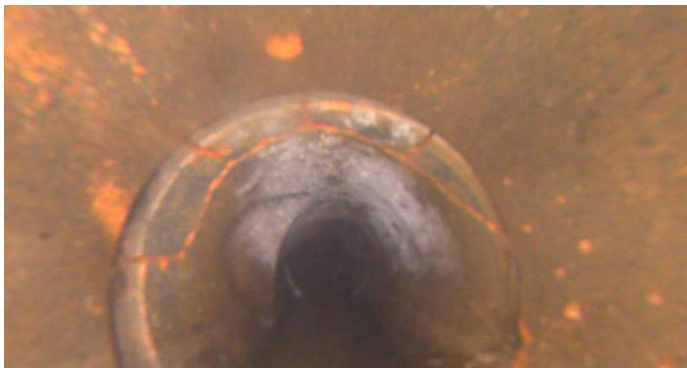
Code: **FM**
Description: **Fracture Multiple**

Distance (ft): **67.7**
Structural Grade: **4**
O&M Grade: **0**
Clock Start/From: **8**
Clock To: **4**
1st Value:
2nd Value:
Value Percent:
Continuous Index:
Within 8" of Joint: **YES**
Remarks:

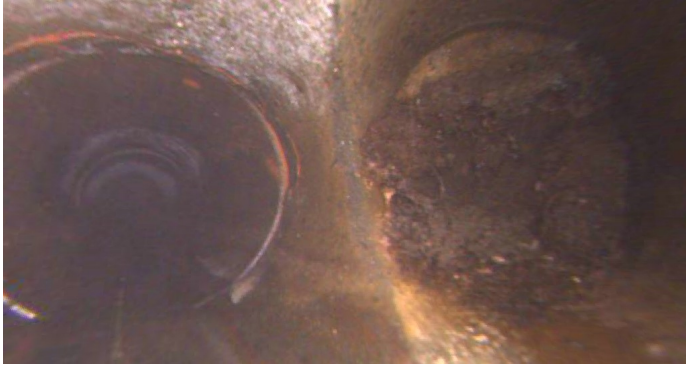
Code: **TFC**
Description: **Tap Factory Capped**

Distance (ft): **69.3**
Structural Grade: **0**
O&M Grade: **0**
Clock Start/From: **8**
Clock To:
1st Value: **4.000**
2nd Value:
Value Percent:
Continuous Index:
Within 8" of Joint:
Remarks:

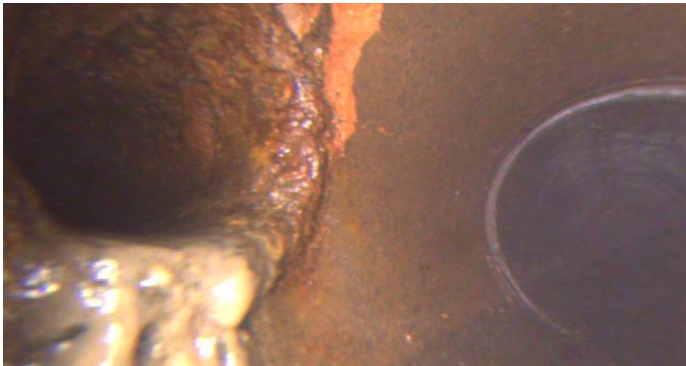
Code: **TB**
Description: **Tap Break-in**

Distance (ft): **75.8**
Structural Grade: **0**
O&M Grade: **0**
Clock Start/From: **4**
Clock To:
1st Value: **4.000**
2nd Value:
Value Percent:
Continuous Index:
Within 8" of Joint:
Remarks:

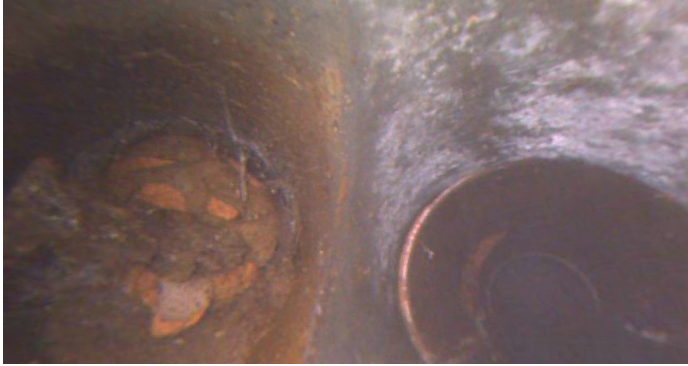
Code: **TFC**
Description: **Tap Factory Capped**

Distance (ft): **77.6**
Structural Grade: **0**
O&M Grade: **0**
Clock Start/From: **4**
Clock To:
1st Value: **4.000**
2nd Value:
Value Percent:
Continuous Index:
Within 8" of Joint:
Remarks:

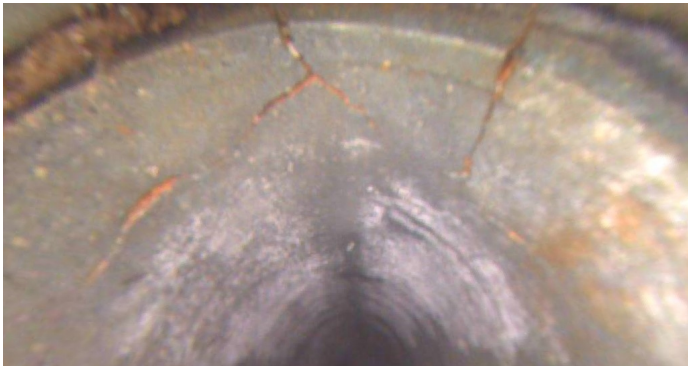
Code: **CM**
Description: **Crack Multiple**

Distance (ft): **80.5**
Structural Grade: **3**
O&M Grade: **0**
Clock Start/From: **10**
Clock To: **1**
1st Value:
2nd Value:
Value Percent:
Continuous Index:
Within 8" of Joint: **YES**
Remarks:

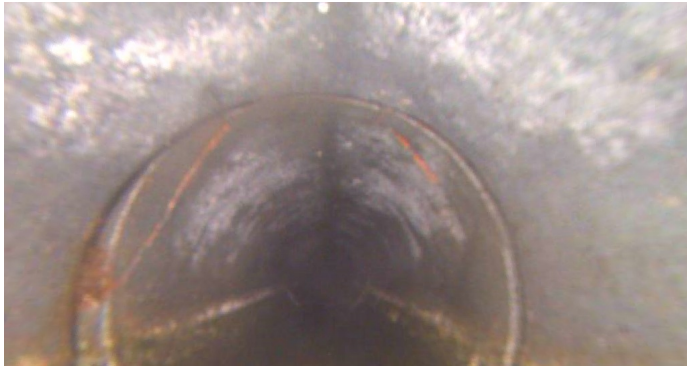
Code: **CS**
Description: **Crack Spiral**

Distance (ft): **82.3**
Structural Grade: **2**
O&M Grade: **0**
Clock Start/From: **8**
Clock To: **3**
1st Value:
2nd Value:
Value Percent:
Continuous Index:
Within 8" of Joint: **YES**
Remarks:

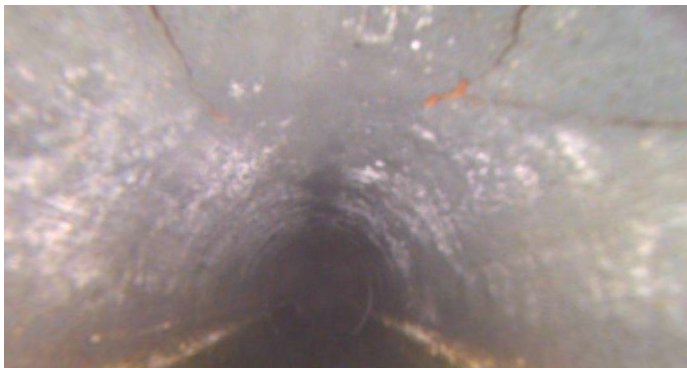
Code: **CM**
Description: **Crack Multiple**

Distance (ft): **84.7**
Structural Grade: **3**
O&M Grade: **0**
Clock Start/From: **7**
Clock To: **5**
1st Value:
2nd Value:
Value Percent:
Continuous Index: **S02**
Within 8" of Joint:
Remarks:

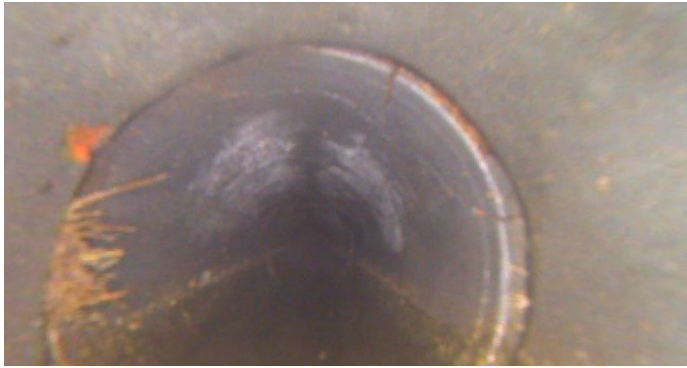
Code: **RFJ**
Description: **Roots Fine Joint**

Distance (ft): **90.6**
Structural Grade: **0**
O&M Grade: **1**
Clock Start/From: **7**
Clock To: **9**
1st Value:
2nd Value:
Value Percent:
Continuous Index:
Within 8" of Joint: **YES**
Remarks:

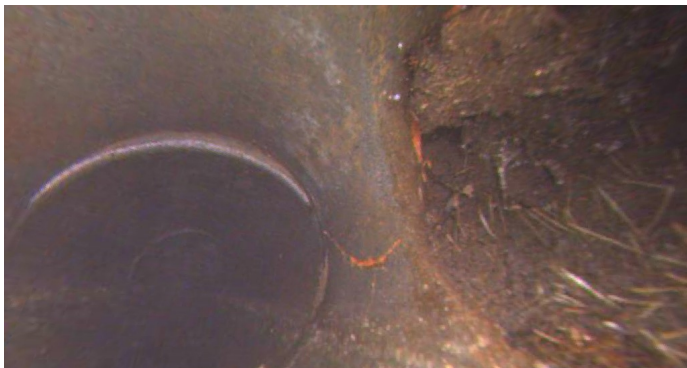
Code: **TFD**
Description: **Tap Factory Defective**

Distance (ft): **100.3**
Structural Grade: **0**
O&M Grade: **2**
Clock Start/From: **10**
Clock To:
1st Value: **4.000**
2nd Value:
Value Percent:
Continuous Index:
Within 8" of Joint:
Remarks: **Roots**

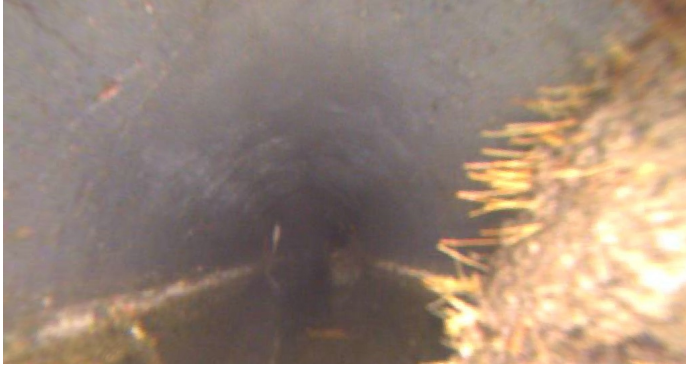
Code: **RFJ**
Description: **Roots Fine Joint**

Distance (ft): **103.1**
Structural Grade: **0**
O&M Grade: **1**
Clock Start/From: **7**
Clock To: **5**
1st Value:
2nd Value:
Value Percent:
Continuous Index: **S03**
Within 8" of Joint: **YES**
Remarks:

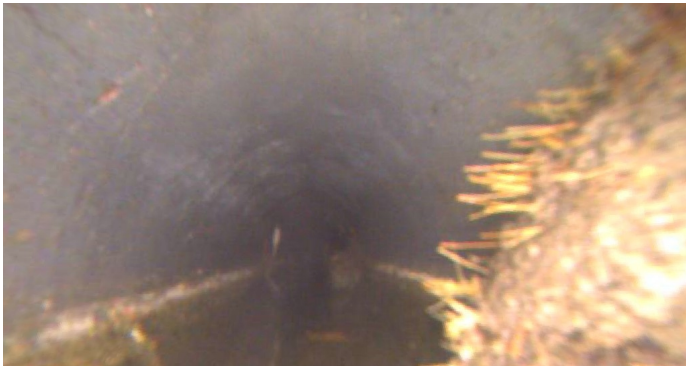
Code: **CM**
Description: **Crack Multiple**

Distance (ft): **103.1**
Structural Grade: **3**
O&M Grade: **0**
Clock Start/From: **7**
Clock To: **5**
1st Value:
2nd Value:
Value Percent:
Continuous Index: **F02**
Within 8" of Joint:
Remarks:

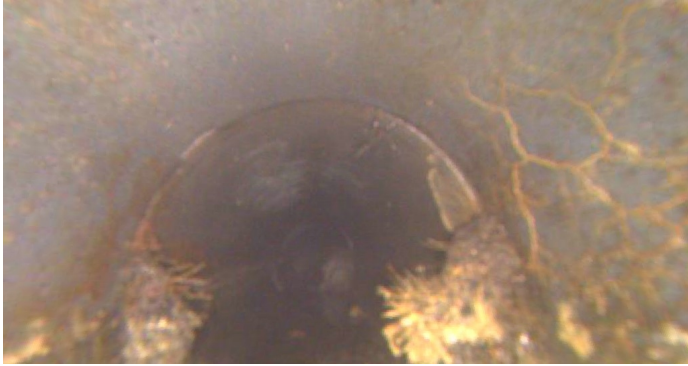
Code: **RFJ**
Description: **Roots Fine Joint**

Distance (ft): **111.0**
Structural Grade: **0**
O&M Grade: **1**
Clock Start/From: **7**
Clock To: **5**
1st Value:
2nd Value:
Value Percent:
Continuous Index: **F03**
Within 8" of Joint: **YES**
Remarks:

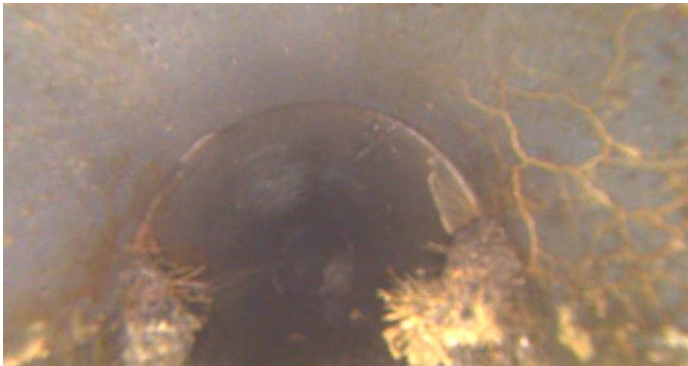
Code: **MSA**
Description: **Abandoned Survey**

Distance (ft): **111.0**
Structural Grade: **0**
O&M Grade: **0**
Clock Start/From:
Clock To:
1st Value:
2nd Value:
Value Percent:
Continuous Index:
Within 8" of Joint: **NO**
Remarks: **RFJ**
