## Profile/Photo Observation Report

Date:	<b>04/21/2018</b>	Weather:		Coding:	<b>PACP 6.0</b>
Pipe Length (ft):	<b>267.7</b>	Owner:	<b>NA</b>	Pre Clean:	<b>Not Known</b>
P.O.#:		Surveyor:	<b>Mark Ruby</b>	PSR:	<b>P-705-022-019</b>
Customer:		Clean Date:	<b>01/01/1900</b>	Shape:	<b>C</b>

Street:	<b>E 6TH ST &amp; LAKE ST</b>	Flow Control:	<b>Not Controlled</b>
City:	<b>Hobart, IN</b>	Year Renewed:	
Location:	<b>Light Highway</b>	Tape/Media #:	
Purpose:	<b>Maintenance Related</b>	Dia/Height:	<b>8"</b>
Use:	<b>Sanitary</b>	Material:	<b>VCP</b>
Drain Area:	<b>NA</b>	Lining:	<b>Cured in Place</b>
Category:	<b>NA</b>		
Comment:	<b>Reverse setup. Roots at 118'-flow is incorrect.</b>		
Location Details:		Direction of Survey:	<b>Downstream</b>
US MH:	<b>M-705-019</b>	DS MH:	<b>M-705-022</b>
		Total Length Surveyed (ft):	<b>119.2</b>

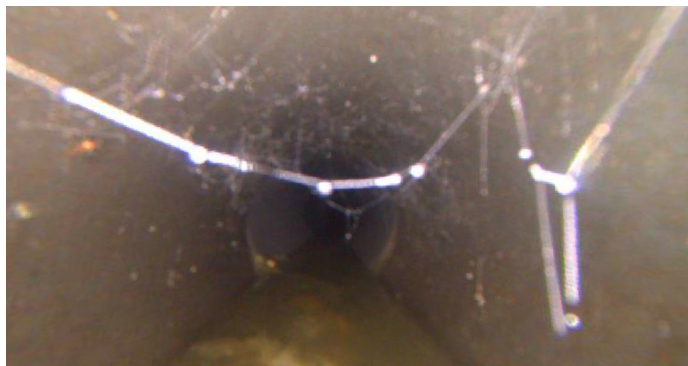
Code: **AMH**  
 Description: **Manhole**

Distance (ft): **.0**  
 Structural Grade: **0**  
 O&M Grade: **0**  
 Clock Start/From:  
 Clock To:  
 1st Value:  
 2nd Value:  
 Value Percent:  
 Continuous Index:  
 Within 8" of Joint: **NO**  
 Remarks: **M-705-019**

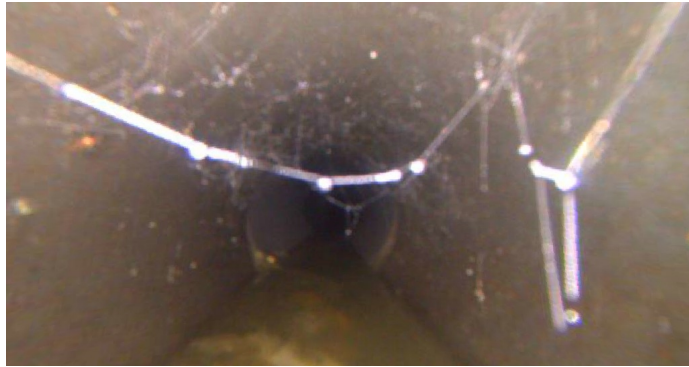
Code: **MWL**  
Description: **Water Level**

Distance (ft): **.0**  
Structural Grade: **0**  
O&M Grade: **0**  
Clock Start/From:  
Clock To:  
1st Value:  
2nd Value:  
Value Percent: **10.000**  
Continuous Index:  
Within 8" of Joint: **NO**  
Remarks:

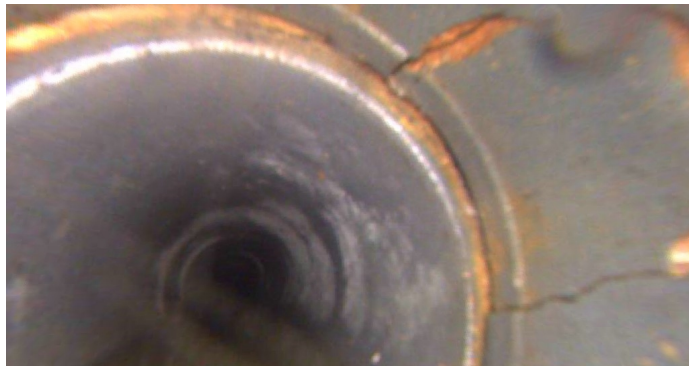
Code: **CS**  
Description: **Crack Spiral**

Distance (ft): **37.1**  
Structural Grade: **2**  
O&M Grade: **0**  
Clock Start/From: **1**  
Clock To: **4**  
1st Value:  
2nd Value:  
Value Percent:  
Continuous Index:  
Within 8" of Joint: **YES**  
Remarks:

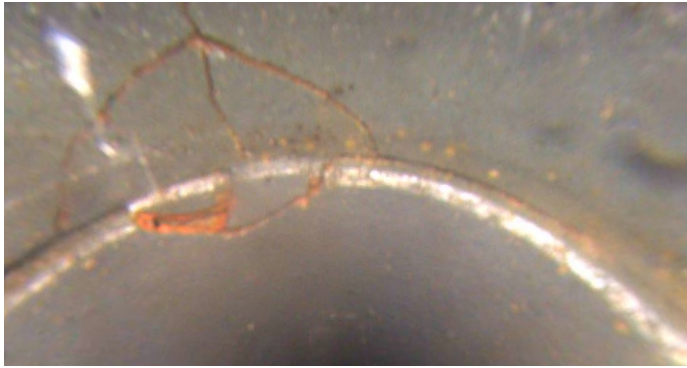
Code: **CM**  
Description: **Crack Multiple**

Distance (ft): **41.2**  
Structural Grade: **3**  
O&M Grade: **0**  
Clock Start/From: **11**  
Clock To: **12**  
1st Value:  
2nd Value:  
Value Percent:  
Continuous Index:  
Within 8" of Joint: **YES**  
Remarks:

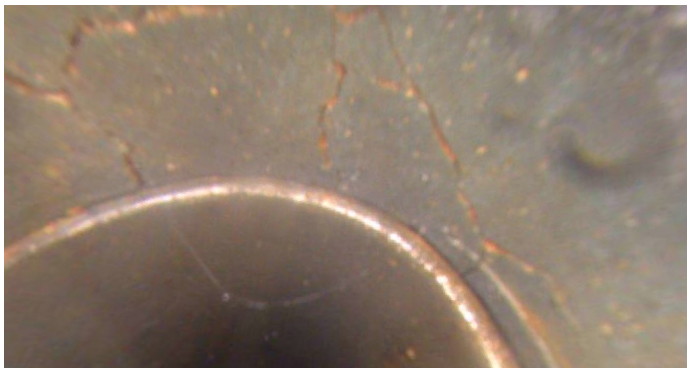
Code: **CM**  
Description: **Crack Multiple**

Distance (ft): **43.1**  
Structural Grade: **3**  
O&M Grade: **0**  
Clock Start/From: **10**  
Clock To: **4**  
1st Value:  
2nd Value:  
Value Percent:  
Continuous Index:  
Within 8" of Joint: **YES**  
Remarks:

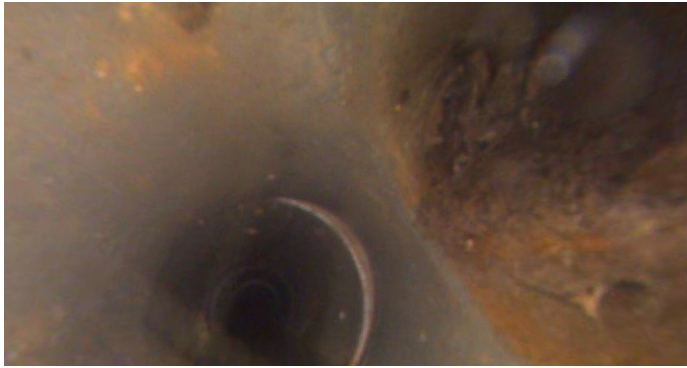
Code: **TFD**  
Description: **Tap Factory Defective**

Distance (ft): **52.6**  
Structural Grade: **0**  
O&M Grade: **2**  
Clock Start/From: **2**  
Clock To:  
1st Value: **4.000**  
2nd Value:  
Value Percent:  
Continuous Index:  
Within 8" of Joint:  
Remarks: **RFL**

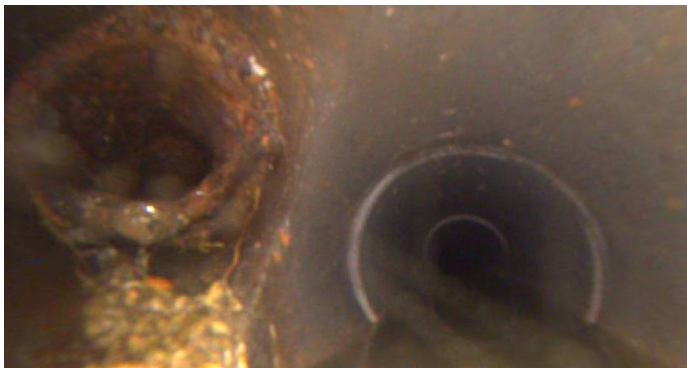
Code: **TF**  
Description: **Tap Factory**

Distance (ft): **54.7**  
Structural Grade: **0**  
O&M Grade: **0**  
Clock Start/From: **9**  
Clock To:  
1st Value: **4.000**  
2nd Value:  
Value Percent:  
Continuous Index:  
Within 8" of Joint:  
Remarks:

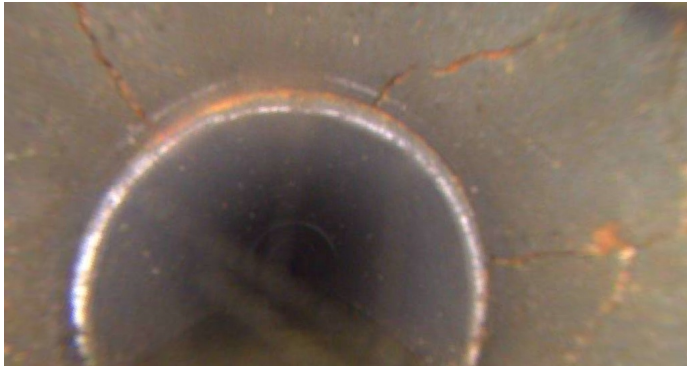
Code: **CM**  
Description: **Crack Multiple**

Distance (ft): **57.2**  
Structural Grade: **3**  
O&M Grade: **0**  
Clock Start/From: **10**  
Clock To: **5**  
1st Value:  
2nd Value:  
Value Percent:  
Continuous Index:  
Within 8" of Joint: **YES**  
Remarks:

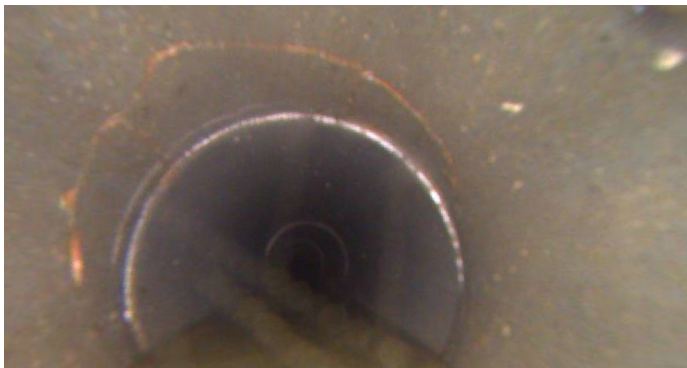
Code: **CM**  
Description: **Crack Multiple**

Distance (ft): **59.1**  
Structural Grade: **3**  
O&M Grade: **0**  
Clock Start/From: **7**  
Clock To: **4**  
1st Value:  
2nd Value:  
Value Percent:  
Continuous Index:  
Within 8" of Joint: **YES**  
Remarks:

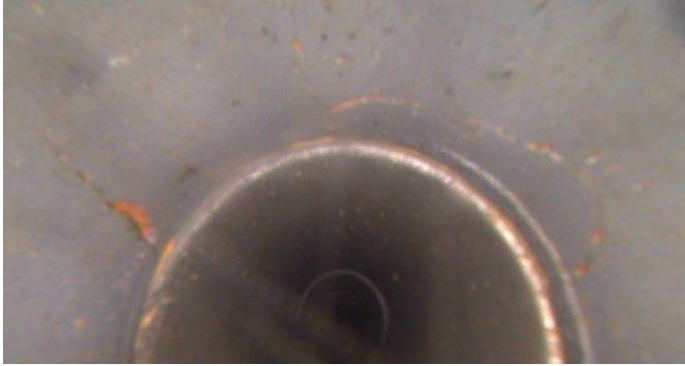
Code: **CM**  
Description: **Crack Multiple**

Distance (ft): **61.3**  
Structural Grade: **3**  
O&M Grade: **0**  
Clock Start/From: **10**  
Clock To: **2**  
1st Value:  
2nd Value:  
Value Percent:  
Continuous Index:  
Within 8" of Joint: **YES**  
Remarks:

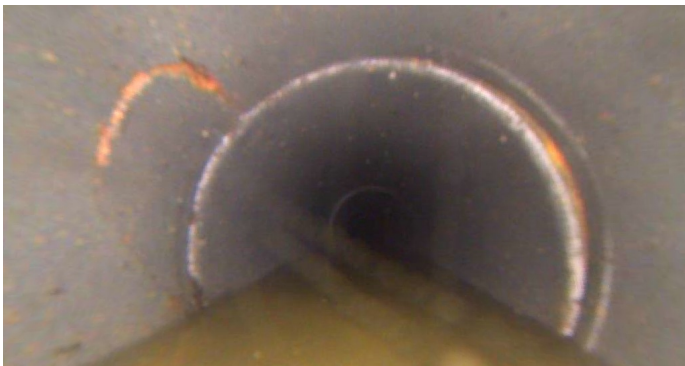
Code: **CS**  
Description: **Crack Spiral**

Distance (ft): **79.7**  
Structural Grade: **2**  
O&M Grade: **0**  
Clock Start/From: **7**  
Clock To: **10**  
1st Value:  
2nd Value:  
Value Percent:  
Continuous Index:  
Within 8" of Joint: **YES**  
Remarks:

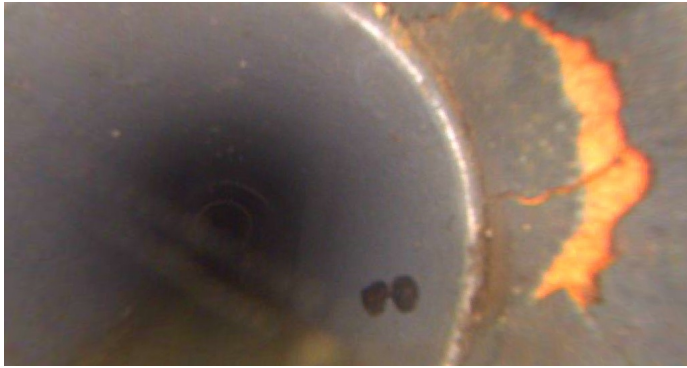
Code: **CM**  
Description: **Crack Multiple**

Distance (ft): **90.2**  
Structural Grade: **3**  
O&M Grade: **0**  
Clock Start/From: **2**  
Clock To: **5**  
1st Value:  
2nd Value:  
Value Percent:  
Continuous Index:  
Within 8" of Joint: **YES**  
Remarks:

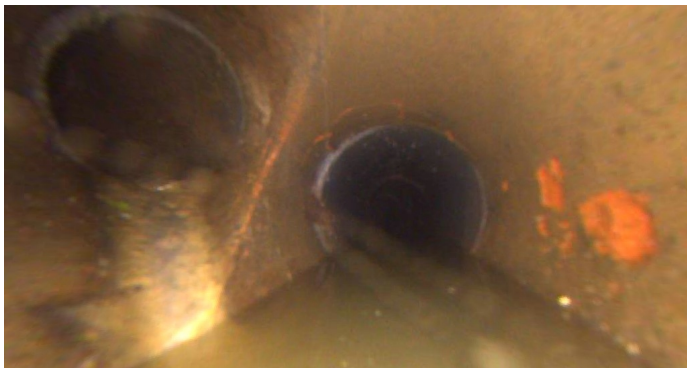
Code: **TF**  
Description: **Tap Factory**

Distance (ft): **95.6**  
Structural Grade: **0**  
O&M Grade: **0**  
Clock Start/From: **9**  
Clock To:  
1st Value: **4.000**  
2nd Value:  
Value Percent:  
Continuous Index:  
Within 8" of Joint:  
Remarks:

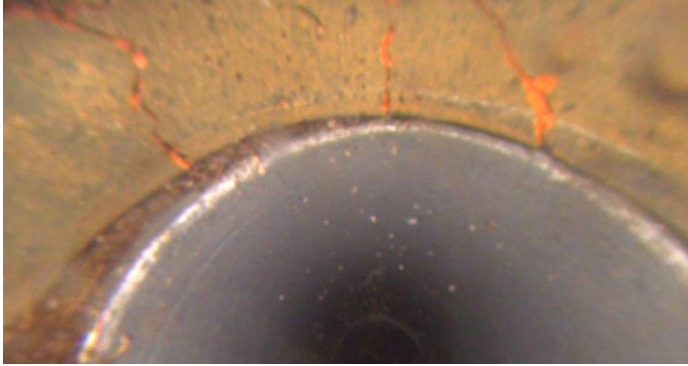
Code: **CM**  
Description: **Crack Multiple**

Distance (ft): **96.4**  
Structural Grade: **3**  
O&M Grade: **0**  
Clock Start/From: **7**  
Clock To: **2**  
1st Value:  
2nd Value:  
Value Percent:  
Continuous Index:  
Within 8" of Joint: **YES**  
Remarks:

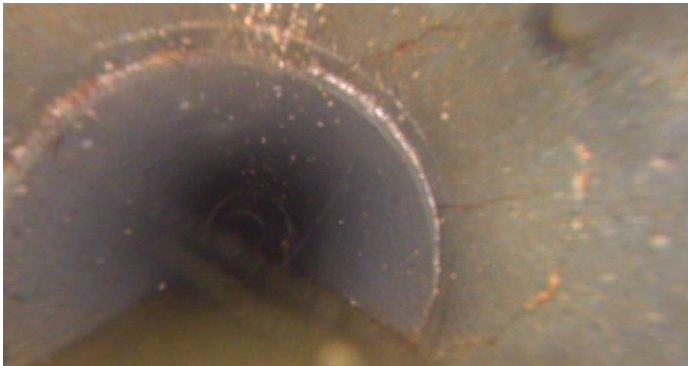
Code: **CM**  
Description: **Crack Multiple**

Distance (ft): **98.3**  
Structural Grade: **3**  
O&M Grade: **0**  
Clock Start/From: **2**  
Clock To: **5**  
1st Value:  
2nd Value:  
Value Percent:  
Continuous Index:  
Within 8" of Joint: **YES**  
Remarks:

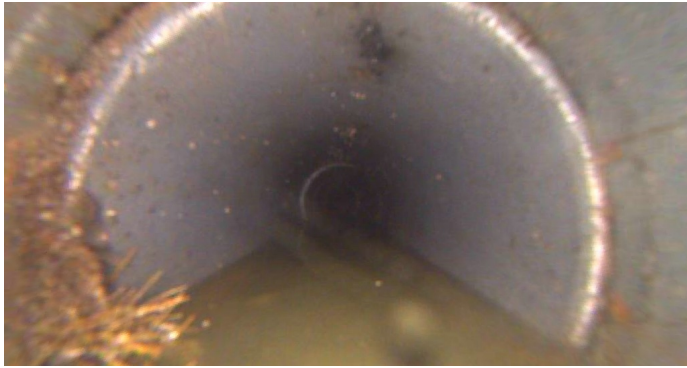
Code: **RFJ**  
Description: **Roots Fine Joint**

Distance (ft): **108.7**  
Structural Grade: **0**  
O&M Grade: **1**  
Clock Start/From: **7**  
Clock To:  
1st Value:  
2nd Value:  
Value Percent:  
Continuous Index:  
Within 8" of Joint: **YES**  
Remarks:

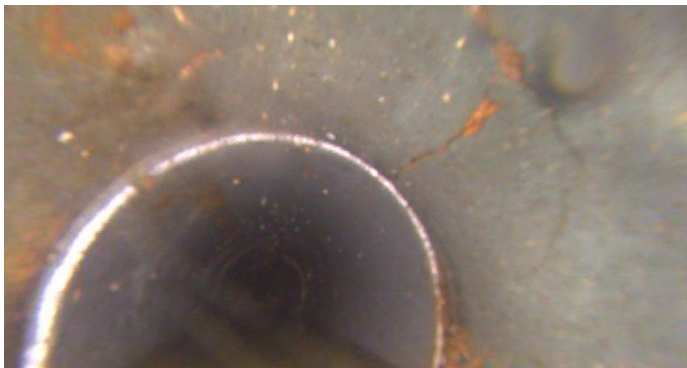
Code: **CM**  
Description: **Crack Multiple**

Distance (ft): **110.5**  
Structural Grade: **3**  
O&M Grade: **0**  
Clock Start/From: **12**  
Clock To: **5**  
1st Value:  
2nd Value:  
Value Percent:  
Continuous Index:  
Within 8" of Joint: **YES**  
Remarks:

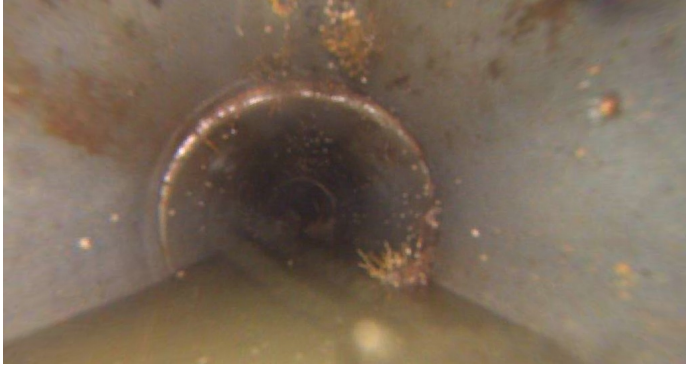
Code: **RFJ**  
Description: **Roots Fine Joint**

Distance (ft): **114.4**  
Structural Grade: **0**  
O&M Grade: **1**  
Clock Start/From: **10**  
Clock To: **5**  
1st Value:  
2nd Value:  
Value Percent:  
Continuous Index:  
Within 8" of Joint: **YES**  
Remarks:

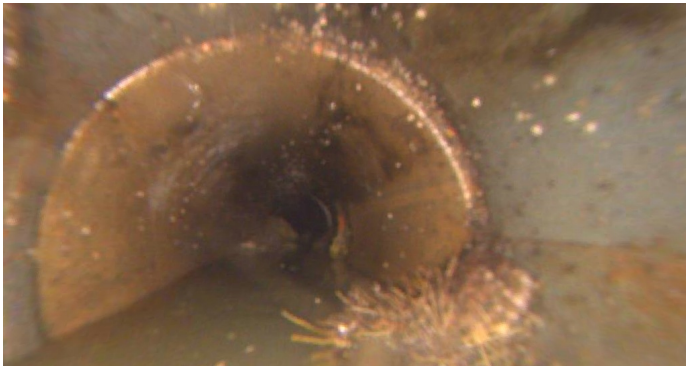
Code: **RFJ**  
Description: **Roots Fine Joint**

Distance (ft): **116.7**  
Structural Grade: **0**  
O&M Grade: **1**  
Clock Start/From: **5**  
Clock To:  
1st Value:  
2nd Value:  
Value Percent:  
Continuous Index:  
Within 8" of Joint: **YES**  
Remarks:

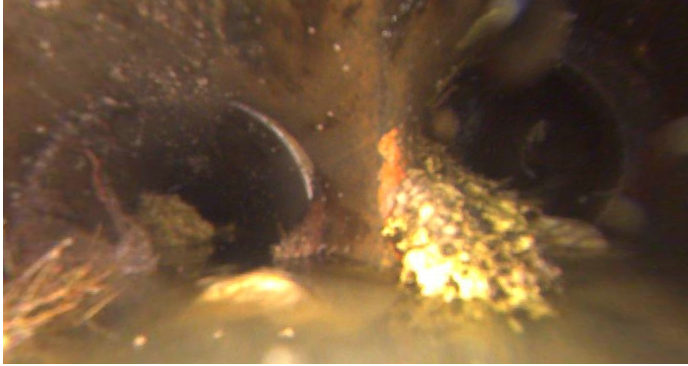
Code: **TF**  
Description: **Tap Factory**

Distance (ft): **118.2**  
Structural Grade: **0**  
O&M Grade: **0**  
Clock Start/From: **4**  
Clock To:  
1st Value: **4.000**  
2nd Value:  
Value Percent:  
Continuous Index:  
Within 8" of Joint:  
Remarks:

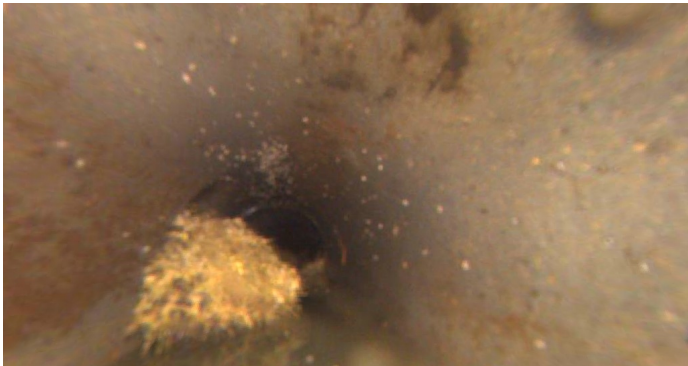
Code: **RFJ**  
Description: **Roots Fine Joint**

Distance (ft): **119.2**  
Structural Grade: **0**  
O&M Grade: **1**  
Clock Start/From: **7**  
Clock To: **5**  
1st Value:  
2nd Value:  
Value Percent:  
Continuous Index:  
Within 8" of Joint: **YES**  
Remarks:

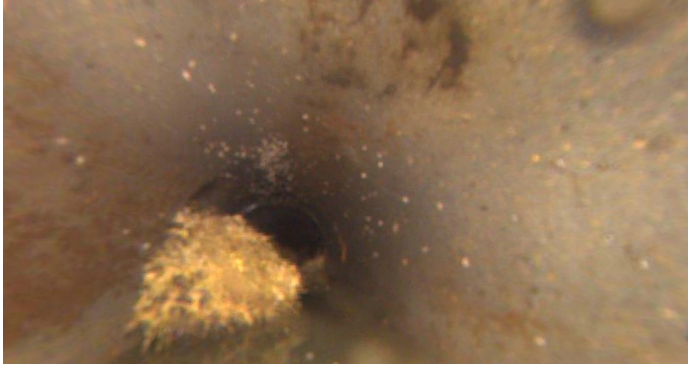
Code:	<b>MSA</b>
Description:	<b>Abandoned Survey</b>
Distance (ft):	<b>119.2</b>
Structural Grade:	<b>0</b>
O&M Grade:	<b>0</b>
Clock Start/From:	
Clock To:	
1st Value:	
2nd Value:	
Value Percent:	
Continuous Index:	
Within 8" of Joint:	<b>NO</b>
Remarks:	<b>Roots</b>
