Profile/Photo Observation Report

Date:	04/21/2018	Weather:		Coding:	PACP 6.0
Pipe Length (ft):	267.7	Owner:	NA	Pre Clean:	Not Known
P.O.#:		Surveyor:	Mark Ruby	PSR:	P-705-022-019
Customer:		Clean Date:	01/01/1900	Shape:	C

Street:	Capitol	Flow Control:	Not Controlled
City:	Hobart, IN	Year Renewed:	
Location:	Light Highway	Tape/Media #:	
Purpose:	Maintenance Related	Dia/Height:	8"
Use:	Sanitary	Material:	VCP
Drain Area:	NA	Lining:	Cured in Place
Category:	NA		
Comment:	Reverse setup. Roots at 118'-flow is incorrect.		
Location Details:		Direction of Survey:	Downstream
US MH:	M-705-019	DS MH:	M-705-022
		Total Length Surveyed (ft):	119.2

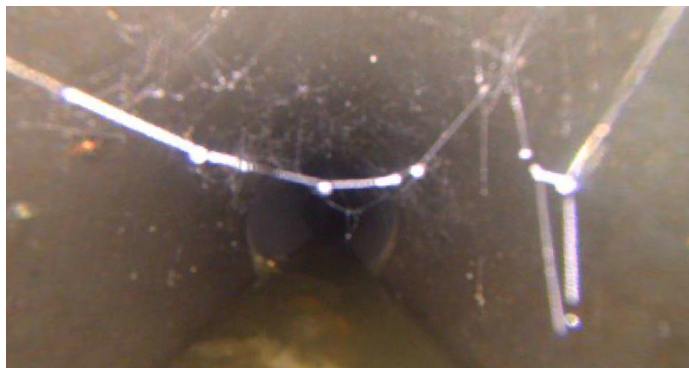
Code: **AMH**
 Description: **Manhole**

Distance (ft): **.0**
 Structural Grade: **0**
 O&M Grade: **0**
 Clock Start/From:
 Clock To:
 1st Value:
 2nd Value:
 Value Percent:
 Continuous Index:
 Within 8" of Joint: **NO**
 Remarks: **M-705-019**

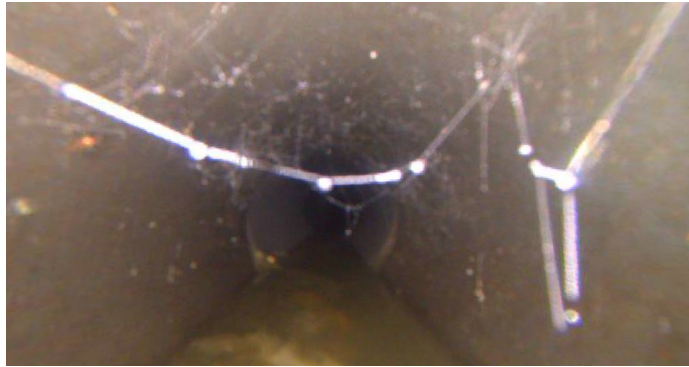
Code: **MWL**
Description: **Water Level**

Distance (ft): **.0**
Structural Grade: **0**
O&M Grade: **0**
Clock Start/From:
Clock To:
1st Value:
2nd Value:
Value Percent: **10.000**
Continuous Index:
Within 8" of Joint: **NO**
Remarks:

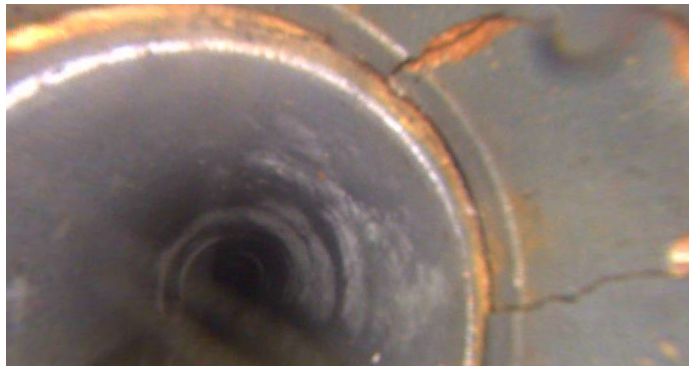
Code: **CS**
Description: **Crack Spiral**

Distance (ft): **37.1**
Structural Grade: **2**
O&M Grade: **0**
Clock Start/From: **1**
Clock To: **4**
1st Value:
2nd Value:
Value Percent:
Continuous Index:
Within 8" of Joint: **YES**
Remarks:

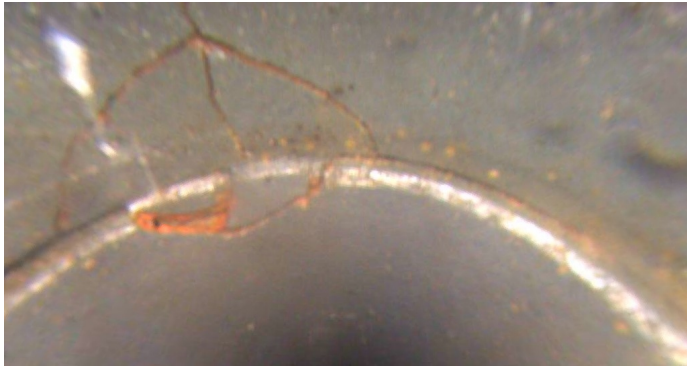
Code: **CM**
Description: **Crack Multiple**

Distance (ft): **41.2**
Structural Grade: **3**
O&M Grade: **0**
Clock Start/From: **11**
Clock To: **12**
1st Value:
2nd Value:
Value Percent:
Continuous Index:
Within 8" of Joint: **YES**
Remarks:

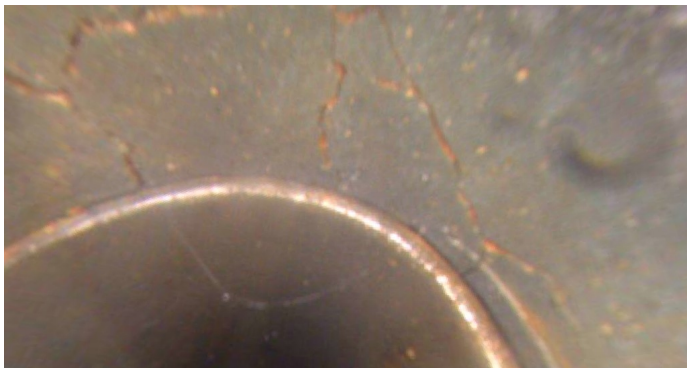
Code: **CM**
Description: **Crack Multiple**

Distance (ft): **43.1**
Structural Grade: **3**
O&M Grade: **0**
Clock Start/From: **10**
Clock To: **4**
1st Value:
2nd Value:
Value Percent:
Continuous Index:
Within 8" of Joint: **YES**
Remarks:

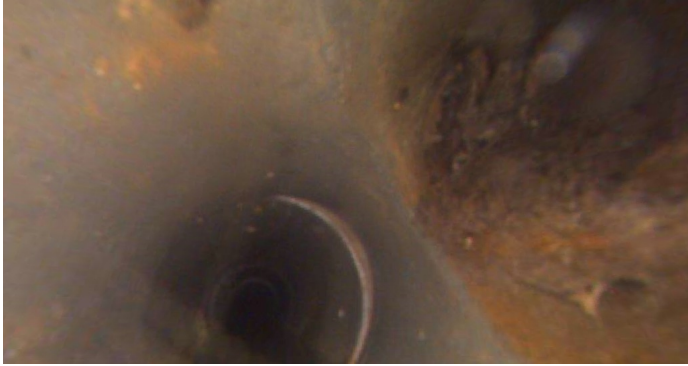
Code: **TFD**
Description: **Tap Factory Defective**

Distance (ft): **52.6**
Structural Grade: **0**
O&M Grade: **2**
Clock Start/From: **2**
Clock To:
1st Value: **4.000**
2nd Value:
Value Percent:
Continuous Index:
Within 8" of Joint:
Remarks: **RFL**

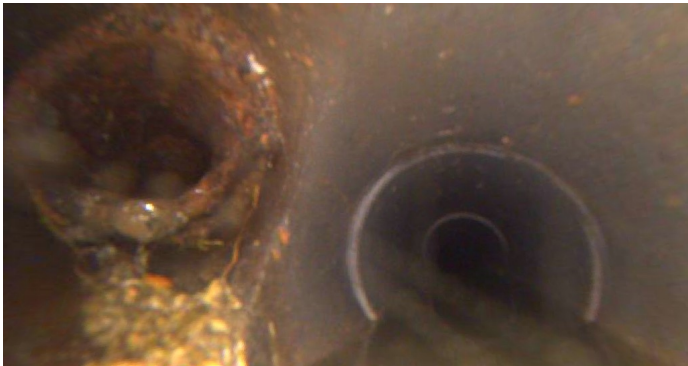
Code: **TF**
Description: **Tap Factory**

Distance (ft): **54.7**
Structural Grade: **0**
O&M Grade: **0**
Clock Start/From: **9**
Clock To:
1st Value: **4.000**
2nd Value:
Value Percent:
Continuous Index:
Within 8" of Joint:
Remarks:

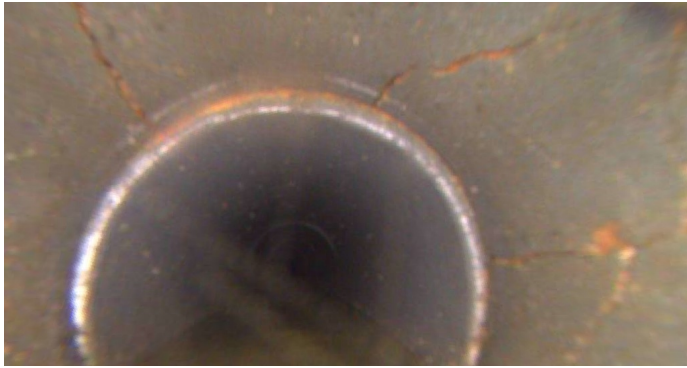
Code: **CM**
Description: **Crack Multiple**

Distance (ft): **57.2**
Structural Grade: **3**
O&M Grade: **0**
Clock Start/From: **10**
Clock To: **5**
1st Value:
2nd Value:
Value Percent:
Continuous Index:
Within 8" of Joint: **YES**
Remarks:

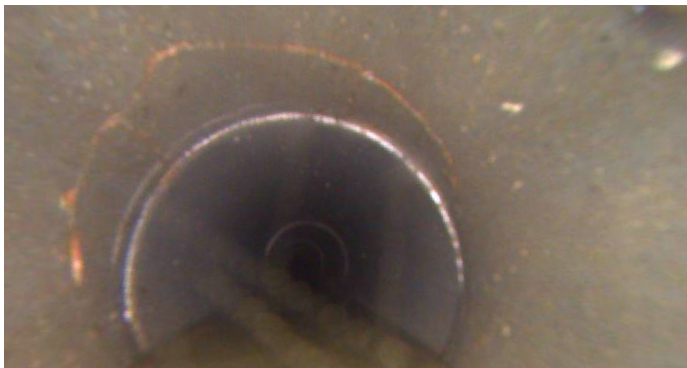
Code: **CM**
Description: **Crack Multiple**

Distance (ft): **59.1**
Structural Grade: **3**
O&M Grade: **0**
Clock Start/From: **7**
Clock To: **4**
1st Value:
2nd Value:
Value Percent:
Continuous Index:
Within 8" of Joint: **YES**
Remarks:

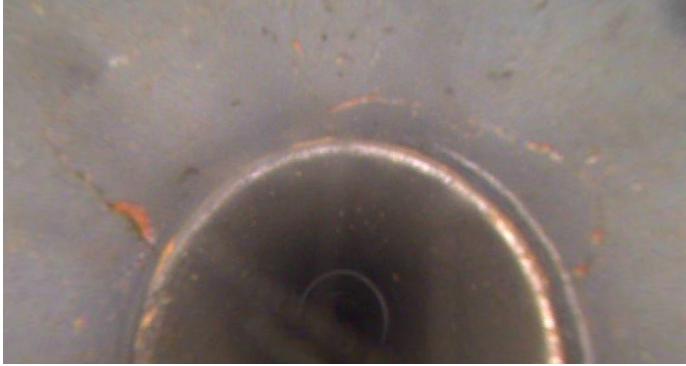
Code: **CM**
Description: **Crack Multiple**

Distance (ft): **61.3**
Structural Grade: **3**
O&M Grade: **0**
Clock Start/From: **10**
Clock To: **2**
1st Value:
2nd Value:
Value Percent:
Continuous Index:
Within 8" of Joint: **YES**
Remarks:

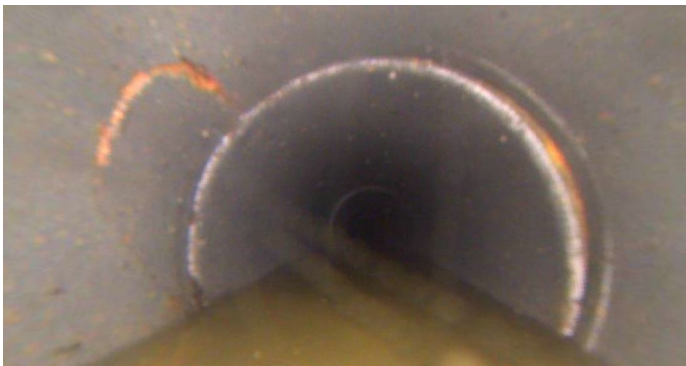
Code: **CS**
Description: **Crack Spiral**

Distance (ft): **79.7**
Structural Grade: **2**
O&M Grade: **0**
Clock Start/From: **7**
Clock To: **10**
1st Value:
2nd Value:
Value Percent:
Continuous Index:
Within 8" of Joint: **YES**
Remarks:

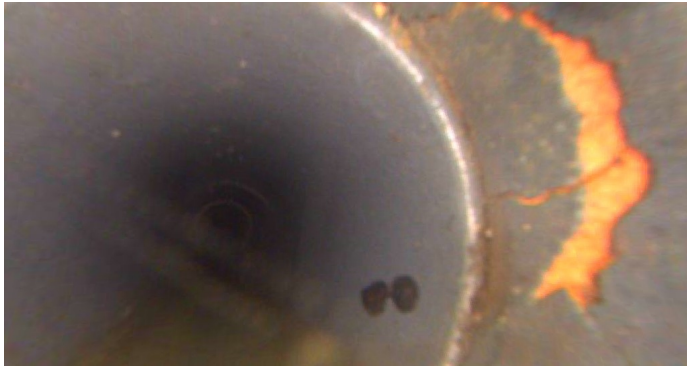
Code: **CM**
Description: **Crack Multiple**

Distance (ft): **90.2**
Structural Grade: **3**
O&M Grade: **0**
Clock Start/From: **2**
Clock To: **5**
1st Value:
2nd Value:
Value Percent:
Continuous Index:
Within 8" of Joint: **YES**
Remarks:

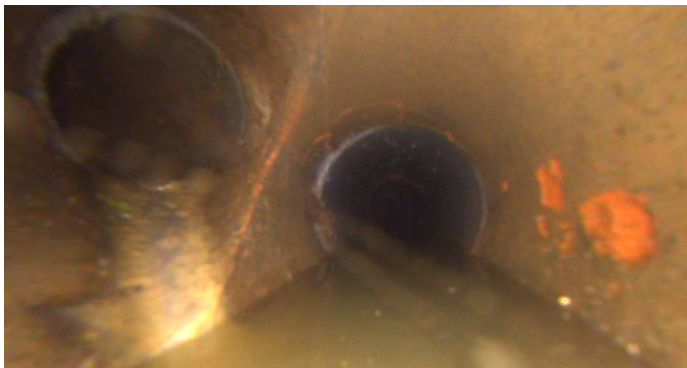
Code: **TF**
Description: **Tap Factory**

Distance (ft): **95.6**
Structural Grade: **0**
O&M Grade: **0**
Clock Start/From: **9**
Clock To:
1st Value: **4.000**
2nd Value:
Value Percent:
Continuous Index:
Within 8" of Joint:
Remarks:

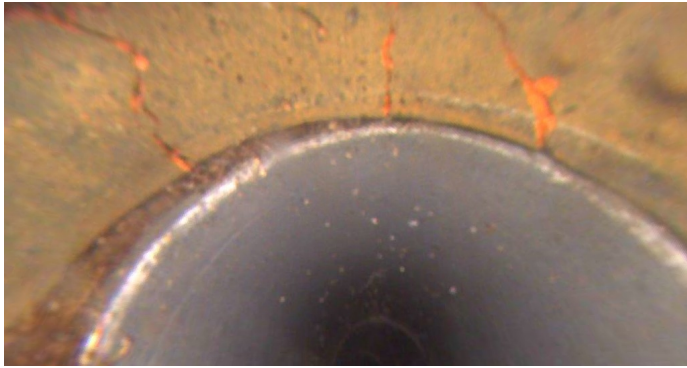
Code: **CM**
Description: **Crack Multiple**

Distance (ft): **96.4**
Structural Grade: **3**
O&M Grade: **0**
Clock Start/From: **7**
Clock To: **2**
1st Value:
2nd Value:
Value Percent:
Continuous Index:
Within 8" of Joint: **YES**
Remarks:

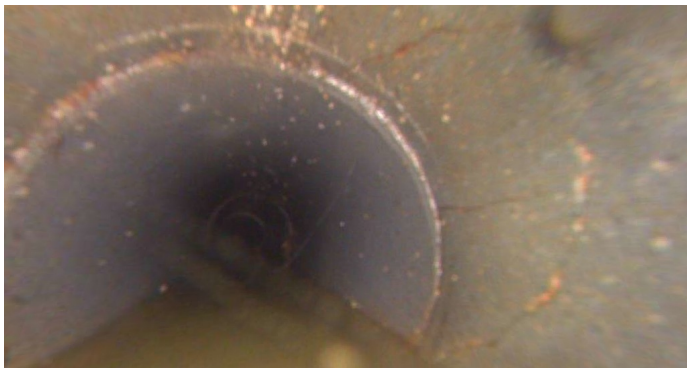
Code: **CM**
Description: **Crack Multiple**

Distance (ft): **98.3**
Structural Grade: **3**
O&M Grade: **0**
Clock Start/From: **2**
Clock To: **5**
1st Value:
2nd Value:
Value Percent:
Continuous Index:
Within 8" of Joint: **YES**
Remarks:

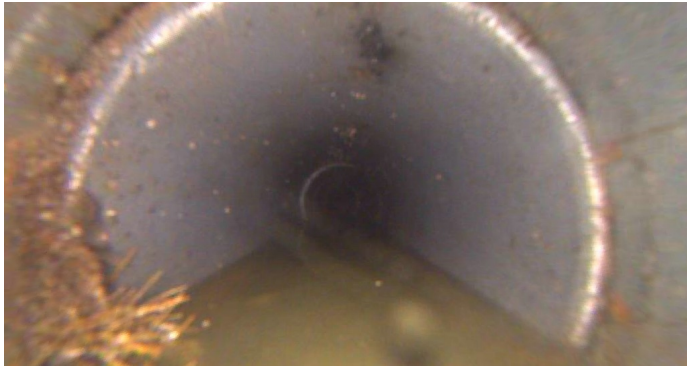
Code: **RFJ**
Description: **Roots Fine Joint**

Distance (ft): **108.7**
Structural Grade: **0**
O&M Grade: **1**
Clock Start/From: **7**
Clock To:
1st Value:
2nd Value:
Value Percent:
Continuous Index:
Within 8" of Joint: **YES**
Remarks:

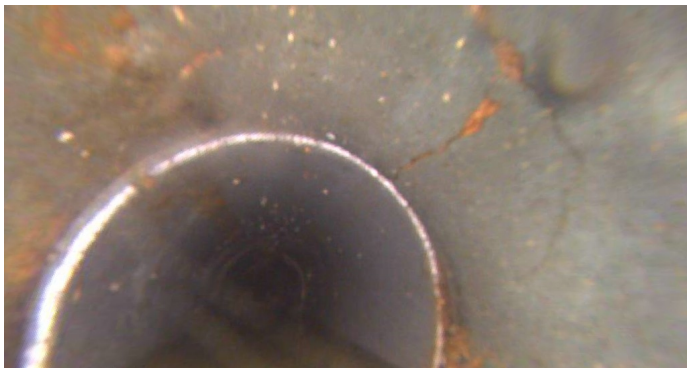
Code: **CM**
Description: **Crack Multiple**

Distance (ft): **110.5**
Structural Grade: **3**
O&M Grade: **0**
Clock Start/From: **12**
Clock To: **5**
1st Value:
2nd Value:
Value Percent:
Continuous Index:
Within 8" of Joint: **YES**
Remarks:

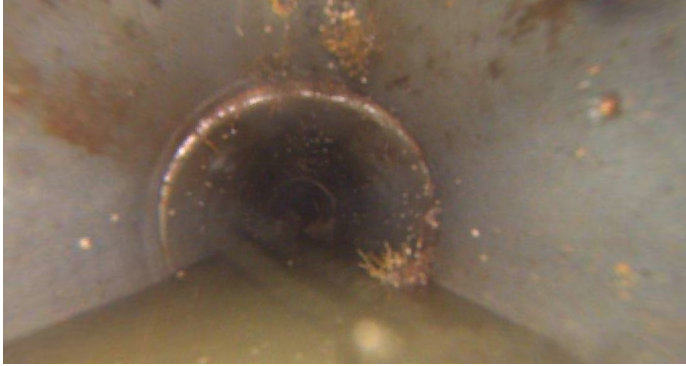
Code: **RFJ**
Description: **Roots Fine Joint**

Distance (ft): **114.4**
Structural Grade: **0**
O&M Grade: **1**
Clock Start/From: **10**
Clock To: **5**
1st Value:
2nd Value:
Value Percent:
Continuous Index:
Within 8" of Joint: **YES**
Remarks:

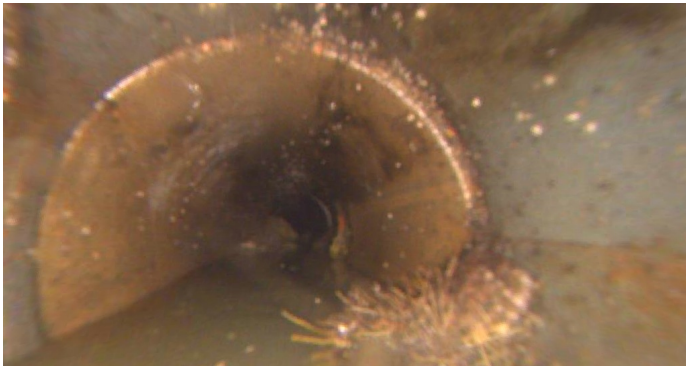
Code: **RFJ**
Description: **Roots Fine Joint**

Distance (ft): **116.7**
Structural Grade: **0**
O&M Grade: **1**
Clock Start/From: **5**
Clock To:
1st Value:
2nd Value:
Value Percent:
Continuous Index:
Within 8" of Joint: **YES**
Remarks:

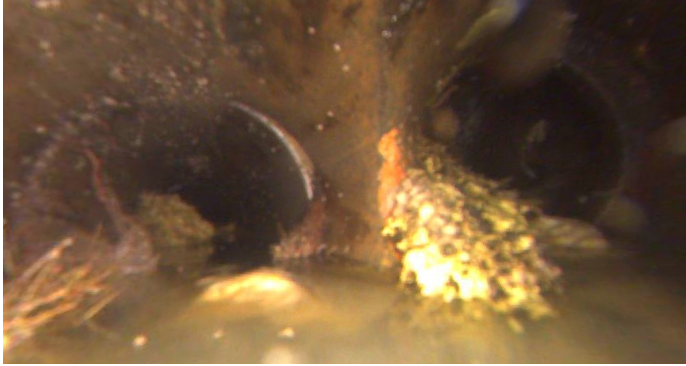
Code: **TF**
Description: **Tap Factory**

Distance (ft): **118.2**
Structural Grade: **0**
O&M Grade: **0**
Clock Start/From: **4**
Clock To:
1st Value: **4.000**
2nd Value:
Value Percent:
Continuous Index:
Within 8" of Joint:
Remarks:

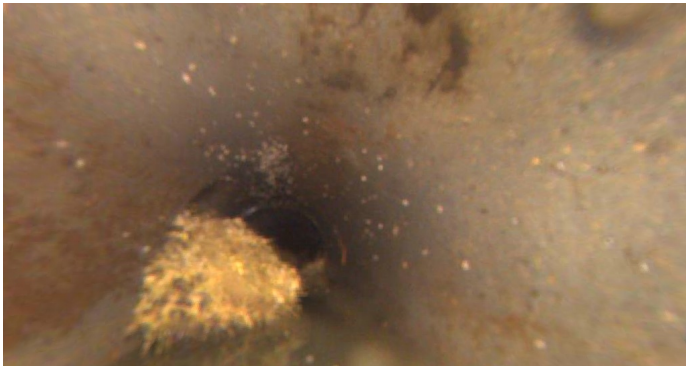
Code: **RFJ**
Description: **Roots Fine Joint**

Distance (ft): **119.2**
Structural Grade: **0**
O&M Grade: **1**
Clock Start/From: **7**
Clock To: **5**
1st Value:
2nd Value:
Value Percent:
Continuous Index:
Within 8" of Joint: **YES**
Remarks:

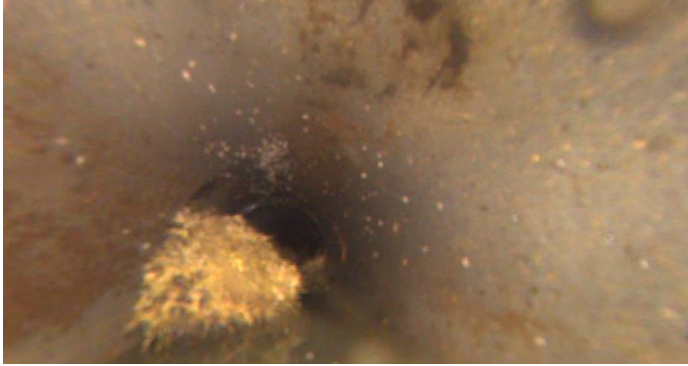
Code:	MSA
Description:	Abandoned Survey
Distance (ft):	119.2
Structural Grade:	0
O&M Grade:	0
Clock Start/From:	
Clock To:	
1st Value:	
2nd Value:	
Value Percent:	
Continuous Index:	
Within 8" of Joint:	NO
Remarks:	Roots
