# Profile/Photo Observation Report

Date:	03/09/2022	Weather:		Coding:	PACP 7.0
Pipe Length (ft):	268.0	Owner:	City of Hobart	Pre Clean:	Heavy Cleaning
P.O.#:	YES502259	Surveyor:	S. Bucklin	PSR:	P-705-022-019
Customer:	City of Hobart, IN (Red	Clean Date:	03/06/2022	Shape:	C

Street:	South Lake Street	Flow Control:	Not Controlled
City:	Hobart, IN	Year Renewed:	
Location:	Local rural streets with light traffic, t	Tape/Media #:	
Purpose:	Routine Assessment	Dia/Height:	8"
Use:	Sanitary Sewage Pipe	Material:	VCP
Drain Area:		Lining:	None
Category:	NA		
Comment:			
Location Details:		Direction of Survey:	Downstream
US MH:	M-705-019	DS MH:	M-705-022
		Total Length Surveyed (ft):	261.1

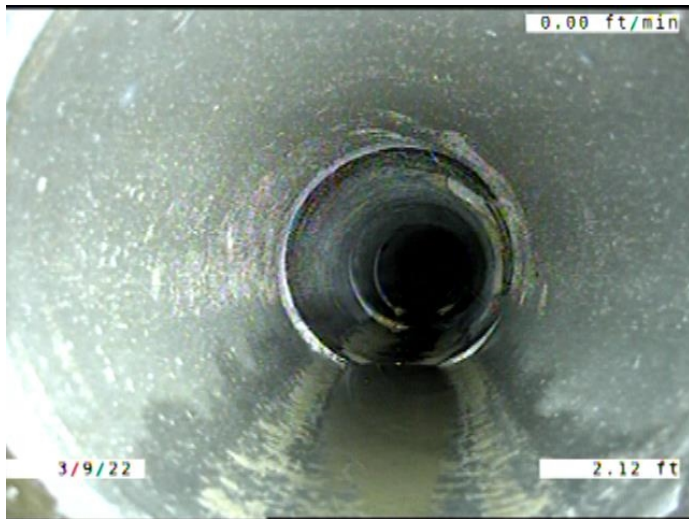
Code: **DSF**  
 Description: **Deposits Settled Fine**

Distance (ft): **2.1**  
 Structural Grade: **0**  
 O&M Grade: **2**  
 Clock Start/From: **5**  
 Clock To: **7**  
 1st Value:  
 2nd Value:  
 Value Percent: **5.000**  
 Continuous Index: **S01**  
 Within 8" of Joint: **YES**  
 Remarks:

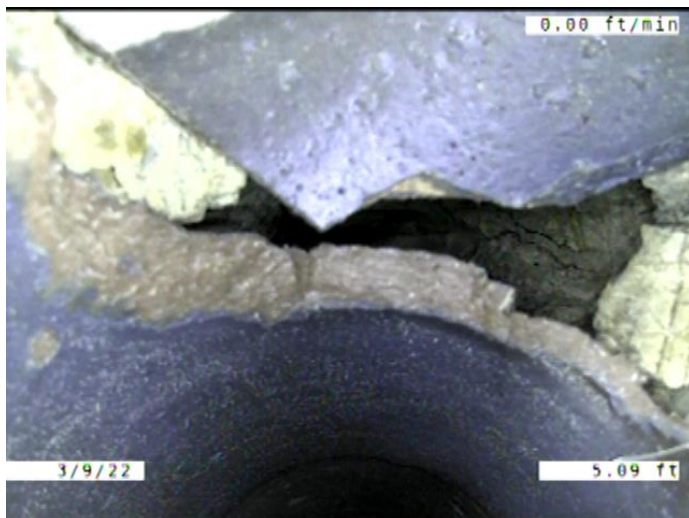
Code: **BVV**  
 Description: **Broken Void Visible**

Distance (ft): **5.1**  
 Structural Grade: **5**  
 O&M Grade: **0**  
 Clock Start/From: **12**  
 Clock To: **4**  
 1st Value:  
 2nd Value:  
 Value Percent:  
 Continuous Index:  
 Within 8" of Joint: **YES**  
 Remarks: **SOIL VISIBLE TOO**

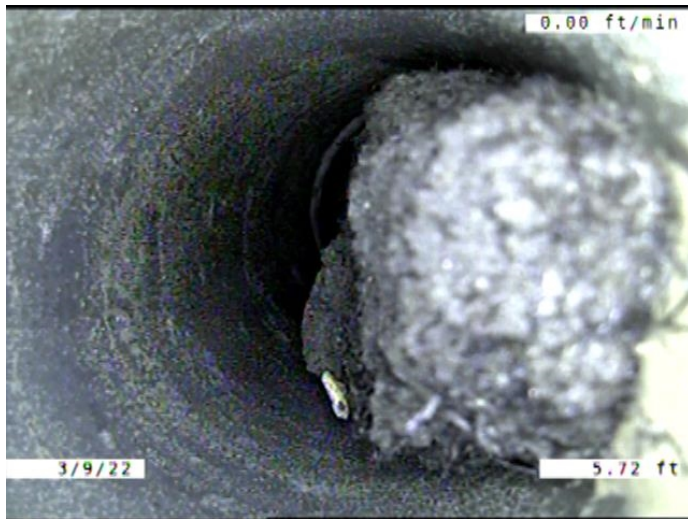
Code: **TBD**  
Description: **Tap Break-in/Hammer Defective**

Distance (ft): **5.7**  
Structural Grade: **0**  
O&M Grade: **3**  
Clock Start/From: **3**  
Clock To:  
1st Value: **6.000**  
2nd Value:  
Value Percent:  
Continuous Index:  
Within 8" of Joint: **YES**  
Remarks: **95% PLUGGED**

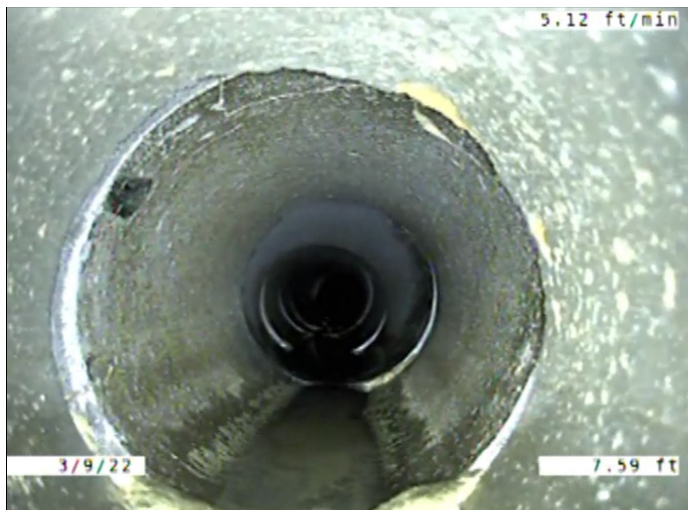
Code: **CM**  
Description: **Crack Multiple**

Distance (ft): **7.6**  
Structural Grade: **3**  
O&M Grade: **0**  
Clock Start/From: **8**  
Clock To: **4**  
1st Value:  
2nd Value:  
Value Percent:  
Continuous Index: **S04**  
Within 8" of Joint: **YES**  
Remarks: **Wandering**

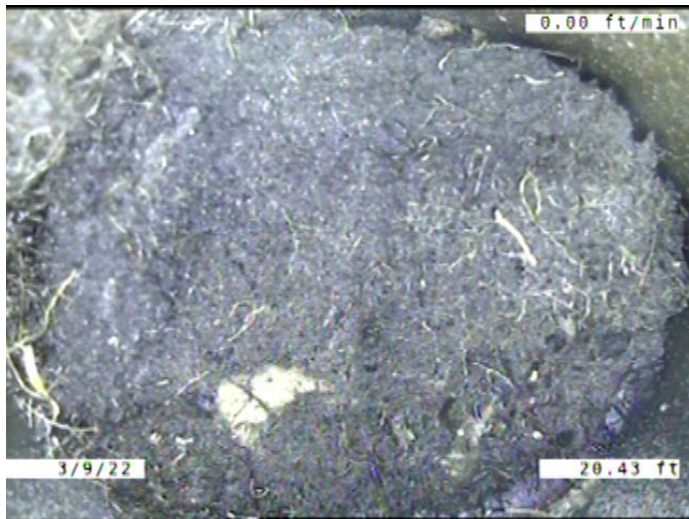
Code: **TFD**  
 Description: **Tap Factory Defective**

Distance (ft): **20.4**  
 Structural Grade: **0**  
 O&M Grade: **3**  
 Clock Start/From: **10**  
 Clock To:  
 1st Value: **4.000**  
 2nd Value:  
 Value Percent:  
 Continuous Index:  
 Within 8" of Joint: **YES**  
 Remarks: **BROKEN. SERVICE TO MAIN CONNECTION BROKEN AND SOIL VIS**

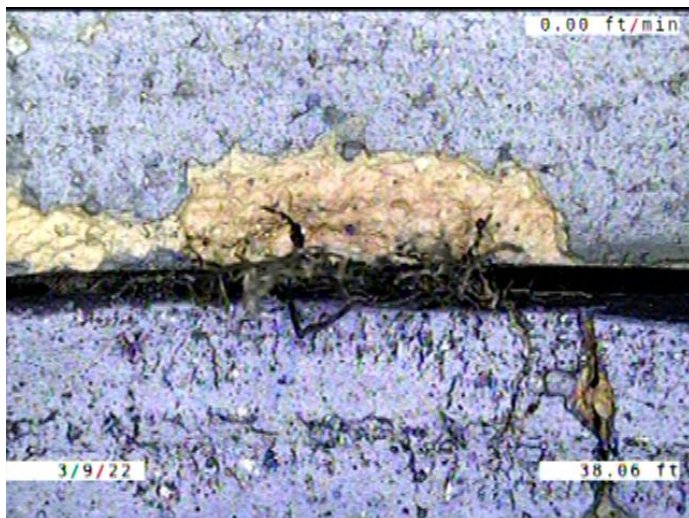
Code: **RFJ**  
 Description: **Roots Fine Joint**

Distance (ft): **38.1**  
 Structural Grade: **0**  
 O&M Grade: **1**  
 Clock Start/From: **9**  
 Clock To: **2**  
 1st Value:  
 2nd Value:  
 Value Percent:  
 Continuous Index:  
 Within 8" of Joint: **YES**  
 Remarks:

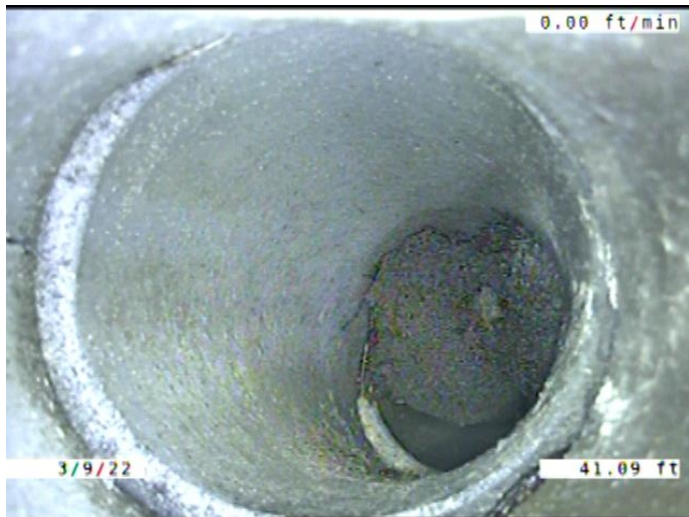
Code:	<b>TF</b>
Description:	<b>Tap Factory</b>
Distance (ft):	<b>41.1</b>
Structural Grade:	<b>0</b>
O&M Grade:	<b>0</b>
Clock Start/From:	<b>2</b>
Clock To:	
1st Value:	<b>4.000</b>
2nd Value:	
Value Percent:	
Continuous Index:	
Within 8" of Joint:	<b>YES</b>
Remarks:	<b>90% PLUGGED WITH ROOTS</b>

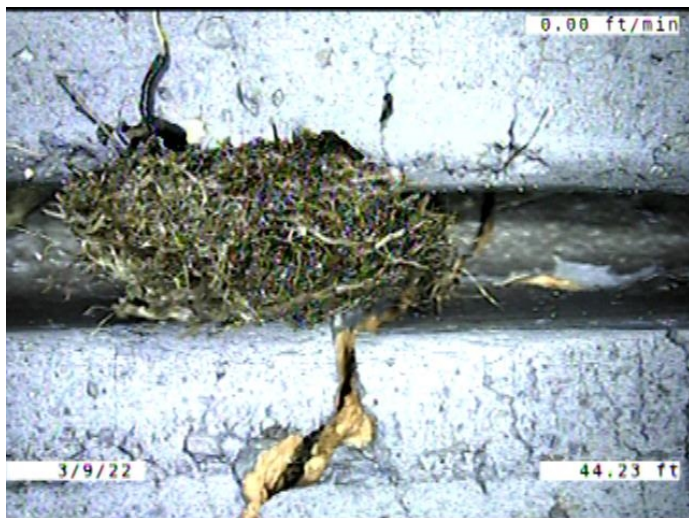
Code:	<b>RFJ</b>
Description:	<b>Roots Fine Joint</b>
Distance (ft):	<b>44.2</b>
Structural Grade:	<b>0</b>
O&M Grade:	<b>1</b>
Clock Start/From:	<b>11</b>
Clock To:	<b>3</b>
1st Value:	
2nd Value:	
Value Percent:	
Continuous Index:	
Within 8" of Joint:	<b>YES</b>
Remarks:

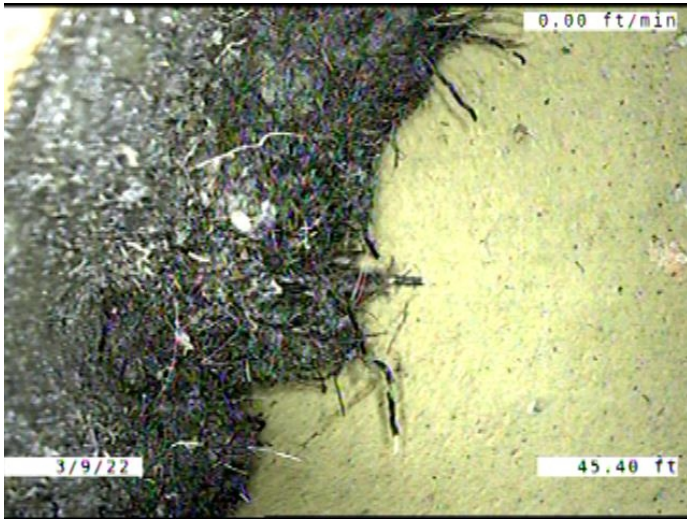
Code:	<b>TB</b>
Description:	<b>Tap Break-in/Hammer</b>
Distance (ft):	<b>45.4</b>
Structural Grade:	<b>0</b>
O&M Grade:	<b>0</b>
Clock Start/From:	<b>10</b>
Clock To:	
1st Value:	<b>4.000</b>
2nd Value:	
Value Percent:	
Continuous Index:	
Within 8" of Joint:	<b>YES</b>
Remarks:	<b>LOOKS TO BE 100% PLUGGED WITH ROOTS. ROOTS GROWING IN THE CO</b>

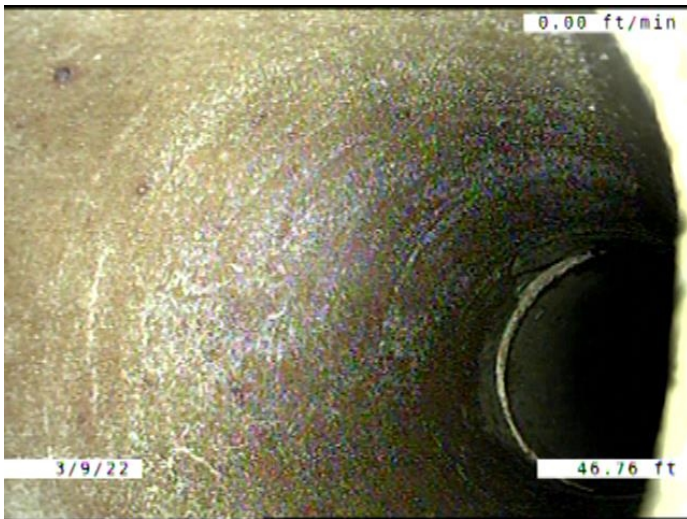
Code:	<b>TBD</b>
Description:	<b>Tap Break-in/Hammer Defective</b>
Distance (ft):	<b>46.8</b>
Structural Grade:	<b>0</b>
O&M Grade:	<b>3</b>
Clock Start/From:	<b>2</b>
Clock To:	
1st Value:	<b>4.000</b>
2nd Value:	
Value Percent:	
Continuous Index:	
Within 8" of Joint:	<b>YES</b>
Remarks:	<b>ROOTS GROWING IN THE CONNECTION</b>

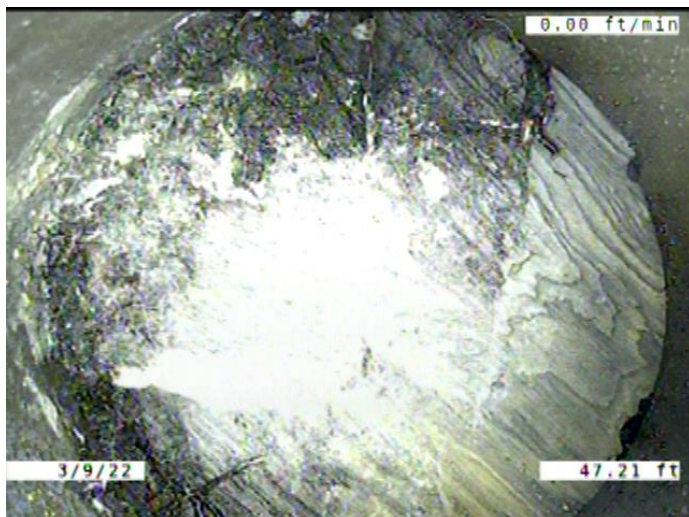
Code:	<b>TFD</b>
Description:	<b>Tap Factory Defective</b>
Distance (ft):	<b>47.2</b>
Structural Grade:	<b>0</b>
O&M Grade:	<b>3</b>
Clock Start/From:	<b>10</b>
Clock To:	
1st Value:	<b>4.000</b>
2nd Value:	
Value Percent:	
Continuous Index:	
Within 8" of Joint:	<b>YES</b>
Remarks:	<b>CAPPED WITH WOOD. ROOTS GROWING IN AROUND THE BROKEN</b>

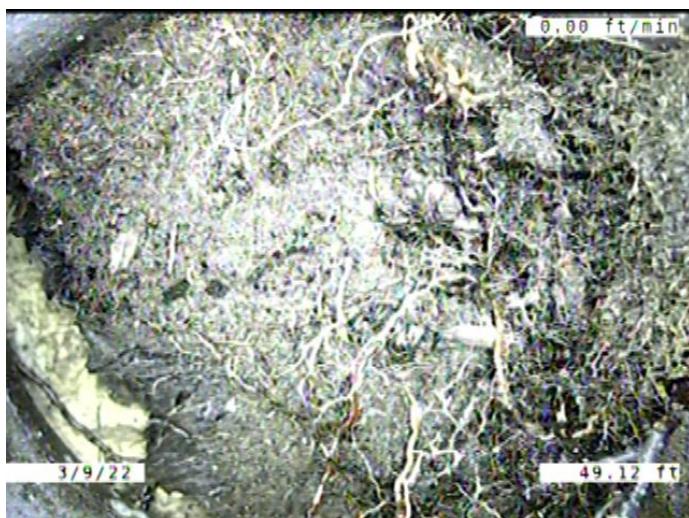
Code:	<b>TFD</b>
Description:	<b>Tap Factory Defective</b>
Distance (ft):	<b>49.1</b>
Structural Grade:	<b>0</b>
O&M Grade:	<b>3</b>
Clock Start/From:	<b>2</b>
Clock To:	
1st Value:	<b>6.000</b>
2nd Value:	
Value Percent:	
Continuous Index:	
Within 8" of Joint:	<b>YES</b>
Remarks:	<b>95% PLUGGED WITH ROOTS. SOIL VISIBLE.</b>

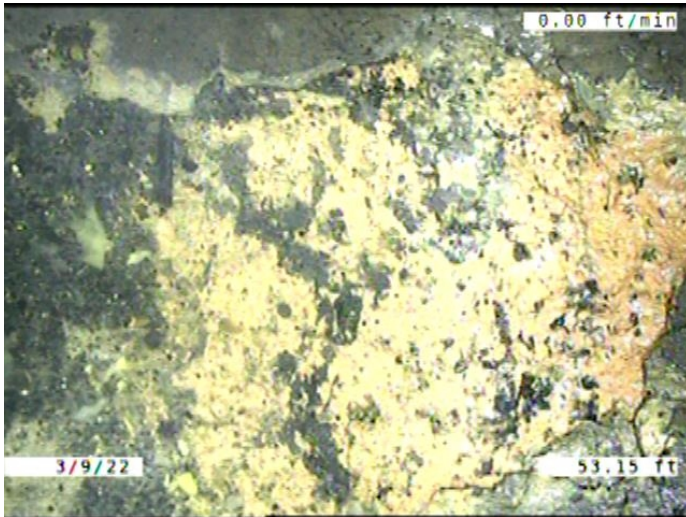
Code: **SSS**  
Description: **Surface Damage Surface Spalling**

Distance (ft): **53.1**  
Structural Grade: **2**  
O&M Grade: **0**  
Clock Start/From: **4**  
Clock To: **8**  
1st Value:  
2nd Value:  
Value Percent:  
Continuous Index:  
Within 8" of Joint: **YES**  
Remarks:

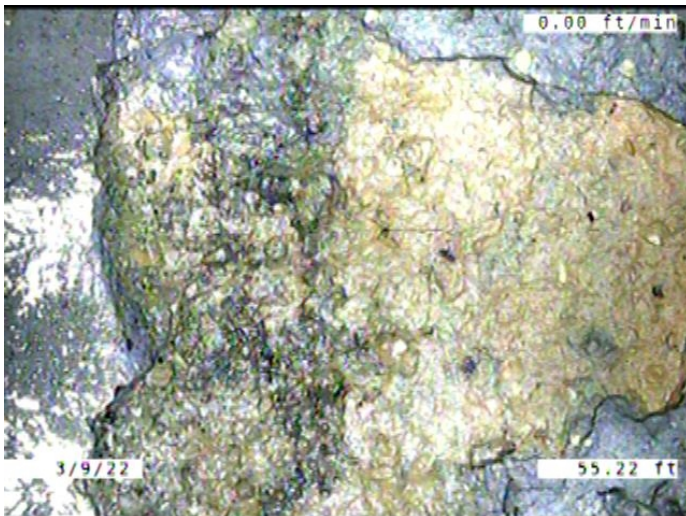
Code: **SSS**  
Description: **Surface Damage Surface Spalling**

Distance (ft): **55.2**  
Structural Grade: **2**  
O&M Grade: **0**  
Clock Start/From: **4**  
Clock To:  
1st Value:  
2nd Value:  
Value Percent:  
Continuous Index:  
Within 8" of Joint: **YES**  
Remarks:

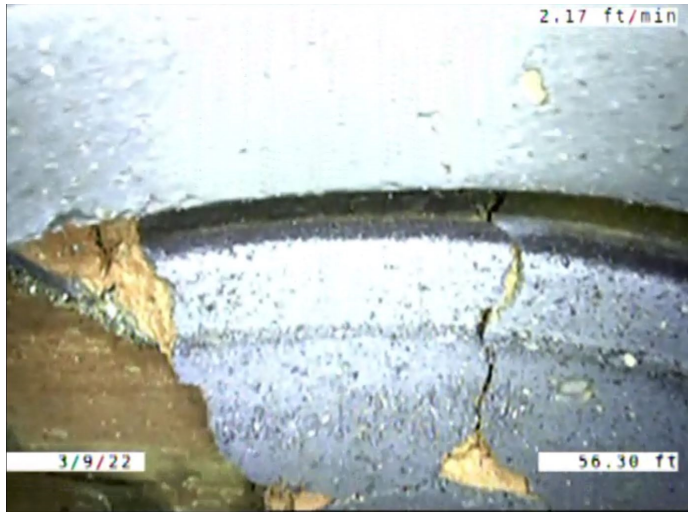
Code: **B**  
 Description: **Broken**

Distance (ft): **56.3**  
 Structural Grade: **4**  
 O&M Grade: **0**  
 Clock Start/From: **12**  
 Clock To: **12**  
 1st Value:  
 2nd Value:  
 Value Percent:  
 Continuous Index:  
 Within 8" of Joint: **NO**  
 Remarks:

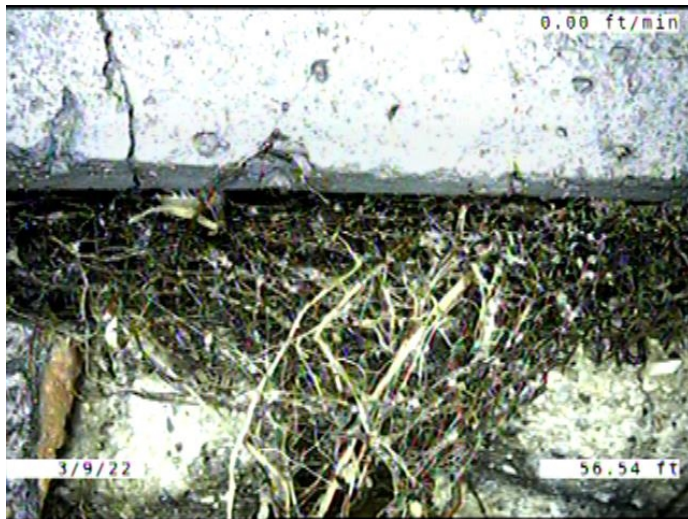
Code: **RFJ**  
 Description: **Roots Fine Joint**

Distance (ft): **56.5**  
 Structural Grade: **0**  
 O&M Grade: **1**  
 Clock Start/From: **9**  
 Clock To: **3**  
 1st Value:  
 2nd Value:  
 Value Percent:  
 Continuous Index:  
 Within 8" of Joint: **YES**  
 Remarks:

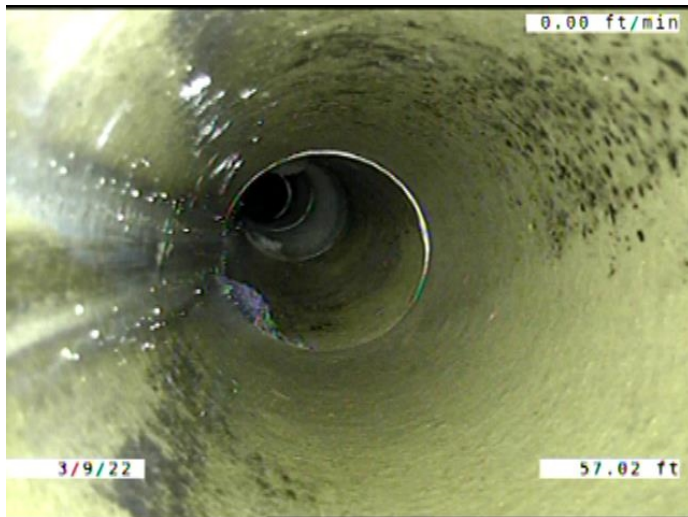
Code: **TBI**  
 Description: **Tap Break-in Intruding**

Distance (ft): **57.0**  
 Structural Grade: **0**  
 O&M Grade: **2**  
 Clock Start/From: **9**  
 Clock To:  
 1st Value: **6.000**  
 2nd Value: **2.000**  
 Value Percent:  
 Continuous Index:  
 Within 8" of Joint: **YES**  
 Remarks:

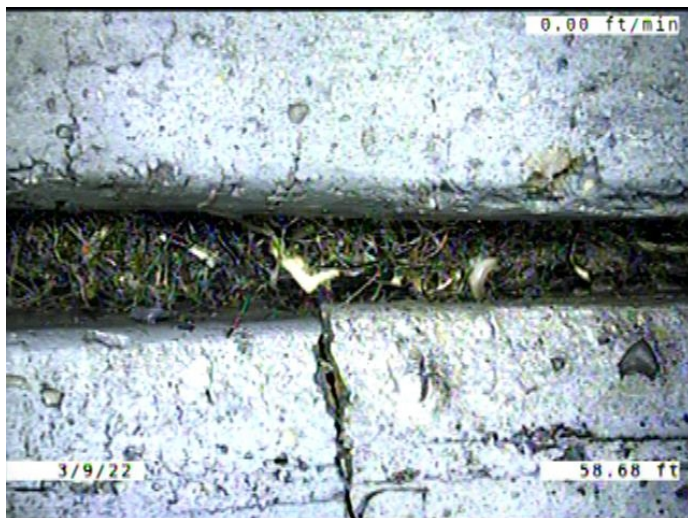
Code: **RFJ**  
 Description: **Roots Fine Joint**

Distance (ft): **58.7**  
 Structural Grade: **0**  
 O&M Grade: **1**  
 Clock Start/From: **8**  
 Clock To: **4**  
 1st Value:  
 2nd Value:  
 Value Percent:  
 Continuous Index:  
 Within 8" of Joint: **YES**  
 Remarks:

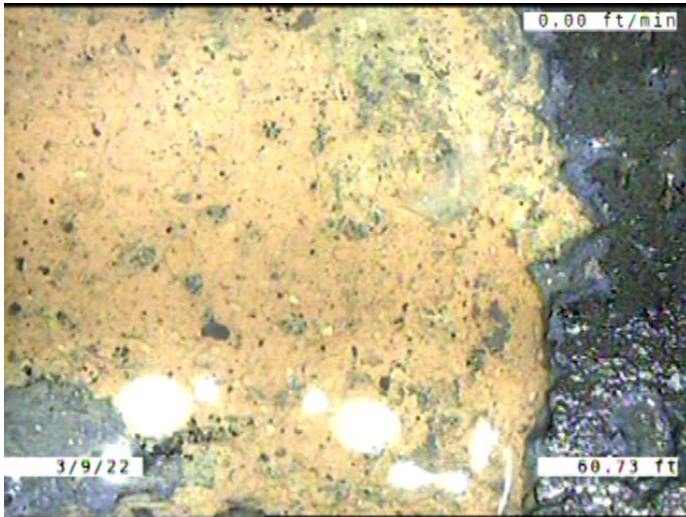
Code: **SSS**  
 Description: **Surface Damage Surface Spalling**

Distance (ft): **60.7**  
 Structural Grade: **2**  
 O&M Grade: **0**  
 Clock Start/From: **5**  
 Clock To: **9**  
 1st Value:  
 2nd Value:  
 Value Percent:  
 Continuous Index:  
 Within 8" of Joint: **YES**  
 Remarks:

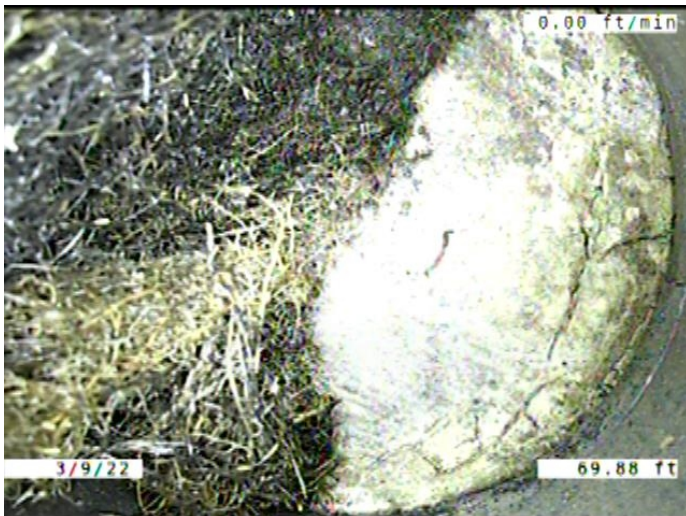
Code: **TFD**  
 Description: **Tap Factory Defective**

Distance (ft): **69.9**  
 Structural Grade: **0**  
 O&M Grade: **3**  
 Clock Start/From: **9**  
 Clock To:  
 1st Value: **6.000**  
 2nd Value:  
 Value Percent:  
 Continuous Index:  
 Within 8" of Joint: **YES**  
 Remarks: **CAP BROKEN. ROOTS GROWING AROUND AND THROUGH THE CAP.**

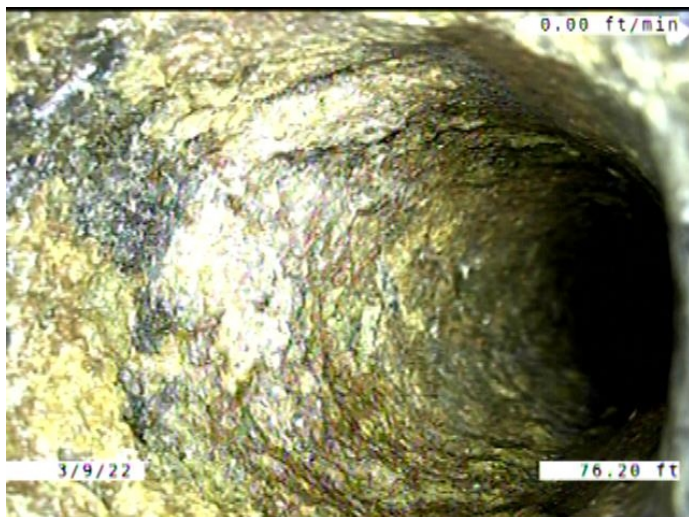
Code: **TBI**  
 Description: **Tap Break-in Intruding**

Distance (ft): **76.2**  
 Structural Grade: **0**  
 O&M Grade: **2**  
 Clock Start/From: **2**  
 Clock To:  
 1st Value: **4.000**  
 2nd Value: **1.000**  
 Value Percent:  
 Continuous Index:  
 Within 8" of Joint: **YES**  
 Remarks: **CONSTANTLY RUNNING WATER.**

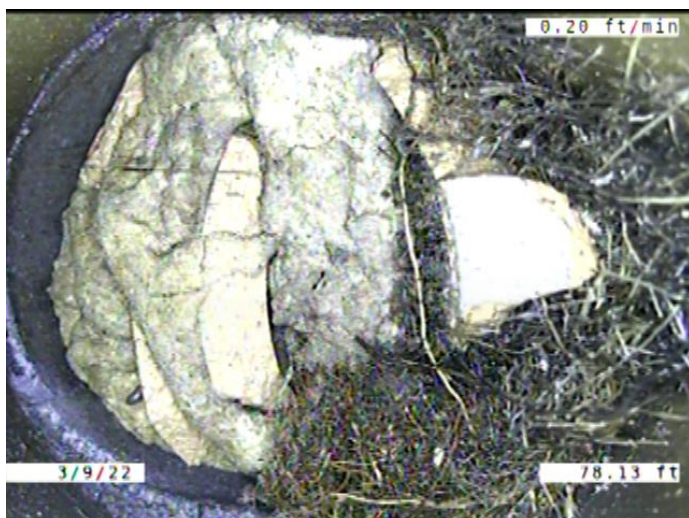
Code: **TFD**  
 Description: **Tap Factory Defective**

Distance (ft): **78.1**  
 Structural Grade: **0**  
 O&M Grade: **3**  
 Clock Start/From: **2**  
 Clock To:  
 1st Value: **4.000**  
 2nd Value:  
 Value Percent:  
 Continuous Index:  
 Within 8" of Joint: **YES**  
 Remarks: **PLUGGED. ROOTS GROWING  
 AROUND THE THROUGH THE PLUG**

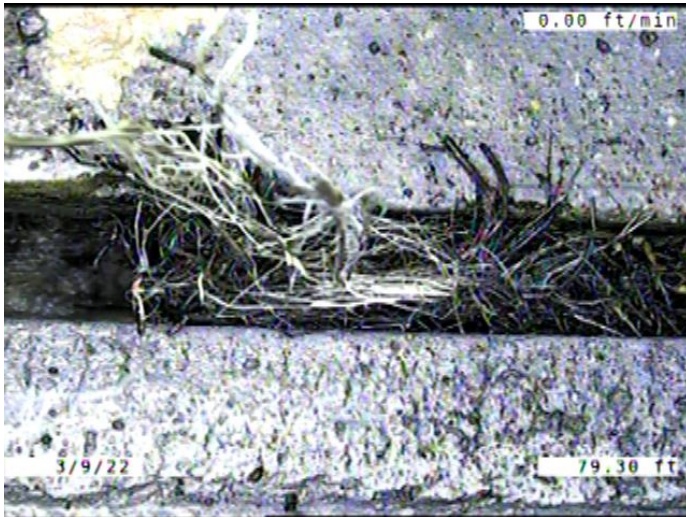
Code: **RMJ**  
 Description: **Roots Medium Joint**

Distance (ft): **79.3**  
 Structural Grade: **0**  
 O&M Grade: **3**  
 Clock Start/From: **8**  
 Clock To: **4**  
 1st Value:  
 2nd Value:  
 Value Percent: **5.000**  
 Continuous Index: **S03**  
 Within 8" of Joint: **YES**  
 Remarks:

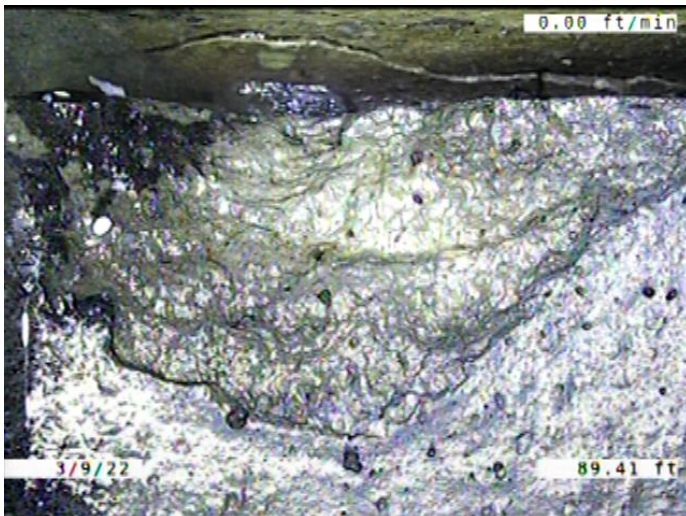
Code: **SZ**  
 Description: **Surface Damage Other**

Distance (ft): **89.4**  
 Structural Grade: **0**  
 O&M Grade: **0**  
 Clock Start/From: **4**  
 Clock To: **5**  
 1st Value:  
 2nd Value:  
 Value Percent:  
 Continuous Index:  
 Within 8" of Joint: **YES**  
 Remarks: **A PIECE CHIPPED AWAY FROM THE JOINT.**

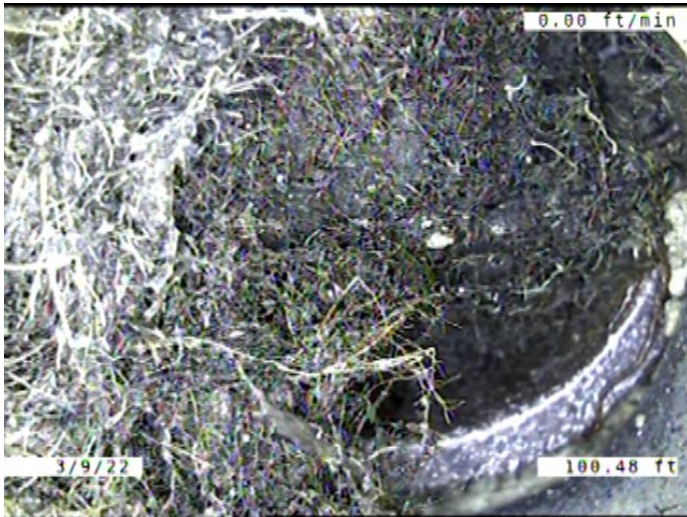
Code:	<b>TFD</b>
Description:	<b>Tap Factory Defective</b>
Distance (ft):	<b>100.5</b>
Structural Grade:	<b>0</b>
O&M Grade:	<b>3</b>
Clock Start/From:	<b>10</b>
Clock To:	
1st Value:	<b>6.000</b>
2nd Value:	
Value Percent:	
Continuous Index:	
Within 8" of Joint:	<b>YES</b>
Remarks:	<b>BROKEN. SERVICE TO MAIN CONNECTION BROKEN AND SOIL VIS</b>

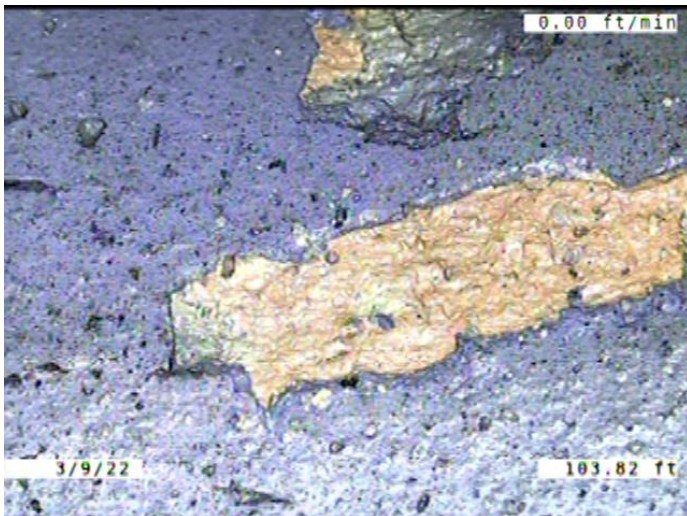
Code:	<b>SSS</b>
Description:	<b>Surface Damage Surface Spalling</b>
Distance (ft):	<b>103.8</b>
Structural Grade:	<b>2</b>
O&M Grade:	<b>0</b>
Clock Start/From:	<b>4</b>
Clock To:	<b>9</b>
1st Value:	
2nd Value:	
Value Percent:	
Continuous Index:	
Within 8" of Joint:	<b>YES</b>
Remarks:

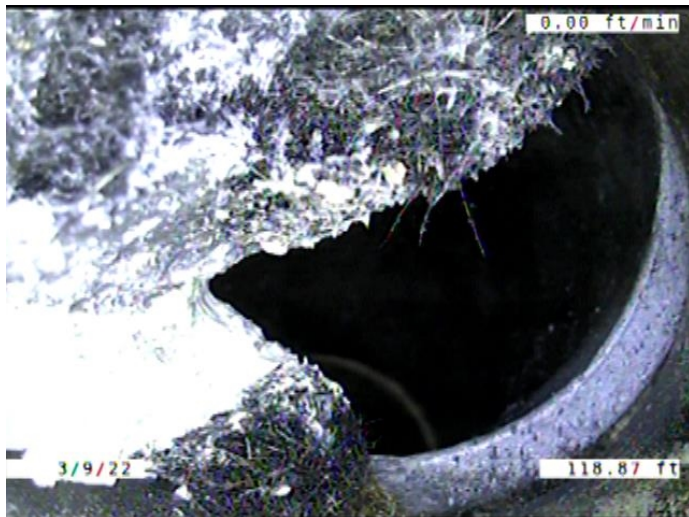
Code: **TF**  
 Description: **Tap Factory**

Remarks: **OFFSET CONNECTION TO THE MAIN.,  
 80% PLUGGED WITH ROOTS.**

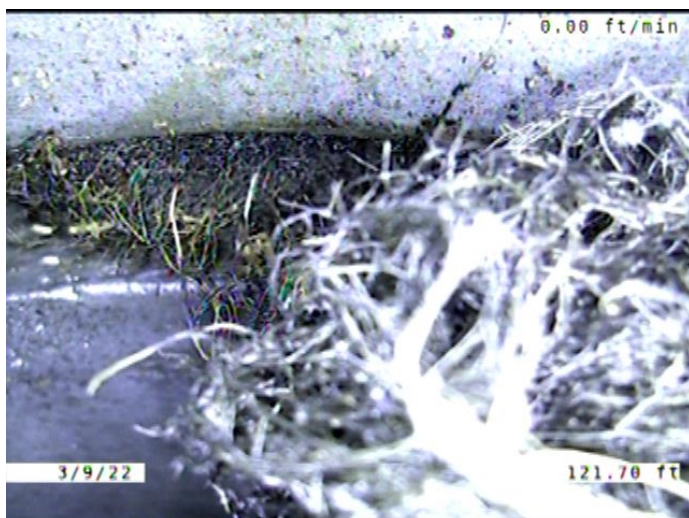
Code: **RMJ**  
 Description: **Roots Medium Joint**

Distance (ft): **121.7**  
 Structural Grade: **0**  
 O&M Grade: **3**  
 Clock Start/From: **9**  
 Clock To: **3**  
 1st Value:  
 2nd Value:  
 Value Percent: **15.000**  
 Continuous Index:  
 Within 8" of Joint: **YES**

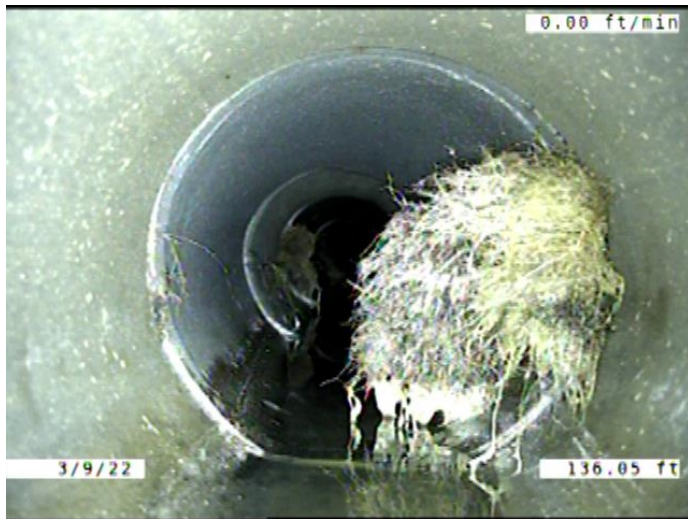
Code: **RMJ**  
 Description: **Roots Medium Joint**

Distance (ft): **136.0**  
 Structural Grade: **0**  
 O&M Grade: **3**  
 Clock Start/From: **8**  
 Clock To: **4**  
 1st Value:  
 2nd Value:  
 Value Percent: **35.000**  
 Continuous Index:  
 Within 8" of Joint: **YES**  
 Remarks:

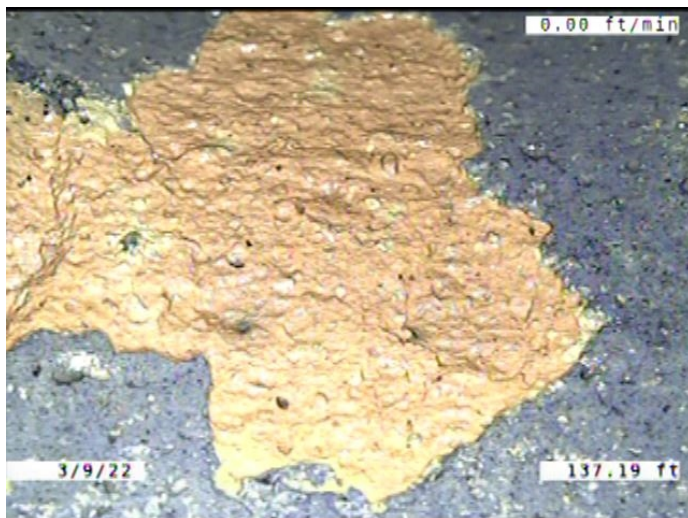
Code: **SSS**  
 Description: **Surface Damage Surface Spalling**

Distance (ft): **137.2**  
 Structural Grade: **2**  
 O&M Grade: **0**  
 Clock Start/From: **2**  
 Clock To: **8**  
 1st Value:  
 2nd Value:  
 Value Percent:  
 Continuous Index:  
 Within 8" of Joint: **YES**  
 Remarks:

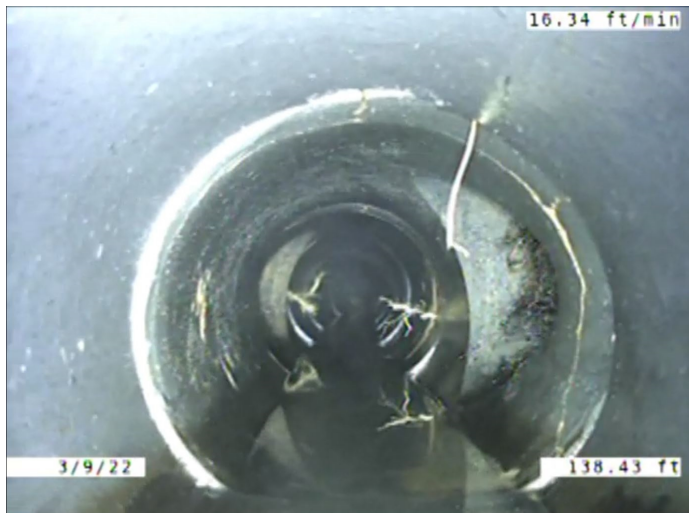
Code: **CM**  
Description: **Crack Multiple**

Distance (ft): **138.4**  
Structural Grade: **3**  
O&M Grade: **0**  
Clock Start/From: **8**  
Clock To: **4**  
1st Value:  
2nd Value:  
Value Percent:  
Continuous Index: **F04**  
Within 8" of Joint: **YES**  
Remarks: **Wandering**

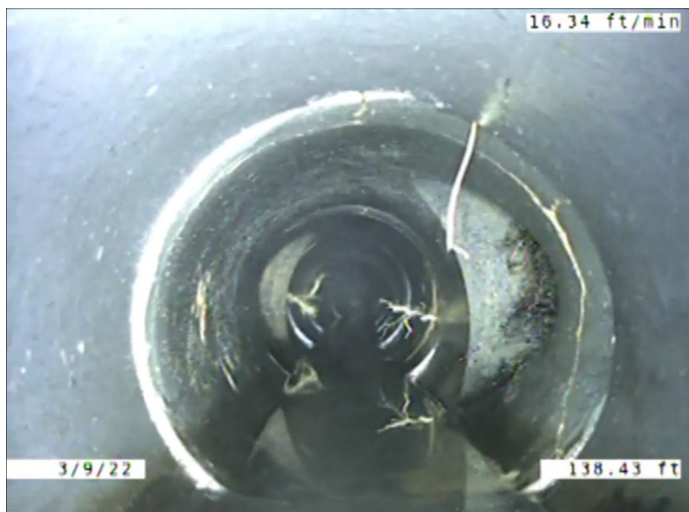
Code: **FM**  
Description: **Fracture Multiple**

Distance (ft): **138.4**  
Structural Grade: **4**  
O&M Grade: **0**  
Clock Start/From: **7**  
Clock To: **5**  
1st Value:  
2nd Value:  
Value Percent:  
Continuous Index:  
Within 8" of Joint: **YES**  
Remarks: **Wandering**

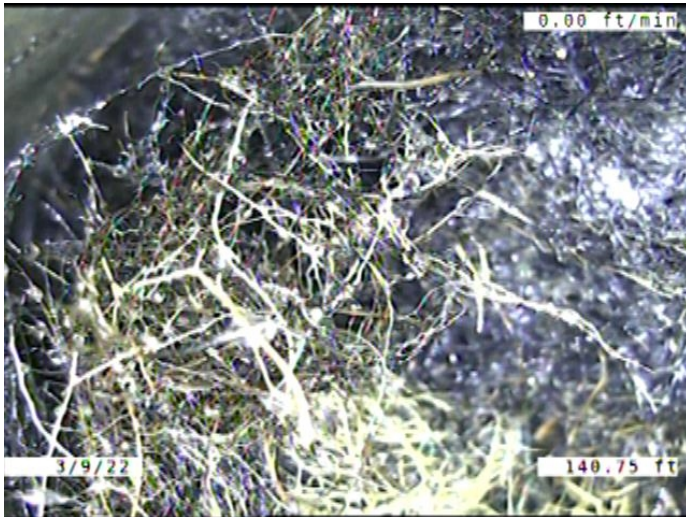
Code:	TF
Description:	Tap Factory
Distance (ft):	140.8
Structural Grade:	0
O&M Grade:	0
Clock Start/From:	2
Clock To:	
1st Value:	6.000
2nd Value:	
Value Percent:	
Continuous Index:	
Within 8" of Joint:	YES
Remarks:	100% PLUGGED WITH ROOTS

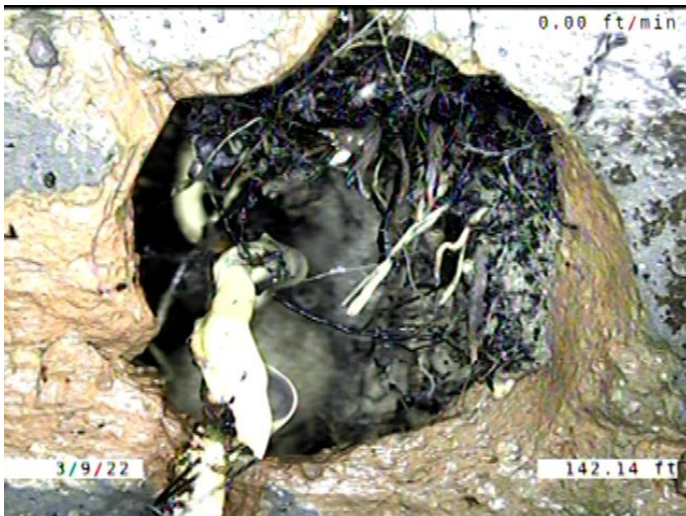
Code:	HVV
Description:	Hole Void Visible
Distance (ft):	142.1
Structural Grade:	5
O&M Grade:	0
Clock Start/From:	3
Clock To:	4
1st Value:	
2nd Value:	
Value Percent:	
Continuous Index:	
Within 8" of Joint:	YES
Remarks:	SOIL VISIBLE TOO

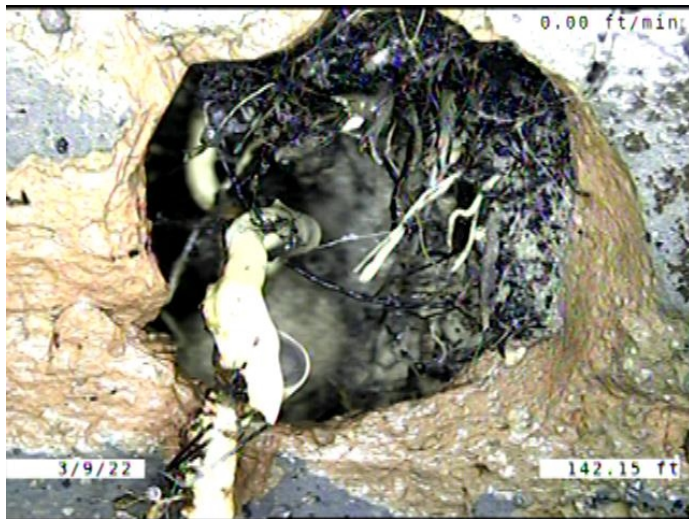
Code: **RFB**  
 Description: **Roots Fine Barrel**

Distance (ft): **142.1**  
 Structural Grade: **0**  
 O&M Grade: **2**  
 Clock Start/From: **3**  
 Clock To: **4**  
 1st Value:  
 2nd Value:  
 Value Percent:  
 Continuous Index:  
 Within 8" of Joint: **NO**  
 Remarks:

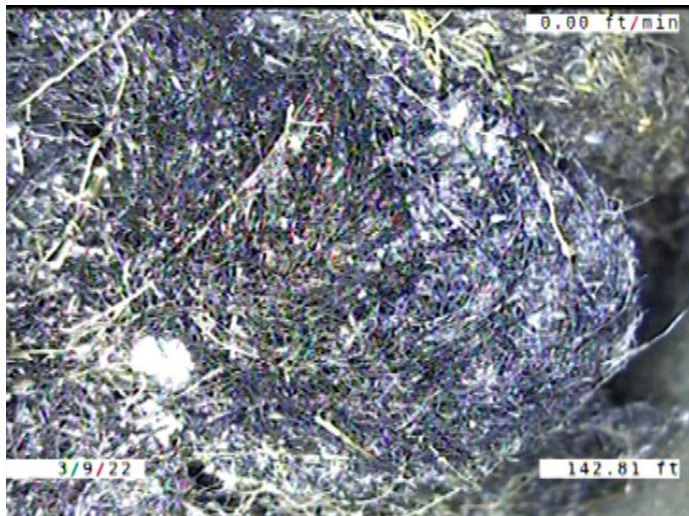
Code: **TF**  
 Description: **Tap Factory**

Distance (ft): **142.8**  
 Structural Grade: **0**  
 O&M Grade: **0**  
 Clock Start/From: **9**  
 Clock To:  
 1st Value: **6.000**  
 2nd Value:  
 Value Percent:  
 Continuous Index:  
 Within 8" of Joint: **YES**  
 Remarks: **100% PLUGGED WITH ROOTS**

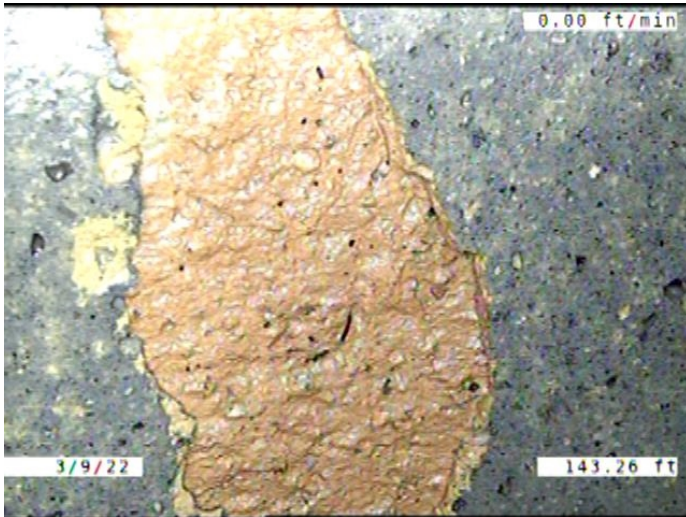
Code: **SSS**  
Description: **Surface Damage Surface Spalling**

Distance (ft): **143.3**  
Structural Grade: **2**  
O&M Grade: **0**  
Clock Start/From: **11**  
Clock To:  
1st Value:  
2nd Value:  
Value Percent:  
Continuous Index:  
Within 8" of Joint: **YES**  
Remarks:

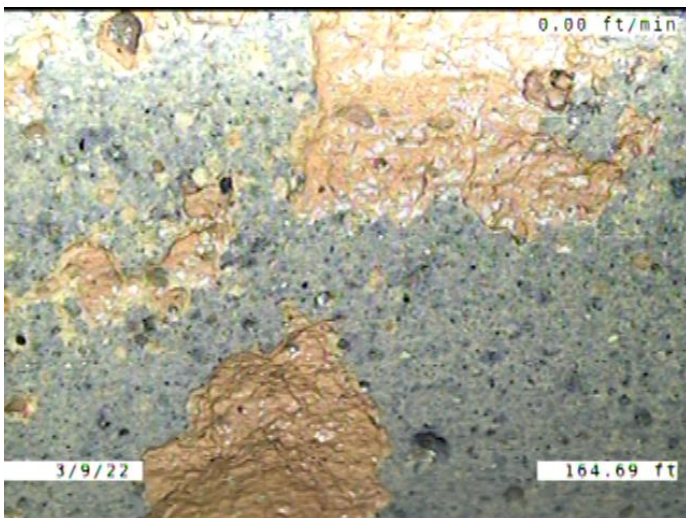
Code: **SSS**  
Description: **Surface Damage Surface Spalling**

Distance (ft): **164.7**  
Structural Grade: **2**  
O&M Grade: **0**  
Clock Start/From: **9**  
Clock To: **10**  
1st Value:  
2nd Value:  
Value Percent:  
Continuous Index:  
Within 8" of Joint: **YES**  
Remarks:

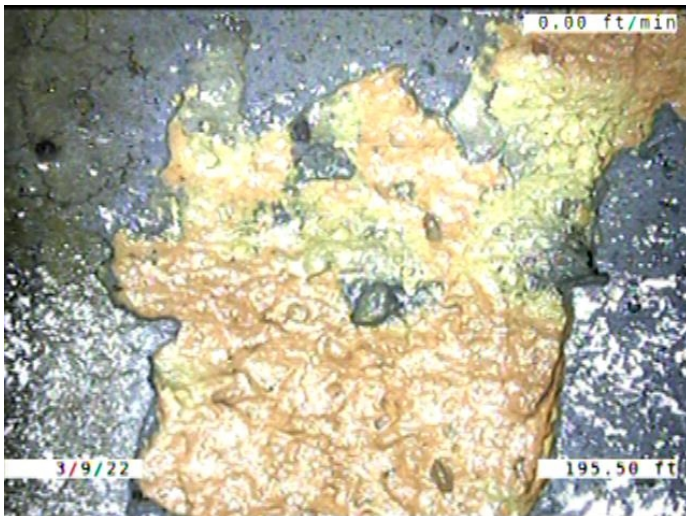
Code: **SSS**  
 Description: **Surface Damage Surface Spalling**

Distance (ft): **195.5**  
 Structural Grade: **2**  
 O&M Grade: **0**  
 Clock Start/From: **4**  
 Clock To:  
 1st Value:  
 2nd Value:  
 Value Percent:  
 Continuous Index:  
 Within 8" of Joint: **NO**  
 Remarks:

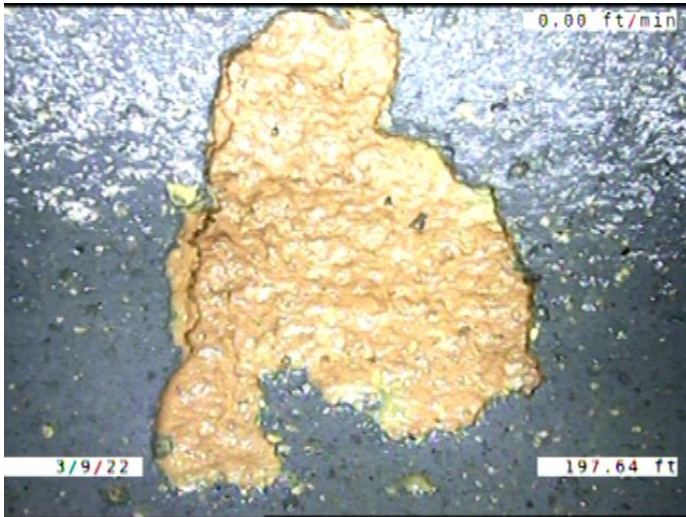
Code: **SSS**  
Description: **Surface Damage Surface Spalling**

Distance (ft): **197.6**  
Structural Grade: **2**  
O&M Grade: **0**  
Clock Start/From: **10**  
Clock To: **11**  
1st Value:  
2nd Value:  
Value Percent:  
Continuous Index:  
Within 8" of Joint: **YES**  
Remarks:

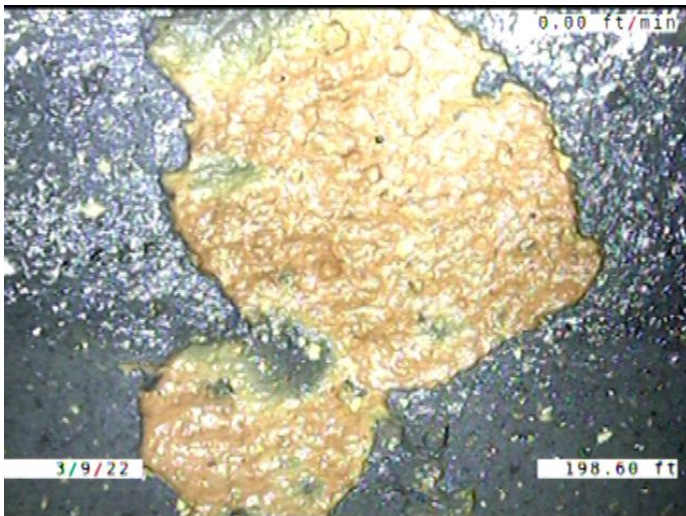
Code: **SSS**  
Description: **Surface Damage Surface Spalling**

Distance (ft): **198.6**  
Structural Grade: **2**  
O&M Grade: **0**  
Clock Start/From: **9**  
Clock To:  
1st Value:  
2nd Value:  
Value Percent:  
Continuous Index:  
Within 8" of Joint: **YES**  
Remarks:

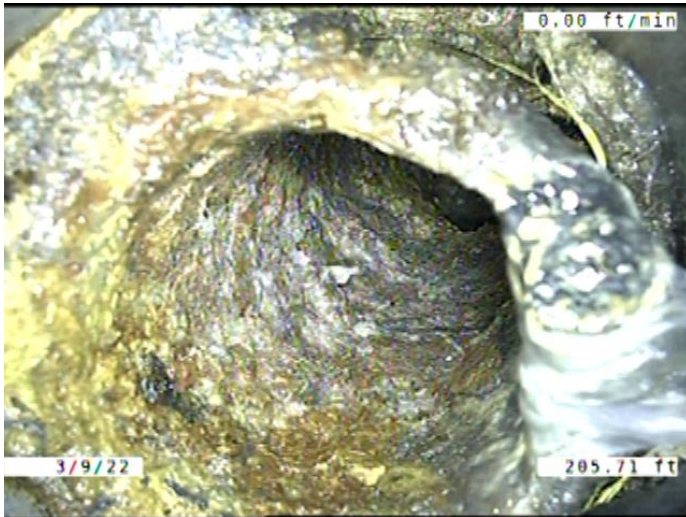
Code:	<b>TFD</b>
Description:	<b>Tap Factory Defective</b>
Distance (ft):	<b>205.7</b>
Structural Grade:	<b>0</b>
O&M Grade:	<b>3</b>
Clock Start/From:	<b>2</b>
Clock To:	
1st Value:	<b>6.000</b>
2nd Value:	
Value Percent:	
Continuous Index:	
Within 8" of Joint:	<b>YES</b>
Remarks:	<b>BROKEN. CONSTANTLY RUNNING WATER</b>

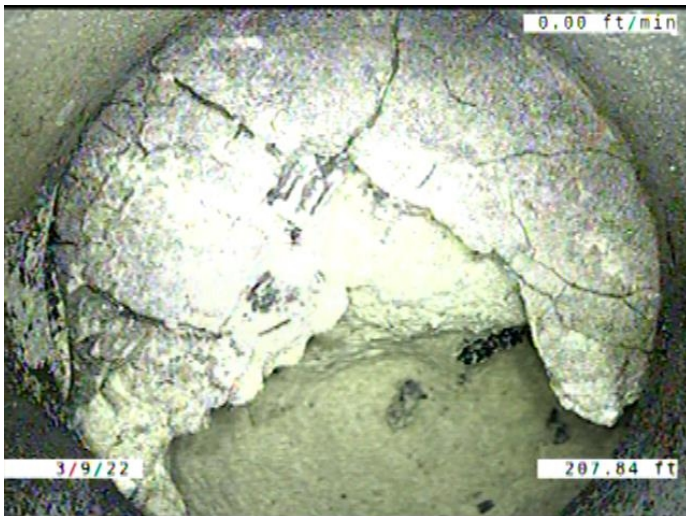
Code:	<b>TFD</b>
Description:	<b>Tap Factory Defective</b>
Distance (ft):	<b>207.8</b>
Structural Grade:	<b>0</b>
O&M Grade:	<b>3</b>
Clock Start/From:	<b>10</b>
Clock To:	
1st Value:	<b>6.000</b>
2nd Value:	
Value Percent:	
Continuous Index:	
Within 8" of Joint:	<b>YES</b>
Remarks:	<b>CAP BROKEN AND MISSING. SOIL VISIBLE</b>

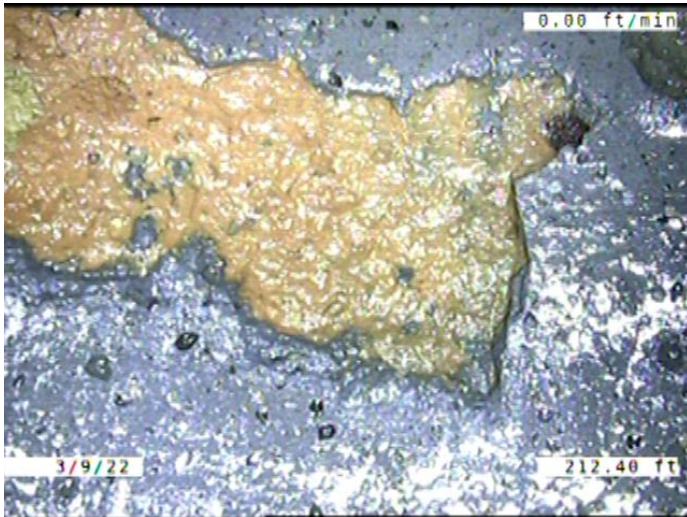
Code: **SSS**  
 Description: **Surface Damage Surface Spalling**

Distance (ft): **212.4**  
 Structural Grade: **2**  
 O&M Grade: **0**  
 Clock Start/From: **3**  
 Clock To: **11**  
 1st Value:  
 2nd Value:  
 Value Percent:  
 Continuous Index:  
 Within 8" of Joint: **YES**  
 Remarks:

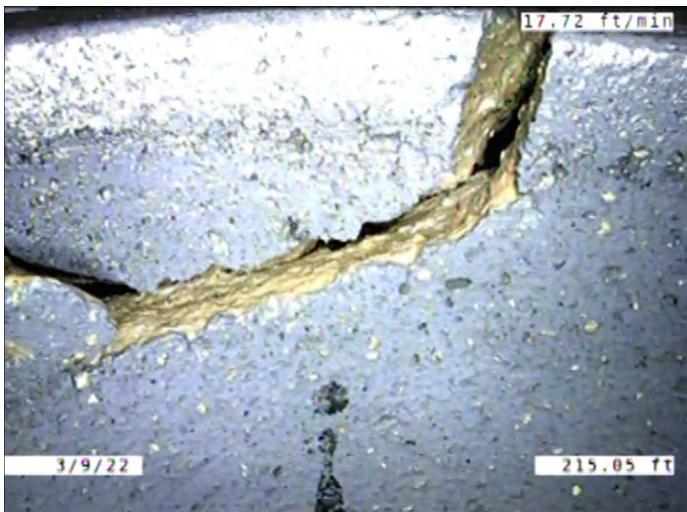
Code: **B**  
 Description: **Broken**

Distance (ft): **215.0**  
 Structural Grade: **4**  
 O&M Grade: **0**  
 Clock Start/From: **8**  
 Clock To: **10**  
 1st Value:  
 2nd Value:  
 Value Percent:  
 Continuous Index:  
 Within 8" of Joint: **YES**  
 Remarks:

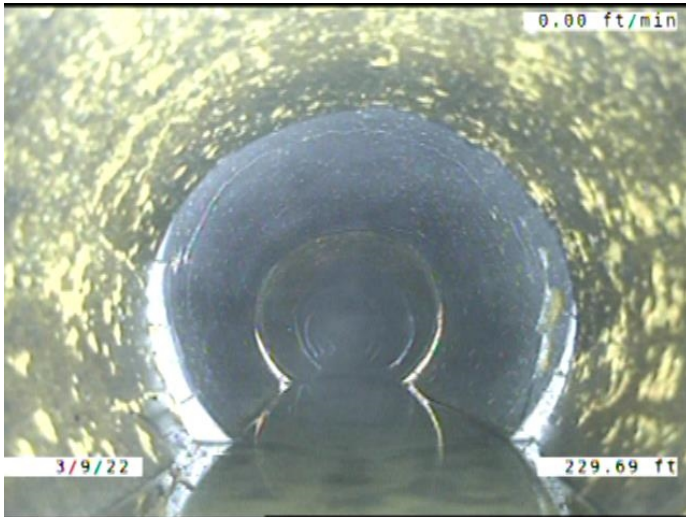
Code: **SSS**  
 Description: **Surface Damage Surface Spalling**

Distance (ft): **229.7**  
 Structural Grade: **2**  
 O&M Grade: **0**  
 Clock Start/From: **8**  
 Clock To: **4**  
 1st Value:  
 2nd Value:  
 Value Percent:  
 Continuous Index:  
 Within 8" of Joint: **YES**  
 Remarks:

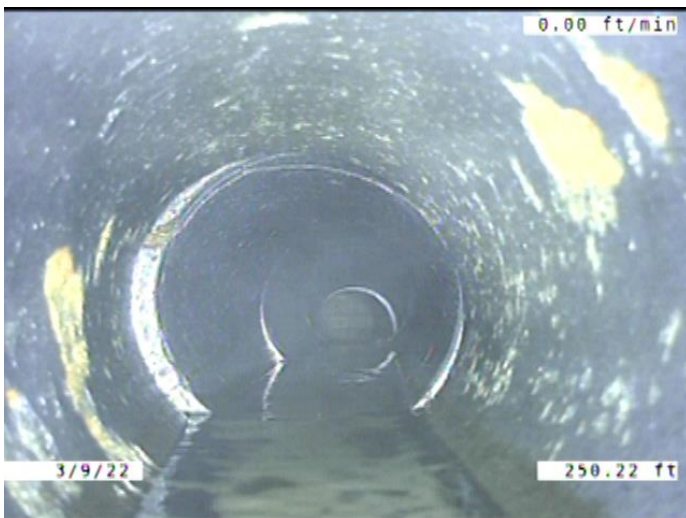
Code: **SSS**  
 Description: **Surface Damage Surface Spalling**

Distance (ft): **250.2**  
 Structural Grade: **2**  
 O&M Grade: **0**  
 Clock Start/From: **8**  
 Clock To: **4**  
 1st Value:  
 2nd Value:  
 Value Percent:  
 Continuous Index:  
 Within 8" of Joint: **YES**  
 Remarks:

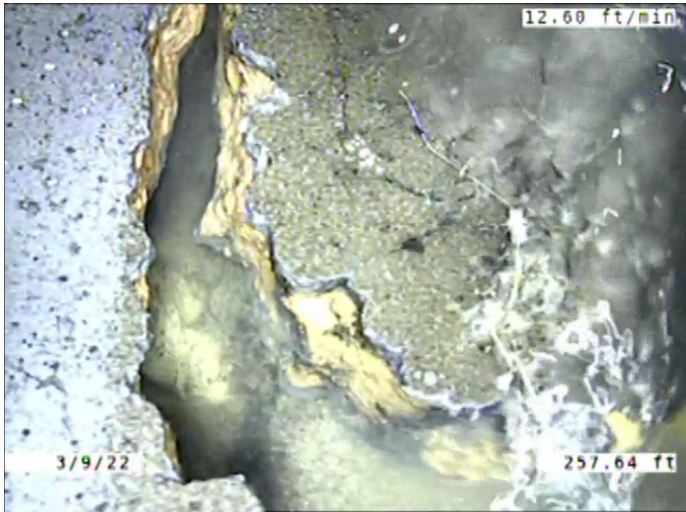
Code: **B**  
Description: **Broken**

Distance (ft): **257.6**  
Structural Grade: **4**  
O&M Grade: **0**  
Clock Start/From: **4**  
Clock To: **8**  
1st Value:  
2nd Value:  
Value Percent:  
Continuous Index:  
Within 8" of Joint: **YES**  
Remarks:

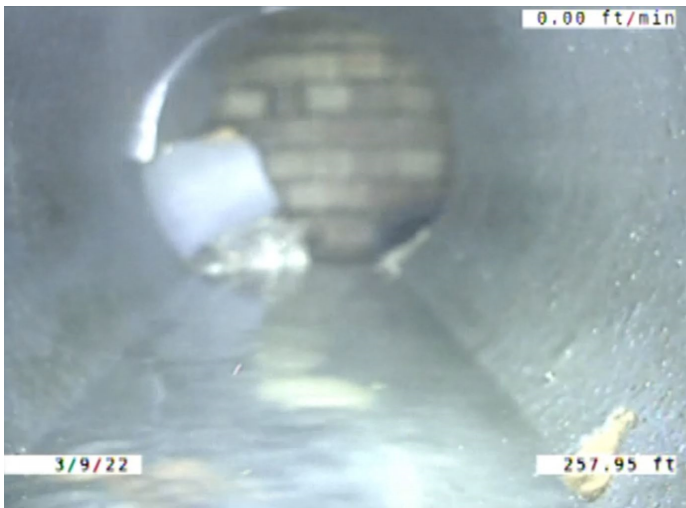
Code: **SSS**  
Description: **Surface Damage Surface Spalling**

Distance (ft): **258.0**  
Structural Grade: **2**  
O&M Grade: **0**  
Clock Start/From: **3**  
Clock To: **9**  
1st Value:  
2nd Value:  
Value Percent:  
Continuous Index:  
Within 8" of Joint: **NO**  
Remarks:

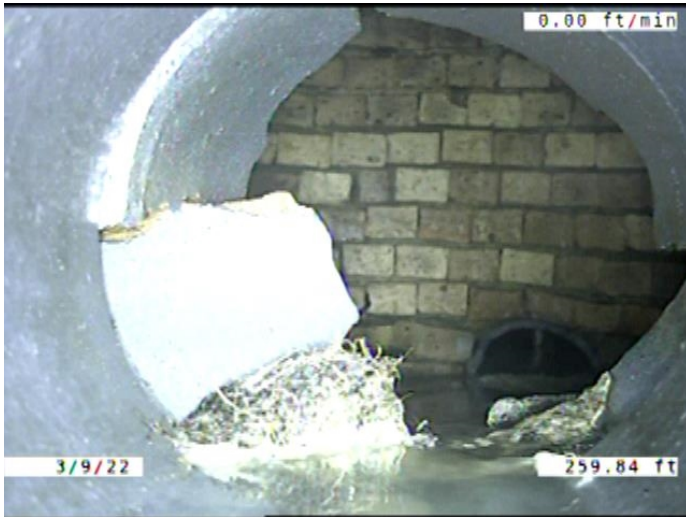
Code: **DR**  
 Description: **Deformed Rigid**

Distance (ft): **259.8**  
 Structural Grade: **5**  
 O&M Grade: **0**  
 Clock Start/From:  
 Clock To:  
 1st Value:  
 2nd Value:  
 Value Percent: **15.000**  
 Continuous Index:  
 Within 8" of Joint: **NO**  
 Remarks:

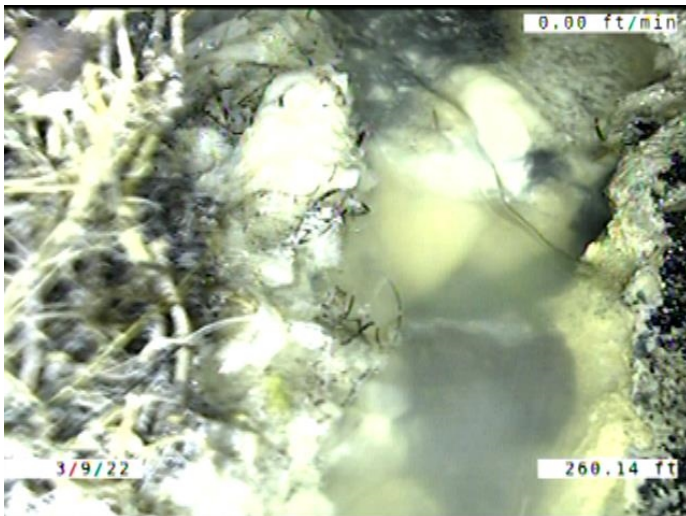
Code: **H**  
 Description: **Hole**

Distance (ft): **260.1**  
 Structural Grade: **5**  
 O&M Grade: **0**  
 Clock Start/From: **5**  
 Clock To: **7**  
 1st Value:  
 2nd Value:  
 Value Percent:  
 Continuous Index:  
 Within 8" of Joint: **YES**  
 Remarks:

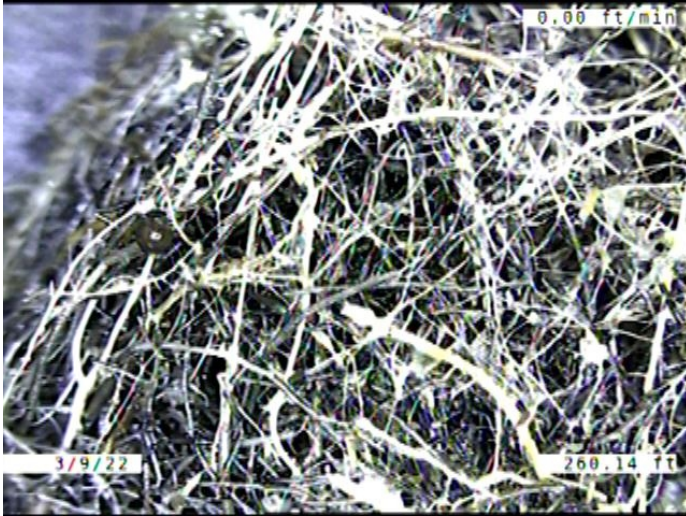
Code: **OBZ**  
Description: **Obstruction Other**

Distance (ft): **260.1**  
Structural Grade: **0**  
O&M Grade: **2**  
Clock Start/From: **6**  
Clock To: **7**  
1st Value:  
2nd Value:  
Value Percent: **5.000**  
Continuous Index:  
Within 8" of Joint: **YES**  
Remarks: **ROOTS THAT HAVE BEEN CUT**
