# Profile/Photo Observation Report

Date:	03/09/2022	Weather:		Coding:	PACP 7.0
Pipe Length (ft):	268.0	Owner:	City of Hobart	Pre Clean:	Heavy Cleaning
P.O.#:	YES502259	Surveyor:	S. Bucklin	PSR:	P-705-022-019
Customer:	City of Hobart, IN (Red	Clean Date:	03/06/2022	Shape:	C

Street:	South Lake Street	Flow Control:	Not Controlled
City:	Hobart, IN	Year Renewed:	
Location:	Local rural streets with light traffic, t	Tape/Media #:	
Purpose:	Routine Assessment	Dia/Height:	8"
Use:	Sanitary Sewage Pipe	Material:	VCP
Drain Area:		Lining:	None
Category:	NA		
Comment:			
Location Details:		Direction of Survey:	Downstream
US MH:	M-705-019	DS MH:	M-705-022
		Total Length Surveyed (ft):	261.1

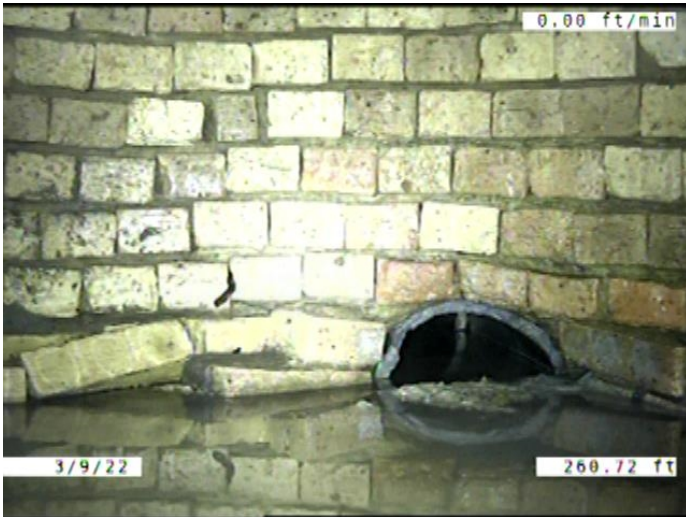
Code: **DSF**  
Description: **Deposits Settled Fine**

Distance (ft): **260.7**  
Structural Grade: **0**  
O&M Grade: **2**  
Clock Start/From: **5**  
Clock To: **7**  
1st Value:  
2nd Value:  
Value Percent: **5.000**  
Continuous Index: **F01**  
Within 8" of Joint: **YES**  
Remarks:

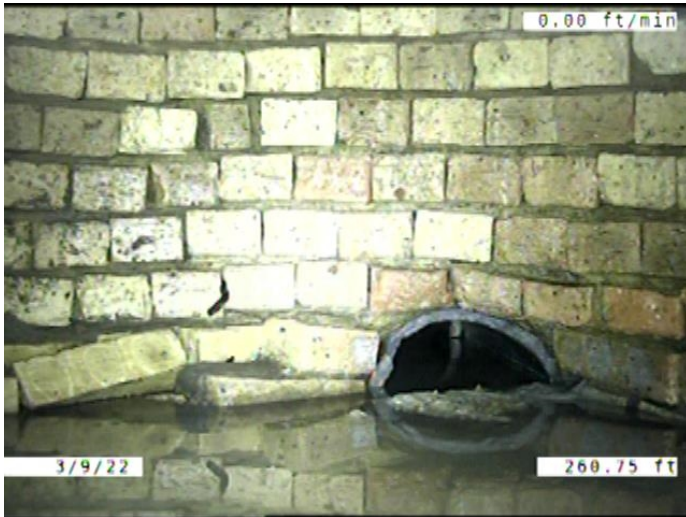
Code: **RMJ**  
 Description: **Roots Medium Joint**

Distance (ft): **260.7**  
 Structural Grade: **0**  
 O&M Grade: **3**  
 Clock Start/From: **8**  
 Clock To: **4**  
 1st Value:  
 2nd Value:  
 Value Percent: **5.000**  
 Continuous Index: **F03**  
 Within 8" of Joint: **YES**  
 Remarks:
