Profile/Photo Observation Report

Date:	05/01/2018	Weather:		Coding:	PACP 6.0
Pipe Length (ft):		Owner:	City of Hobart	Pre Clean:	No Pre-Cleaning
P.O.#:	154	Surveyor:	M. Pielacha	PSR:	P-705-016-023
Customer:	City of Hobart	Clean Date:		Shape:	C

Street:	Main Street	Flow Control:	Not Controlled
City:	Hobart, IN	Year Renewed:	
Location:	Light Highway	Tape/Media #:	DEP 154
Purpose:	Routine Assessment	Dia/Height:	18"
Use:	Sanitary	Material:	VCP
Drain Area:		Lining:	
Category:	NA		
Comment:	5-21-2018		
Location Details:		Direction of Survey:	Upstream
US MH:	M-705-023	DS MH:	M-705-016
		Total Length Surveyed (ft):	1.0

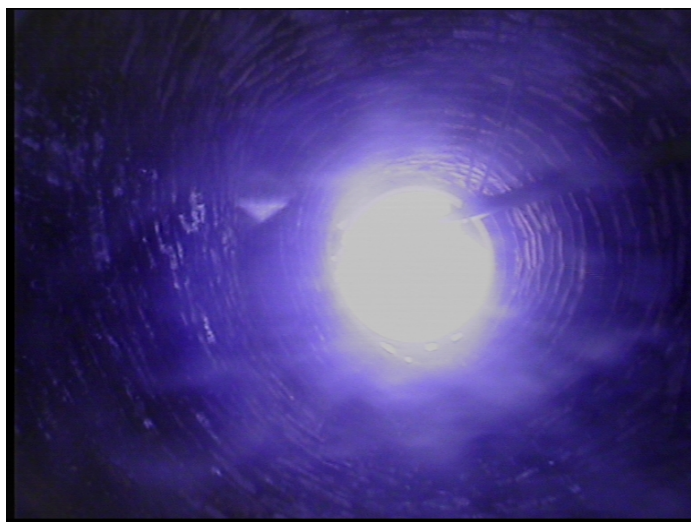
Code: **AMH**
 Description: **Manhole**

Distance (ft): **.0**
 Structural Grade: **0**
 O&M Grade: **0**
 Clock Start/From:
 Clock To:
 1st Value:
 2nd Value:
 Value Percent:
 Continuous Index:
 Within 8" of Joint: **NO**
 Remarks: **M-705-016**

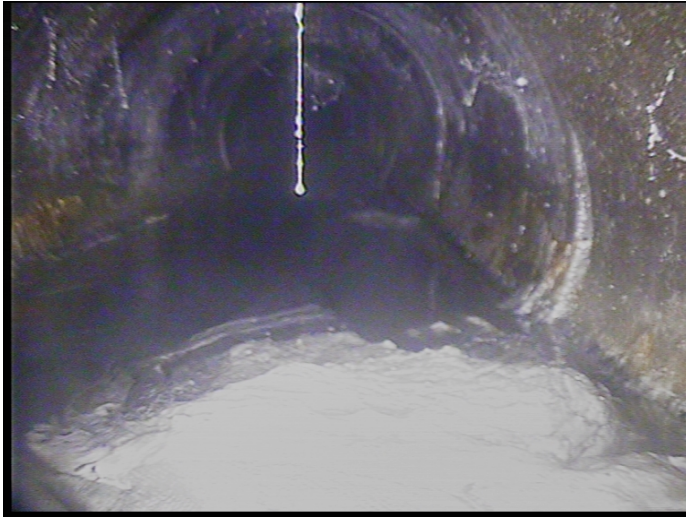
Code: **MWL**
Description: **Water Level**

Distance (ft): **.0**
Structural Grade: **0**
O&M Grade: **0**
Clock Start/From:
Clock To:
1st Value:
2nd Value:
Value Percent: **10.000**
Continuous Index:
Within 8" of Joint: **NO**
Remarks:

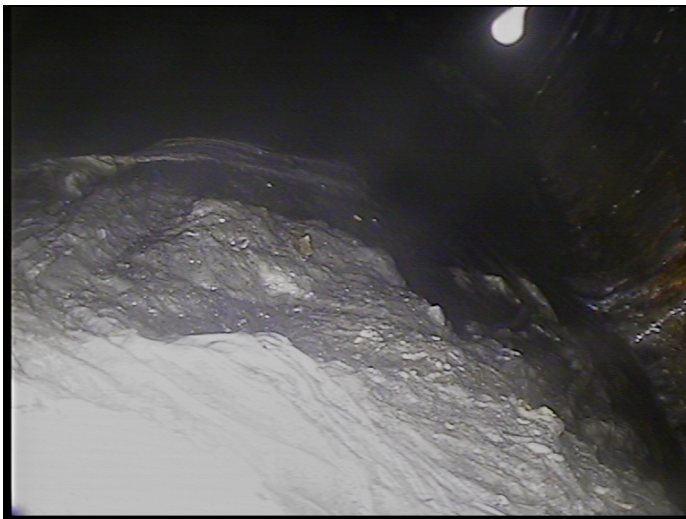
Code: **DSF**
Description: **Deposits Settled Fine**

Distance (ft): **.0**
Structural Grade: **0**
O&M Grade: **3**
Clock Start/From: **4**
Clock To: **8**
1st Value:
2nd Value:
Value Percent: **20.000**
Continuous Index:
Within 8" of Joint: **YES**
Remarks:

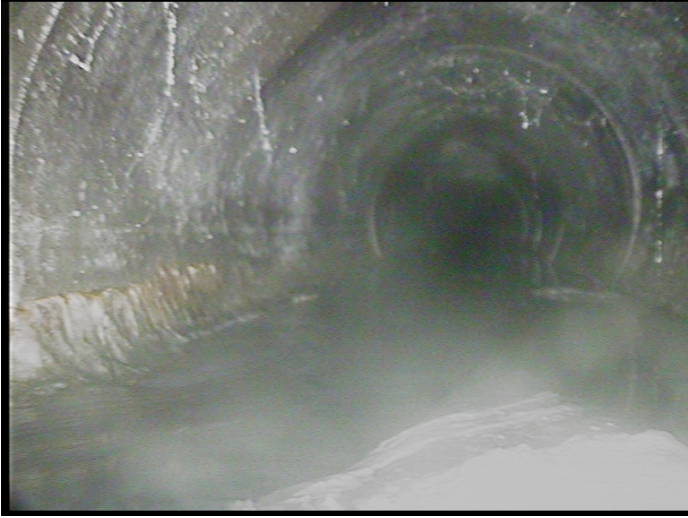
Code:	MSA
Description:	Abandoned Survey
Distance (ft):	1.0
Structural Grade:	0
O&M Grade:	0
Clock Start/From:	
Clock To:	
1st Value:	
2nd Value:	
Value Percent:	
Continuous Index:	
Within 8" of Joint:	NO
Remarks:	sediment
