Profile/Photo Observation Report

| Street: | Main Street | Flow Control: | Not Controlled |
| US MH: | M-705-023 | DS MH: | M-705-016 |

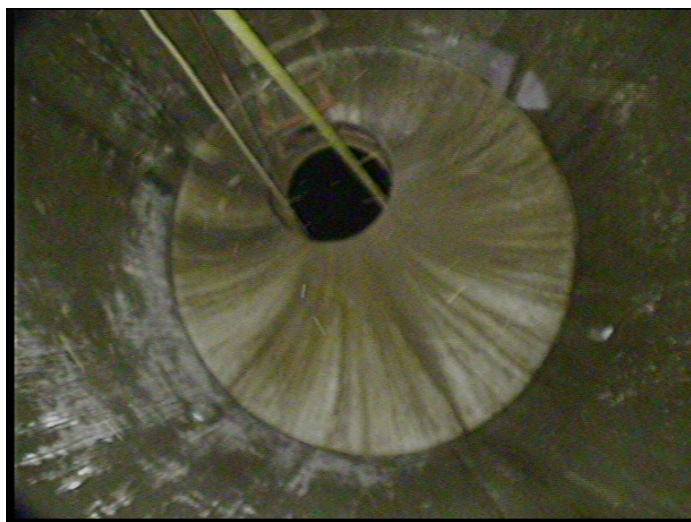
Code: **AMH**
Description: **Manhole**

Distance (ft): **.0**
Structural Grade: **0**
O&M Grade: **0**
Clock Start/From:
Clock To:
1st Value:
2nd Value:
Value Percent:
Continuous Index:
Within 8" of Joint: **NO**
Remarks: **M-705-023**

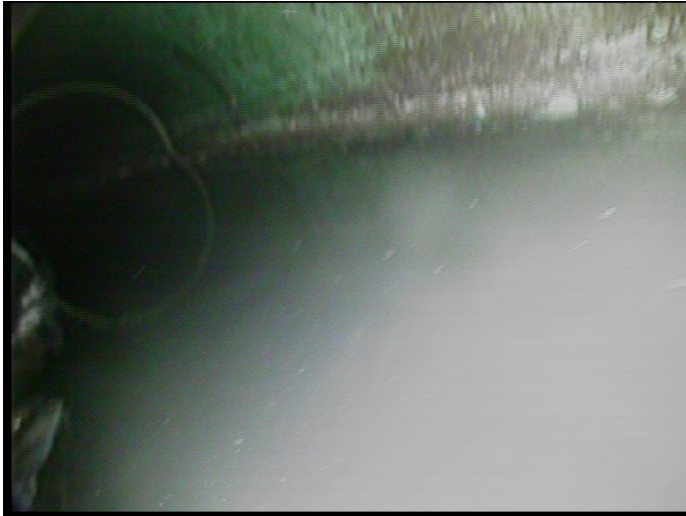
Code: **MWL**
Description: **Water Level**

Distance (ft): **.0**
Structural Grade: **0**
O&M Grade: **0**
Clock Start/From:
Clock To:
1st Value:
2nd Value:
Value Percent: **10.000**
Continuous Index:
Within 8" of Joint: **NO**
Remarks:

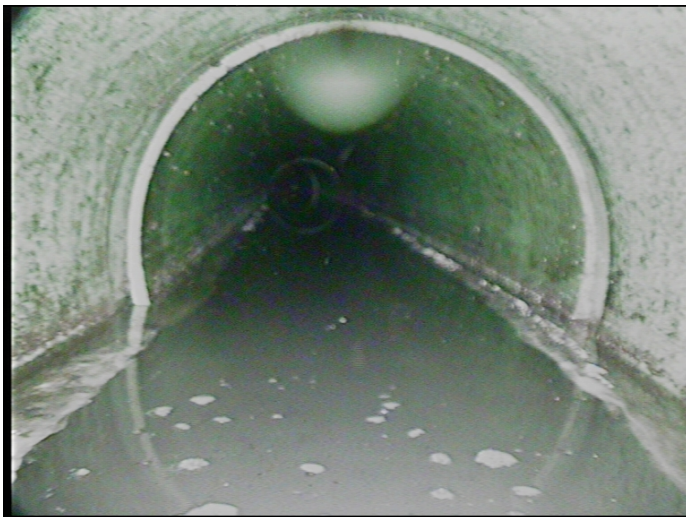
| | Position | Code | Observation | Video (sec) | Grade |
|--|---|---|---|---|---|
| | 2.6 | DSF | Deposits Settled Fine | 221 | M 3 |

Code: **DSF**
Description: **Deposits Settled Fine**

Distance (ft): **2.6**
Structural Grade: **0**
O&M Grade: **3**
Clock Start/From: **4**
Clock To: **8**
1st Value:
2nd Value:
Value Percent: **20.000**
Continuous Index:
Within 8" of Joint: **NO**
Remarks:

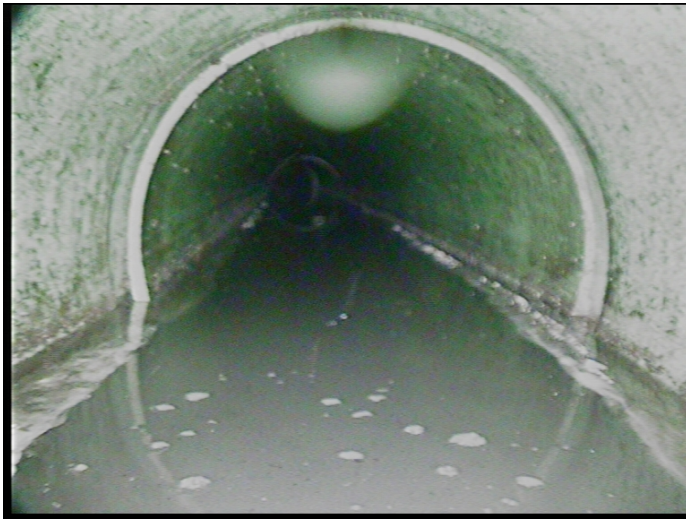
| Code: | MSA |
| Description: | Abandoned Survey |
| Distance (ft): | 2.6 |
| Remarks: | deep sediment |
