Profile/Photo Observation Report

Date:	05/01/2018	Weather:		Coding:	PACP 6.0
Pipe Length (ft):		Owner:	City of Hobart	Pre Clean:	No Pre-Cleaning
P.O.#:	155	Surveyor:	M. Pielacha	PSR:	P-705-023-024
Customer:	City of Hobart	Clean Date:		Shape:	C

Street:	Main Street	Flow Control:	Not Controlled
City:	Hobart, IN	Year Renewed:	
Location:	Light Highway	Tape/Media #:	DEP155
Purpose:	Routine Assessment	Dia/Height:	18"
Use:	Sanitary	Material:	VCP
Drain Area:		Lining:	
Category:	NA		
Comment:	5-21-2018		
Location Details:		Direction of Survey:	Downstream
US MH:	M-705-024	DS MH:	M-705-023
		Total Length Surveyed (ft):	12.3

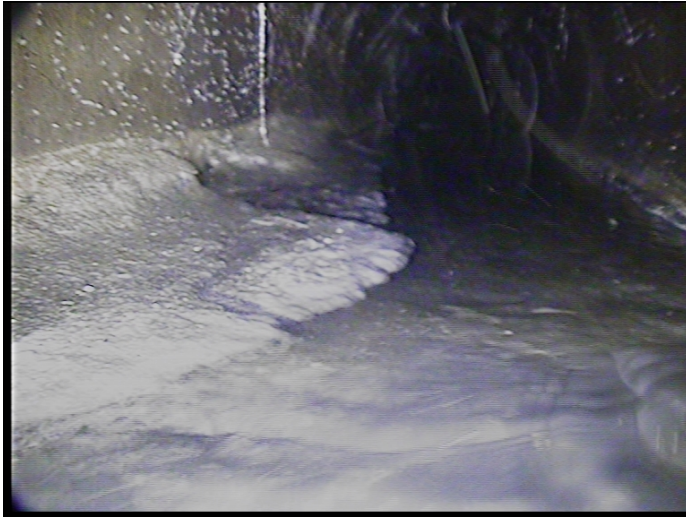
Code: **MWL**
Description: **Water Level**

Distance (ft): **.0**
Structural Grade: **0**
O&M Grade: **0**
Clock Start/From:
Clock To:
1st Value:
2nd Value:
Value Percent: **10.000**
Continuous Index:
Within 8" of Joint: **NO**
Remarks:

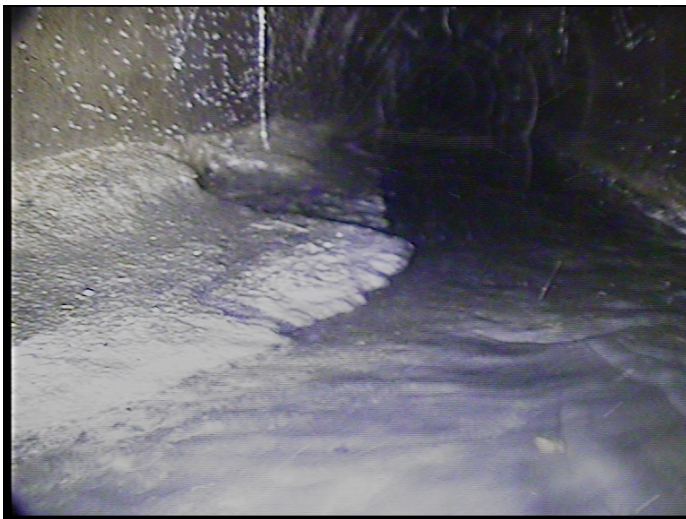
Code: **DSF**
Description: **Deposits Settled Fine**

Distance (ft): **.0**
Structural Grade: **0**
O&M Grade: **3**
Clock Start/From: **4**
Clock To: **8**
1st Value:
2nd Value:
Value Percent: **15.000**
Continuous Index: **S01**
Within 8" of Joint: **YES**
Remarks:

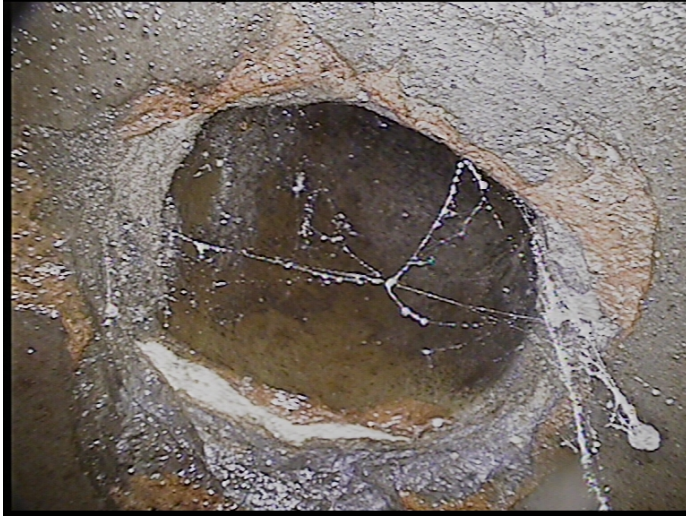
Code: **TF**
Description: **Tap Factory**

Distance (ft): **11.1**
Structural Grade: **0**
O&M Grade: **0**
Clock Start/From: **2**
Clock To:
1st Value: **4.000**
2nd Value:
Value Percent:
Continuous Index:
Within 8" of Joint: **NO**
Remarks:

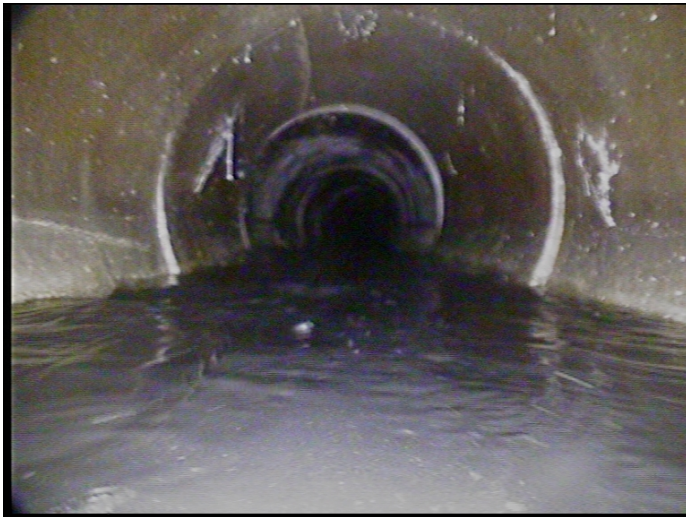
Code: **DSF**
Description: **Deposits Settled Fine**

Distance (ft): **12.2**
Structural Grade: **0**
O&M Grade: **3**
Clock Start/From: **4**
Clock To: **8**
1st Value:
2nd Value:
Value Percent: **20.000**
Continuous Index: **F01**
Within 8" of Joint: **NO**
Remarks:

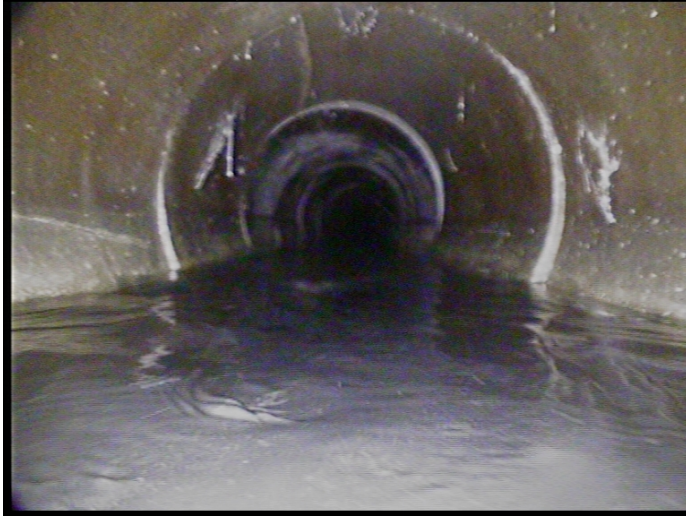
Code:	MSA
Description:	Abandoned Survey
Distance (ft):	12.3
Structural Grade:	0
O&M Grade:	0
Clock Start/From:	
Clock To:	
1st Value:	
2nd Value:	
Value Percent:	
Continuous Index:	
Within 8" of Joint:	NO
Remarks:	sediment
